# NONCOMPLIANCE INFORMATION REPORT FOR DAIMLERCHRYSLER RECALL F11

# **Safety Recall F11**

## **Right Front Door Latch Reinforcement Plate**

2006 (KJ) Jeep® Liberty

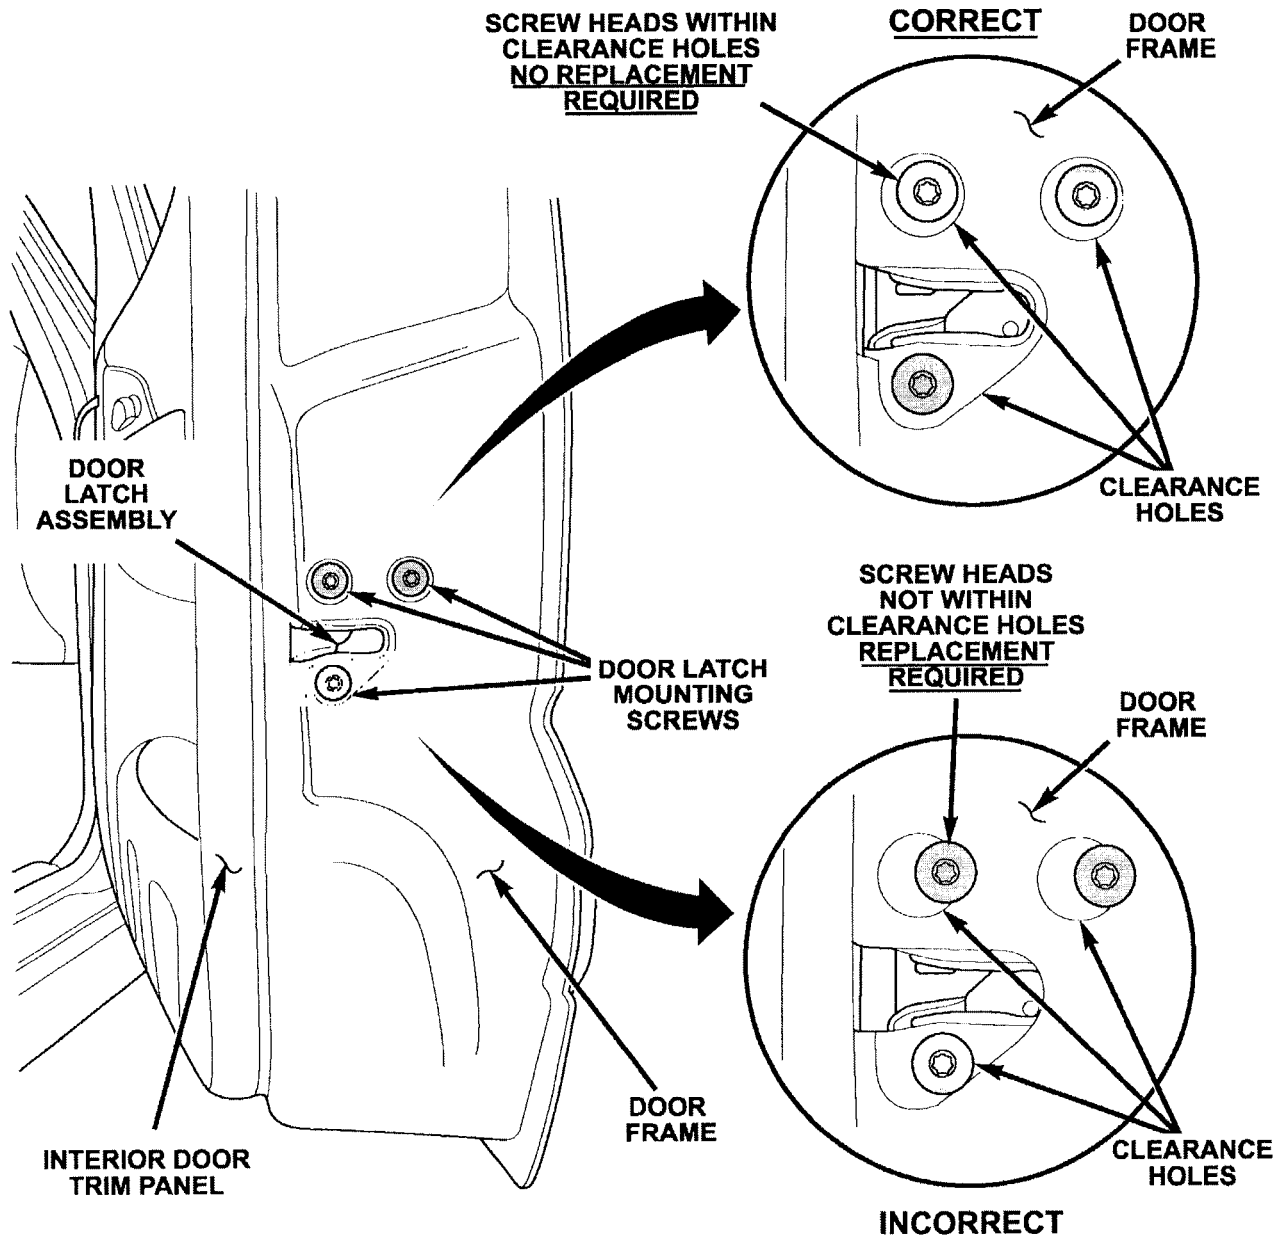
Figure 1 – Right Front Door

- If the screw heads are within the clearance holes (Figure 1) and the primary and secondary latch operates properly, no further action is required.
- If the screw heads are not within the clearance holes (Figure 1) and/or the secondary latch does not engage, replace the door latch reinforcement plate. Continue with **Section B. Door Latch Reinforcement Plate Replacement**.
