56V-100  
(3 Pages)

Re: Report Pursuant to 49 CFR 573.6  
Autocar, LLC, Recall No. A-0602

573.6(c)(1)  
Autocar, LLC

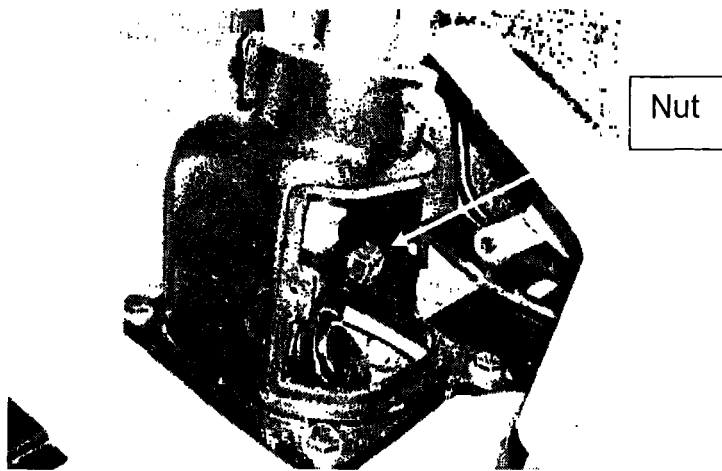
573.6(c)(5)  
A bolt on the steering shaft may not be torqued to the correct specification. Figure 1 shows the position of the nut on the bolt in the shaft.

- 3/3/06 Autocar pre-delivery inspector detected a rubbing noise in the steering column. Upon inspection he found that the nut was not torqued correctly.

- 3/27/06 Follow-up Product Integrity Committee Meeting resulting in the conclusion that the possibility exists that due to the loose nut, the yoke bolt could slide out partially and limit the rotation on the steering shaft, which could result in a loss of steering control. Autocar will administer a recall on behalf of Able. Autocar will institute at Able additional quality inspection (preventative/corrective action request document #030706), which will include on-line sign-off and end-of-line inspection. Autocar will institute at Autocar additional pre-delivery inspection procedures as well.

- 3/3/06 Autocar implemented additional inspection and torque verification procedures on all incoming vehicles and all stock units.
- 3/4/06 Inspection of stock units completed. Four units out of a population of 247 units were found to be suspect (0.81%). The suspect units were delivered from the supplier, Able Manufacturing, Inc., within one week during February 2006.

Autocar will initiate a voluntary owner notification and recall based on the vehicle population found with the sales options described in 573.6(c)(2) above.
