06K-107
(7 Pages)

The following information is submitted in accordance with the requirements of 49 CFR Part 573.6 as it applies to a defect relating to motor vehicle safety.

573.6(c)(2)
American LaFrance Pumper Bodies mounted on Eagle, Metropolitan and Freightliner M2 heavy-duty class 8 chassis manufactured between May 2005 and March 2006. Identified vehicles are fitted with Austin Hardware & Supply D-Handles used to open and close compartment doors.

The number which American LaFrance, LLC, has assigned to this recall for tracking purposes is **ALF - 0106**.

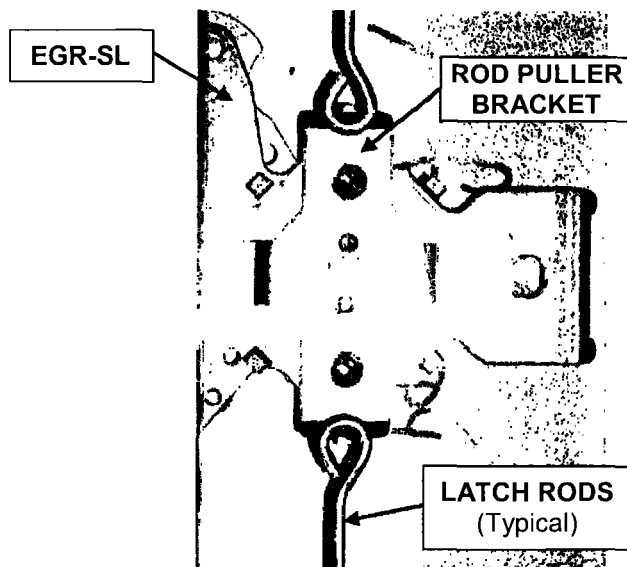
Figure 1

When the door is assembled the LATCH RODS used to activate the top and bottom latches are placed onto the ROD PULLER BRACKET (Figure 1) and adjusted so that when the D-HANDLE is rotated either left or right both top and bottom latches open simultaneously (Figure 2).

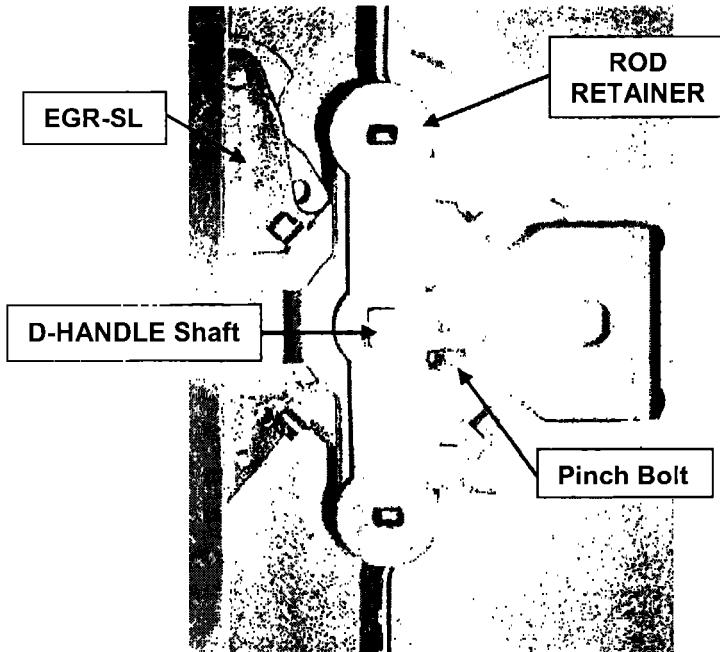
Figure 3

To keep the LATCH RODS on the ROD PULLER BRACKET a ROD RETAINER is placed on top. The ROD RETAINER is designed to be held onto the square D-HANDLE shaft by friction created when the pinch bolt is tightened (Figure 3).

However, due to various assembly issues proper friction is not always achieved and in some cases when a compartment door is slammed shut the “G” forces generated cause the ROD RETAINER to separate from the D-Handle assembly shaft and it falls into the door cavity and sooner or later the LATCH RODS separate from the ROD PULLER BRACKET (Figure 4 above). When this occurs there is no way to open the compartment door without dismantling the D-Handle assembly or in an emergency forcefully opening the door using a pry bar or fireman’s axe.

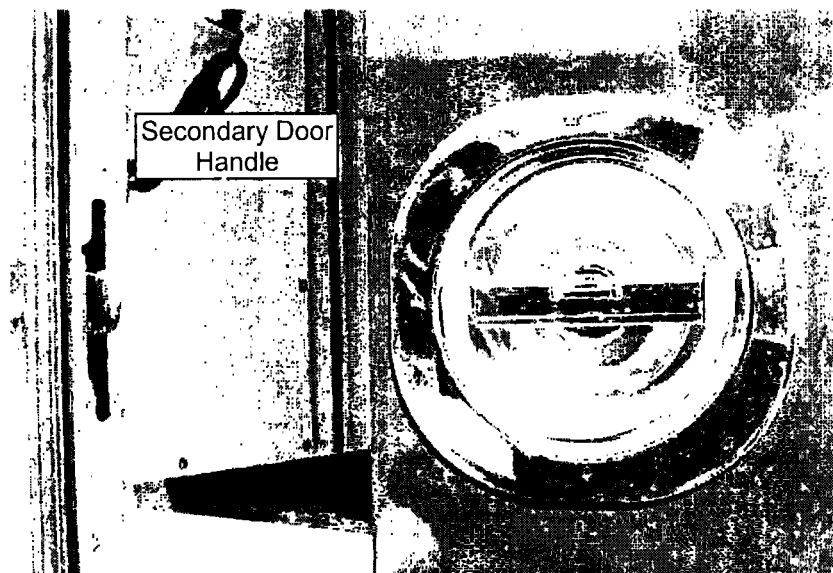
Figure 6

In the case of a large compartment that has a split door, there are two door handles. One door has the D-Handle and the second door has a latch handle that can be accessed once the first door has been opened (see Figure 6). Although there have been no reported failures on the secondary door handle assembly a similar fix has been applied to it as well (see Figure 7) In this case the whole latch assembly will be replaced under this recall.
