**Travel Supreme, Inc.**

06V-152  
(19 pages)

**573 DEFECT & NON COMPLIANCE REPORT**

Description: Mounting nut that attaches brake caliper to the yoke

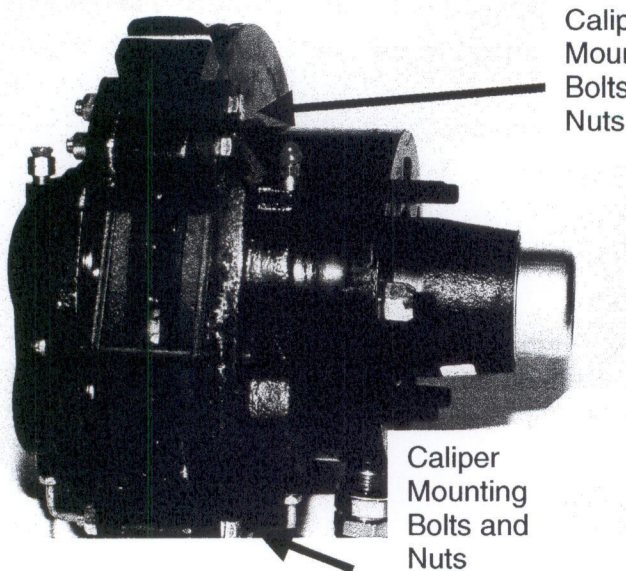
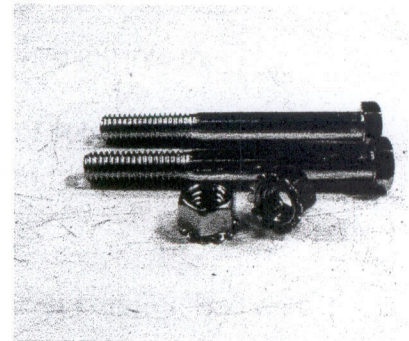
Keps Nuts and Bolts

The nature of the defect relates to stripped disc brake mounting hardware. Some of the axles supplied to us from February through March 2006 may have a caliper mounting bolts that are stripped. Insufficient clamp load between caliper and yoke can cause the caliper to disassemble and adversely affect the trailer's braking system.

1. Jack up trailer and secure on adequate capacity jack stands. Follow trailer manufactures recommendations for lifting and supporting the unit.
2. Remove the wheel from the hub, leaving the brake exposed.
3. Make sure hydraulic system is not pressurized during the hardware replacement.
4. Replace the four caliper mounting bolts and nuts with new supplied bolts and "Keps" nuts

**NOTE:** The bleeder fitting must be removed in order to replace one of the bolts. Carefully remove the fitting and cover the hole to prevent dirt from entering. After inserting the new bolt, re-install the bleeder fitting. **The system will not need to be re-bled if care is taken to prevent loss of fluid.** If excessive brake fluid is lost, the system should be re-bled according to the attached instructions.

5. Torque all four Keps nuts to 30 lb ft.
6. Remount the wheel. Start wheel nuts by hand to prevent cross threading.
7. Tighten wheel nuts in a "cross pattern" following the manufacturers recommendations for proper torque setting.
8. Spin wheel to ensure proper clearance between the wheel, crossover brake line and the rotor.
