# VOLKSWAGEN of America, Inc.

06V-198

Subject: **Notification of Recall Pursuant to 49 CFR Part 573 (2006)**  
**Model Years 1998 - 2000 Audi A6, A6 Avant, S6, and S6 Avant,**  
**Cover for Crossmember**

# A6 Dashboard – Recall Repair Solution

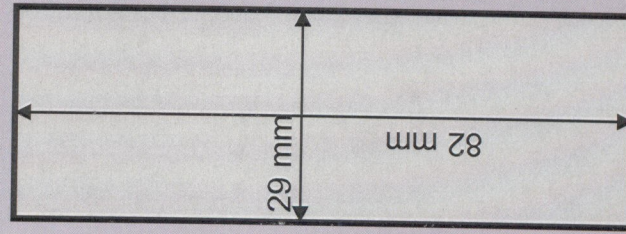
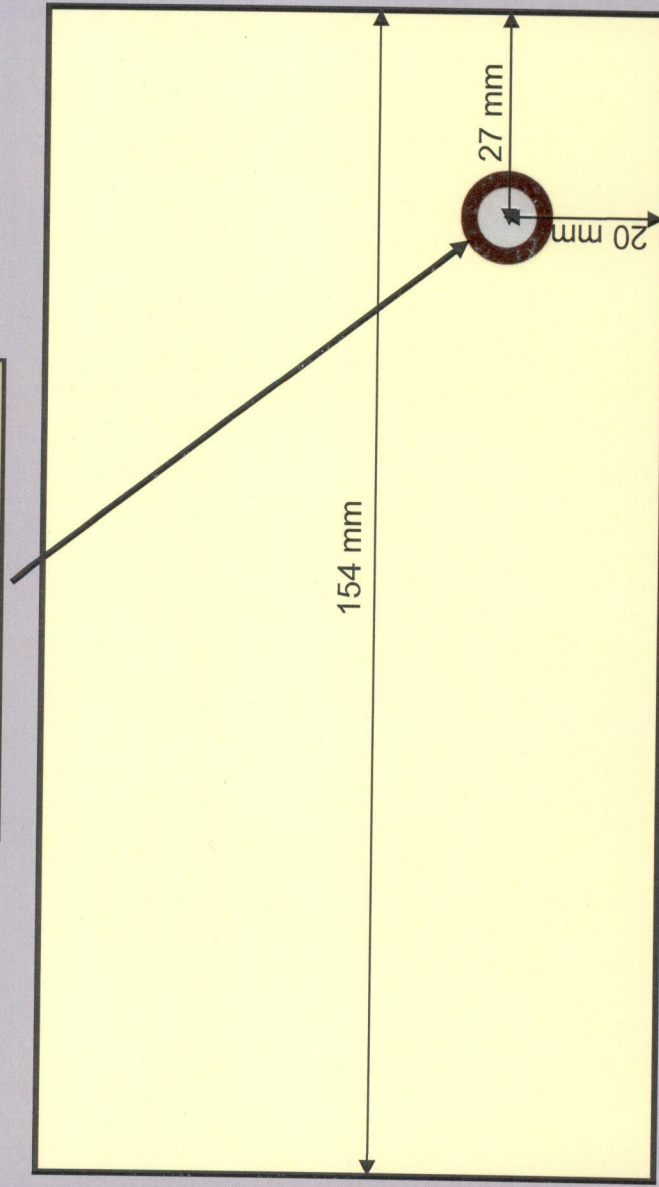
## Dimensional Sketch

- 573.6 (c) (5) **Description of Defect**  
While performing the repair described in NHTSA Recall 04V-133, if the plastic cover is not installed securely to the driver's side support crossmember, the headlight switch wiring harness could come into contact with the crossmember, possibly leading to an electrical short in the harness, which in rare cases could lead to a fire in the driver's side dashboard area.

- 573.6 (c) (6) **Basis for Determination**  
Consumer complaints and field reports.  
Date of determination 05/29/06.
- 573.6 (c) (8) **Proposed Remedial Program**  
An additional cover will be installed over the crossmember to protect against the headlight switch wiring harness rubbing against the crossmember. This cover includes a positive retention wire and can only be installed when the lower dash trim panel is removed. (See the attached drawings for additional details)
