SUBJECT: SAFETY RECALL NOTIFICATION

Safety Defect and Noncompliance Report Guide for Vehicles PART 573 Defect and Noncompliance Report⁽¹⁾

DATE : OCTOBER 2006 SECTION : 12
 SUBJECT : BENDIX® SR-7™ SPRING BRAKE MODULATING VALVE

Sr06-10

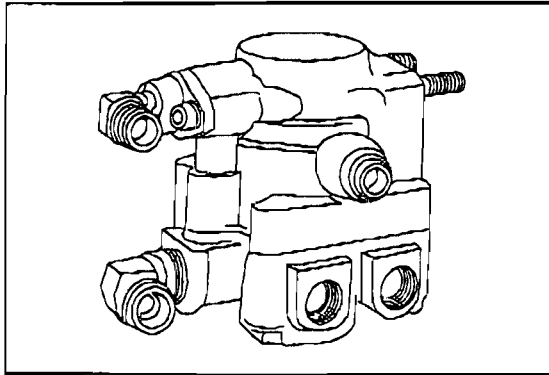
FIGURE1: SR-7 VALVE

Bendix has determined that a check valve inside the Bendix® SR-7™ spring brake modulating valve may not properly seat, causing internal valve leakage. The leakage can result in delayed application of the spring brakes to park the vehicle upon pulling of the dash valve button. The delay, which could last up to three minutes, may be accompanied by secondary air leakage, such that the secondary reservoir is depleted. During this time, there is a risk that the vehicle can roll away. This issue does not affect the operation of the vehicles service brakes, however it could affect the emergency stopping distance in the event of a primary air system failure application of parking brakes.

3. Remove the L.H. side hinged rear fender or raise the vehicle to access the spring brake valve.
4. Identify all lines before disconnecting then disconnect the lines and hoses from the spring brake valve.
5. Remove the two mounting nuts that secure the valve to the frame rail then remove the valve.

1. Align the mounting studs with the mounting holes on the vehicle frame rail. Tighten the mounting nuts to 180-220 inch-lbs.
2. Install the valve (642015) onto the vehicle ensuring all ports are connected as marked during disassembly.

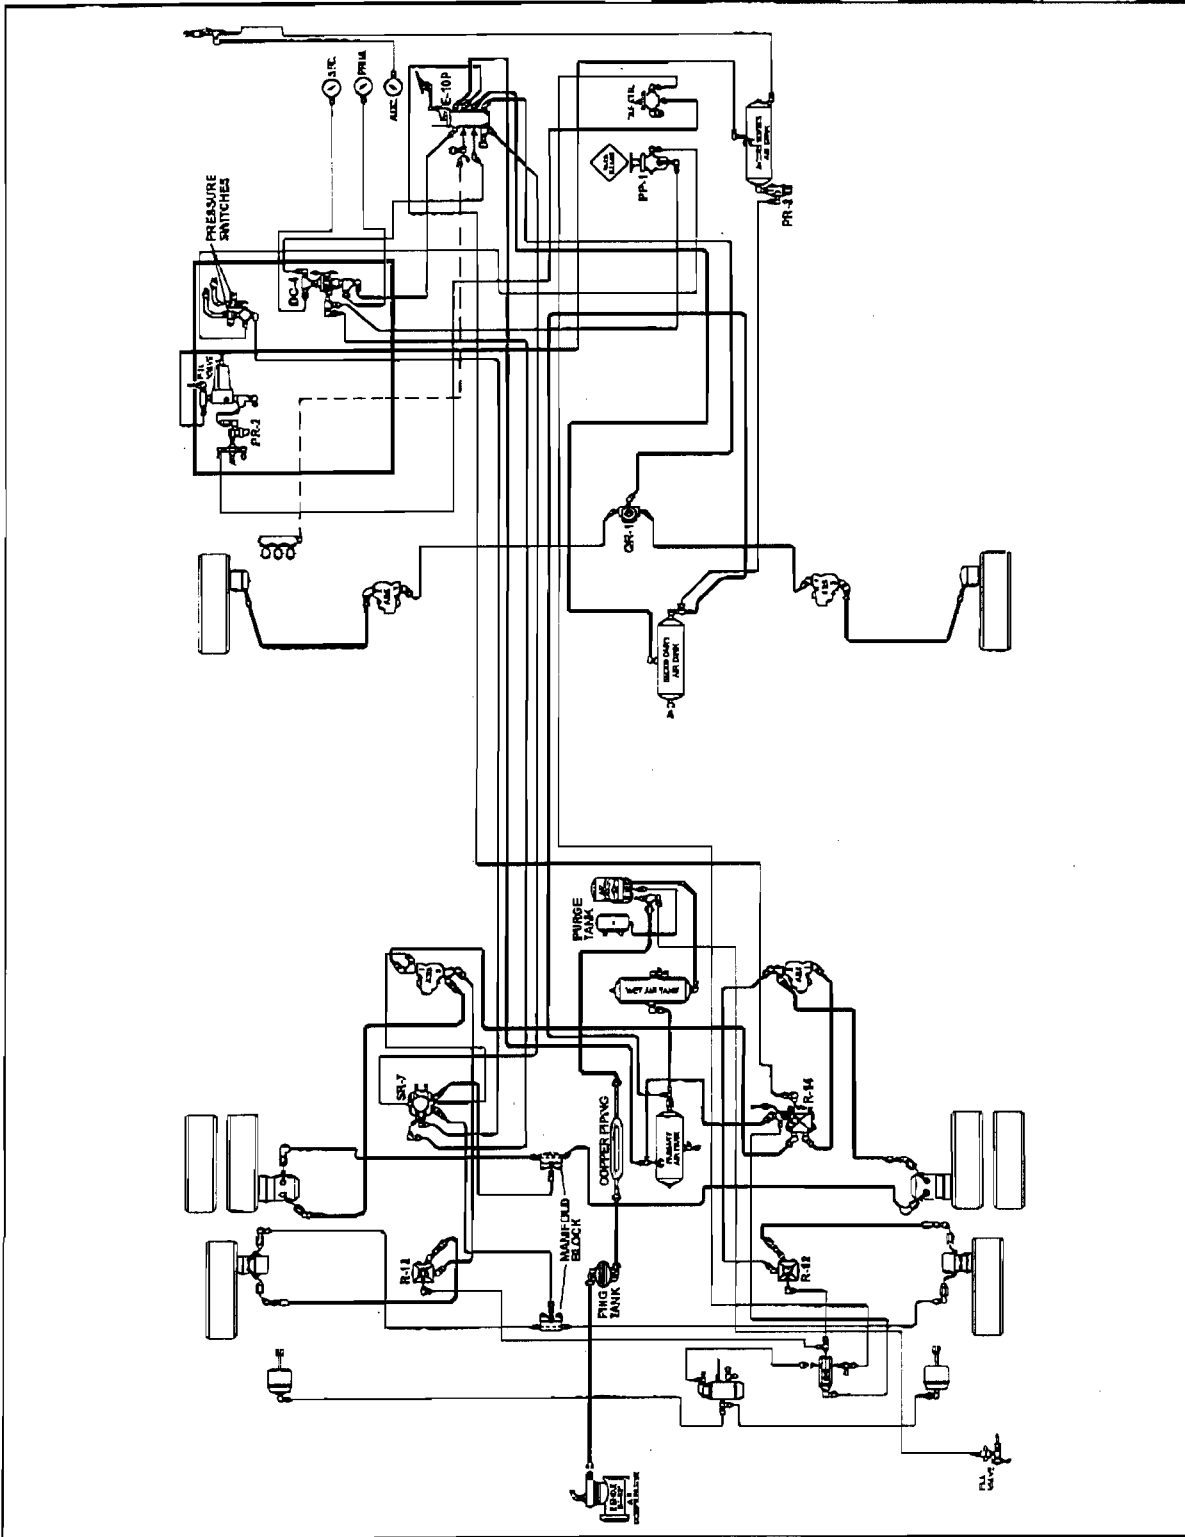
FIGURE 2: AIR-OPERATED BRAKING SYSTEM H3

1. Drain all vehicle reservoirs.
2. The spring brake valve is located above the drive axle, behind the L.H. side hinged rear fender (Refer to figure 2 for H3 vehicles) or in the rear underframe (Refer to figures 3 & 4 for X3-45 coaches).

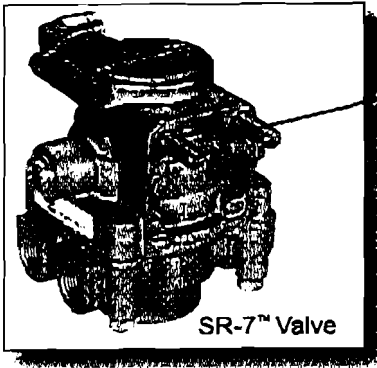
Step 1: Identify the casting as either Bendix 1 or Bendix 2.
(Located on the side of the valve as shown.)

If the casting has "Bendix 1" on the side, it is potentially affected by the recall campaign and must be further identified.

If the casting has "Bendix 2" on the side, it is not affected by the recall campaign, and no further action is required.

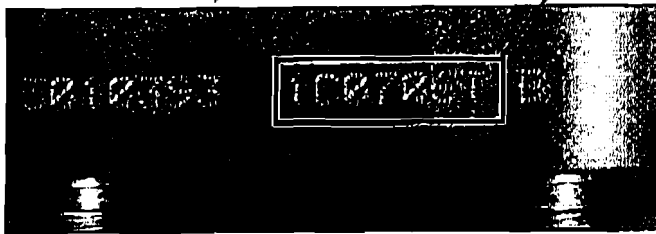
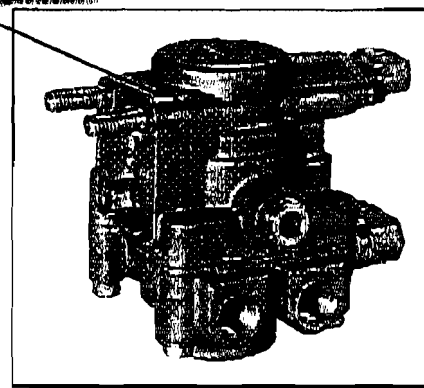
Step 2: Identify the date of manufacture.
(Date code located on the top of the valve as shown.)

SR-7™ valves with the casting code "Bendix 1" manufactured between April 1, 2006 and May 24, 2006 are subject to the recall campaign and must be replaced.

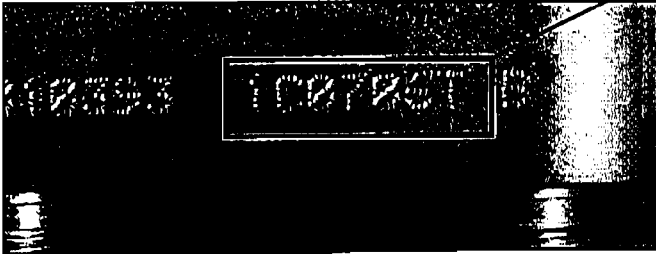
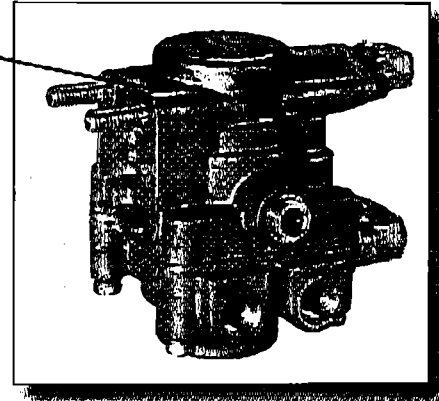
Date Code Location

The key date code characters used for identification are the 2nd through the 6th alphanumeric characters; all others can be disregarded.

The second character in the date code is an alpha character representing the month of manufacture (A through M skipping the letter I) corresponding to January through December (D = April and E = May). The next four characters are numbers representing the two digit day of the month followed by the two digit year. For example the date code 1C0706T, key characters C0706, indicates the valve was manufactured 3-07-06 or March 7, 2006.

SR-7™ valves with a casting code "Bendix 1" and the following date codes are subject to the recall campaign and must be replaced per the SR-7™ Recall Campaign Guidelines.

D0106 (April 1, 2006) through _E2406_ (May 24, 2006) inclusive.
