06V-280

## **Safety Defect and Noncompliance Report Guide for Vehicles** **Part 573 Defect and Noncompliance Report**

## WORKHORSE CUSTOM CHASSIS SERVICE BULLETIN

**SUBJECT:** Steering Intermediate Shaft

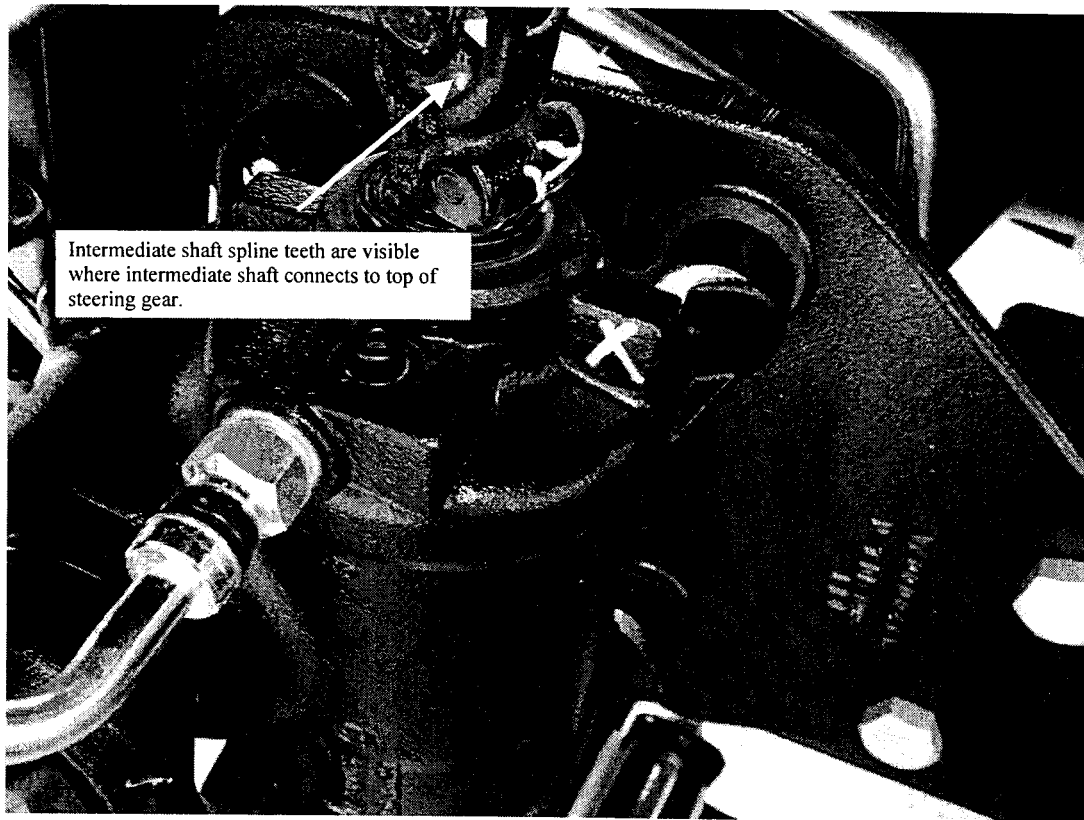
Inspect the intermediate shaft where it is connected to the input shaft at the top of the steering gear. The spline on the intermediate shaft is visible above the tip of the steering gear input shaft, as indicated in the photograph below:
