Subject: 573 Submittal, Prevost Car Inc.

**Safety Defect Report  
Pursuant to 49 CFR part 573**

Wb06-05A

DATE : JUNE 2006	SECTION : 23 - Accessories
EXPIRATION: JUNE 2008	
SUBJECT : INSPECTION OF A PIVOT ON THE WINDSHIELD WIPERS MECHANISM

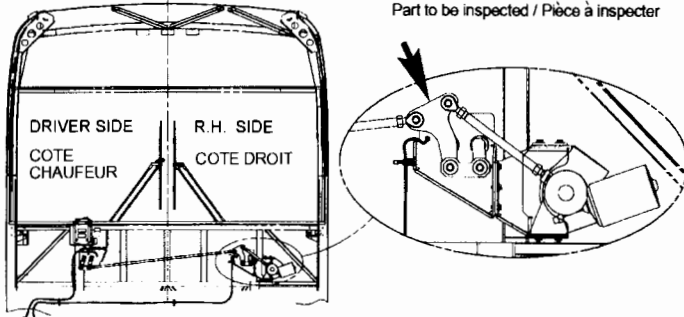
<p>2. Locate the pivots mounting plate on the wipers mechanism (see figure at right).</p>

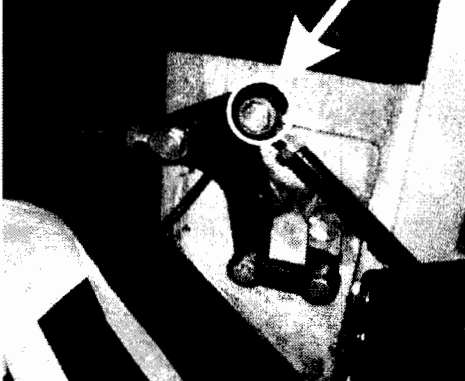
<p>3. The pivot which has to be inspected is indicated on the picture at right.</p>

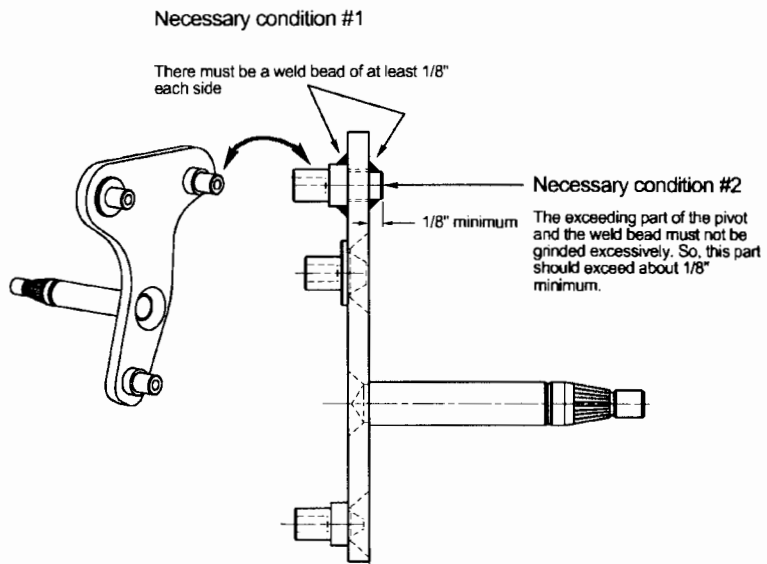
4. Using a flashlight and a small mirror, check if the pivot weld beads are up to the standards of quality by ensuring that the following necessary conditions are satisfied.

- Pivot must be welded on both sides. If one weld bead is missing, replace the part.
- Even if the pivot is welded on both sides, the exceeding part of the pivot must not be grinded excessively. If the exceeding part is grinded too much, and there is not enough welding left, replace the part.

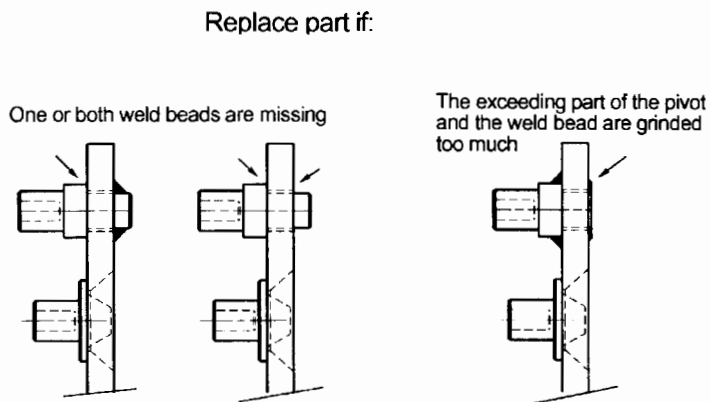
On the above mentioned vehicles, it is necessary to inspect the pivots mounting plate on the wipers mechanism. Prevost Car has determined that some of these parts may be defective due to a weak or missing weld bead on one pivot. If this part is defective, a failure of the wipers mechanism may occur while in use, making the wipers totally inoperative.

Part is not up to the standards of quality and must be replaced in the following cases (see figure at right).
