**DEFECT INFORMATION REPORT FOR DAIMLERCHRYSLER CORPORATION RECALL F39**

# Safety Recall F39

## Airbag Inflator Connector Clips

2006 (WK) Jeep® Grand Cherokee

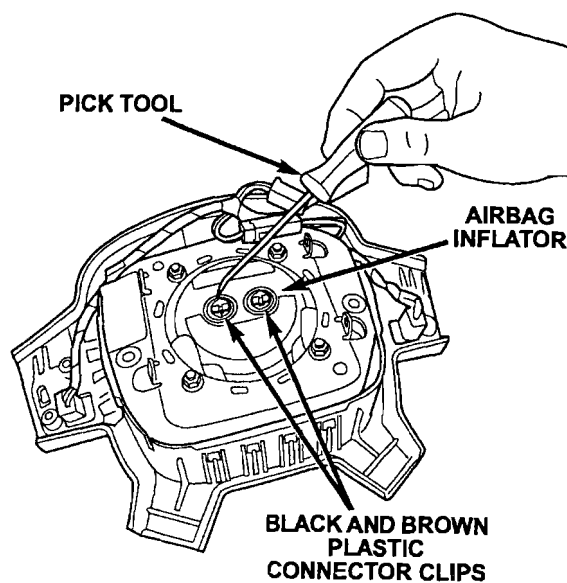
Figure 4

- Investigation determined that a design change was implemented on May 22, 2006. An error was made in updating the supplier drawing, swapping the connector clips of the primary and secondary inflator squibs. These clips are color coded and keyed to their respective connectors on the clock spring. The resulting condition is that the primary and secondary stages are reversed for all outputs.

7. Using a small pick tool, remove and discard the black and the brown plastic connector clips from the airbag inflator wiring connectors (Figure 4).

**CAUTION:** Use extreme care not to bend or damage the inflator connector pins when removing the inflator connector clips.
