06V-301  
(9 Pages)

RE: Notice of Safety Defect in Accordance with 49 CFR Part 573

## 2005 BULLDOG and 2005-2006 N-CHOPPER/MASTIFF IGNITION MODULE RELOCATION Recall # \_\_\_\_\_

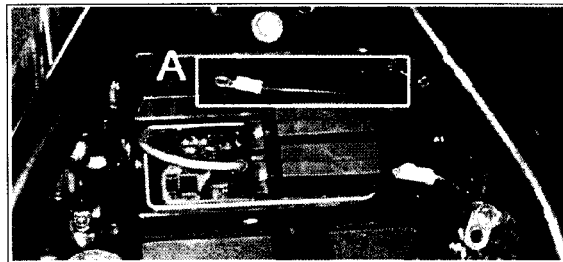
A. Route ignition module wire here.

6. Remove the black wire from the circuit breaker and route in front of the EHC.

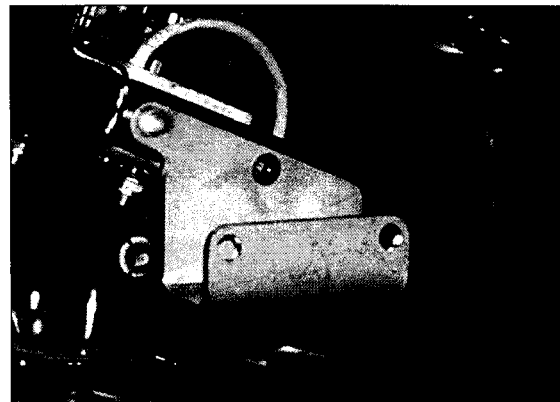
Typical. Note lock nut position.

7. Install the ignition module relocation mount using the #10-24 screws and lock nuts provided. Install the front screw with the head facing the EHC, while the rear screw will be installed with the lock nut facing the EHC.

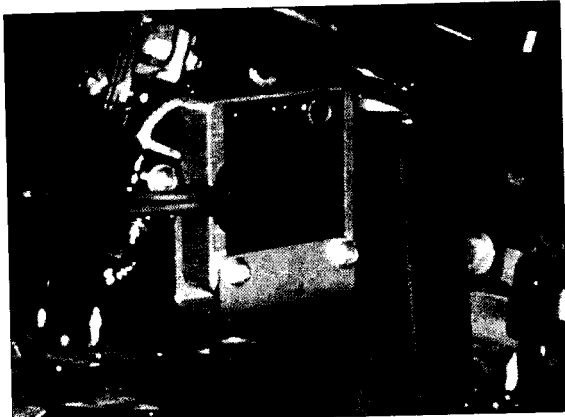
Typical.

8. Install the ignition module in the mount using the original hardware. Use Loctite 2440 on screw threads. Make sure there is adequate clearance between the oil tank fill neck and the ignition module.

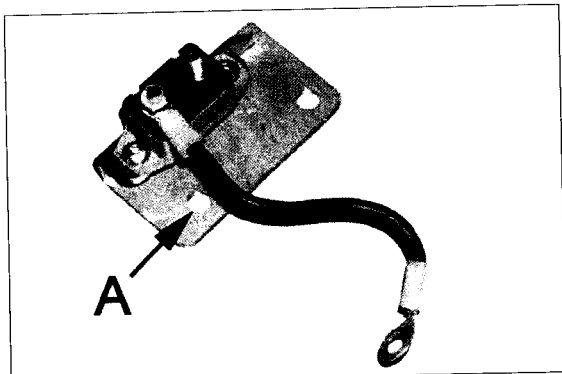
A. Outer mounting hole.

10. Install the circuit breaker on the relocation mount using the previously removed hardware.
11. Loosely install circuit breaker and mount where ignition module was previously located. Install the 1/4-20 x 3/4" screw, washer, and lock nut in the **outer mounting hole only**.

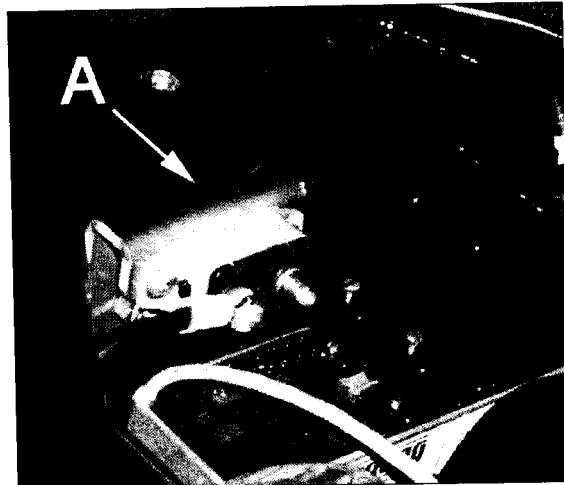
A. Typical. Circuit breaker and bracket installation.

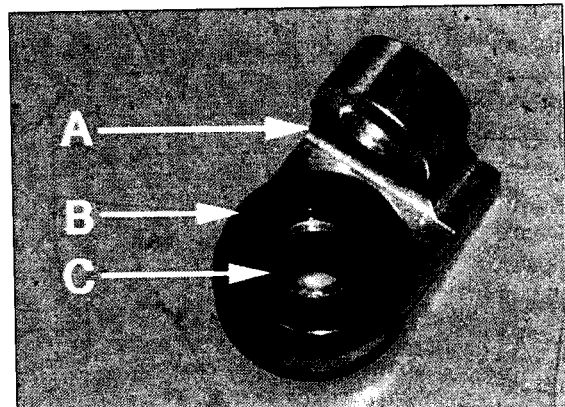
A. Front battery tray mount.  
B. Grommet.  
C. Bushing.

12. Loosen the rear battery tray mounting bolts. Remove and discard the front battery tray mounting bolt and the well nut. These will not be reused.
13. Install the grommet and bushing into the new front battery tray mount.

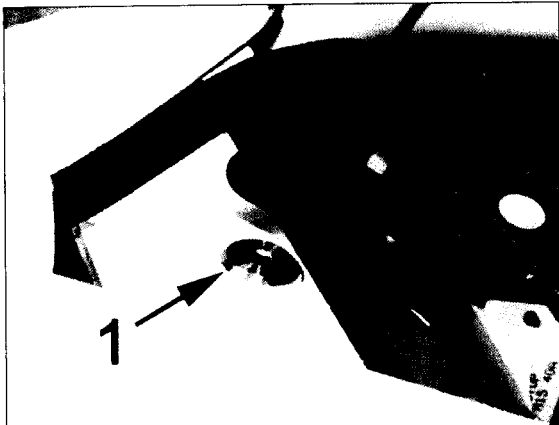
1. Tray mounting screw (P/N 240-000218-00).

14. Apply Loctite 2760 to the threads of the tray mounting screw (P/N 240-000218-00) and install by placing the screw into the old well nut opening under the front of the battery tray as shown in the next image.

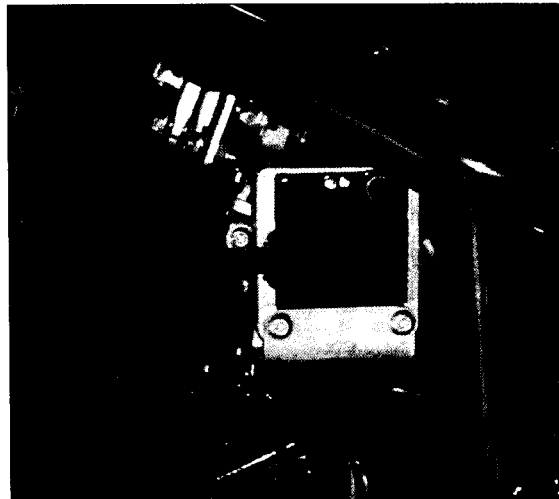
Typical. New bracket installation.

15. Loosely install the lock nut.
16. Tighten the tray mount screw through the front battery tray mounting hole with a hex wrench. Torque to 15-20 ft•lbs.
17. Tighten the circuit breaker relocation mount screws. Torque to 5-7 ft•lbs. When fully tightened, the new front battery tray mounting screw should not be in contact with the battery tray.
