Ref: Ottawa Truck Models Commando 30, 50, and 60 DOT/EPA
Ottawa Truck Models 30, 50, and 60 DOT/EPA

We are writing to advise that Ottawa Truck Division, Kalmar Industries Corp. has determined that a safety related defect exists in it's models Ottawa Commando 30, 50, and 60 DOT/EPA and Ottawa 30, 50, and 60 DOT/EPA vehicles manufactured between September 1, 2002 and July 21, 2006.

PROCEDURE TO REMEDY WIRING DEFECT

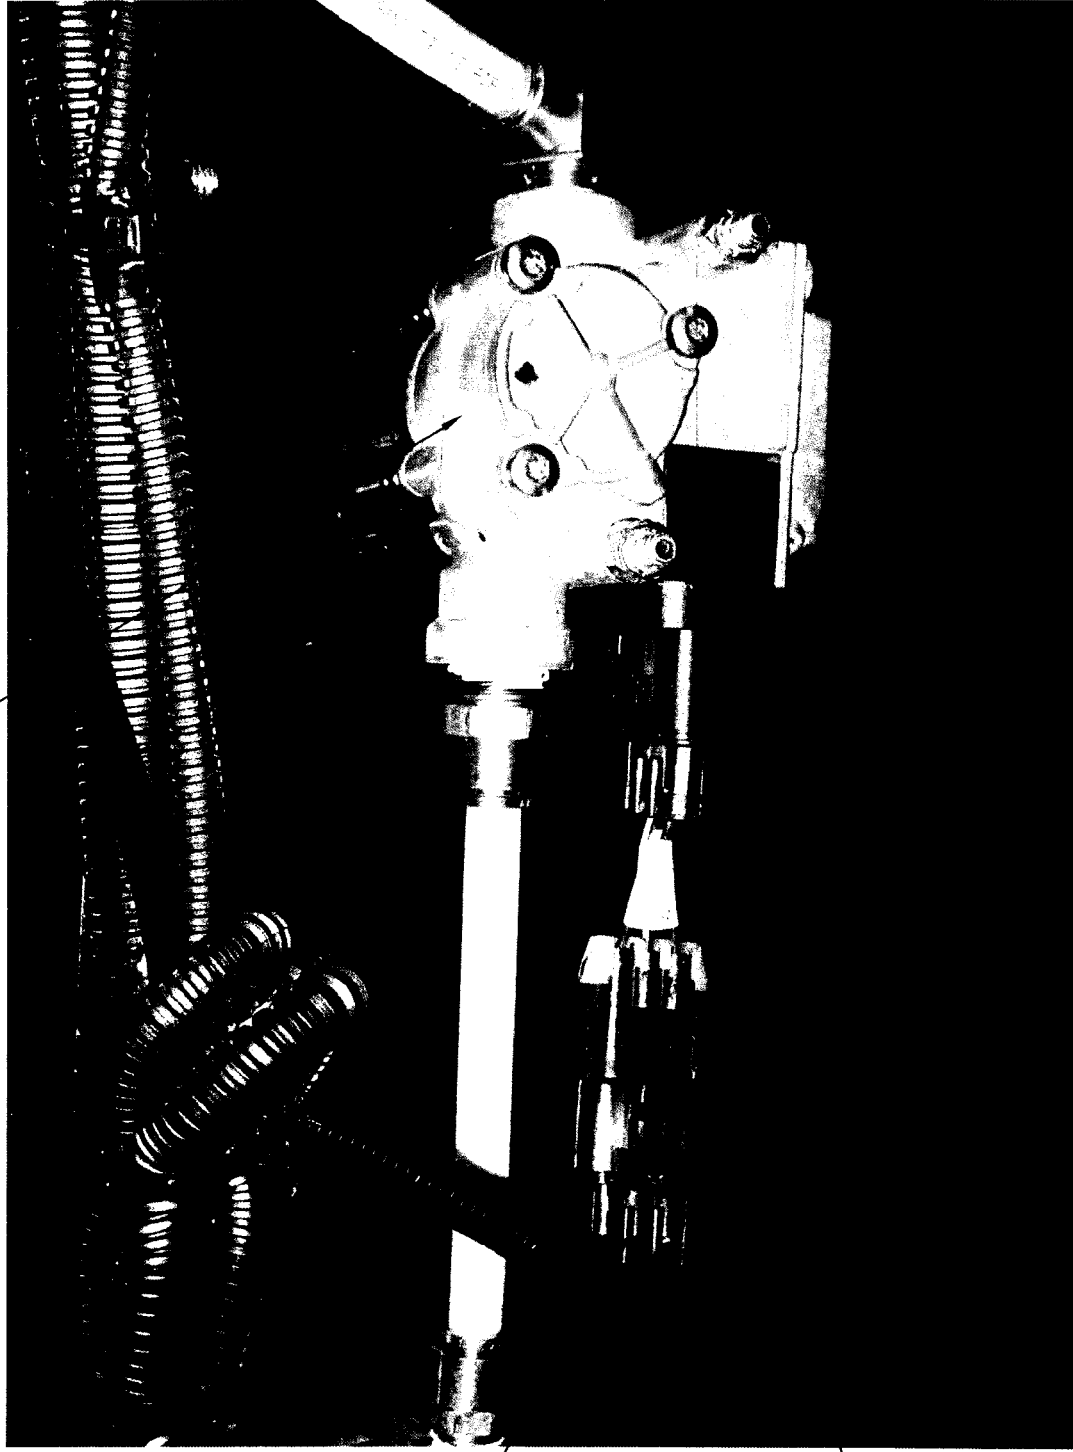
SHEET 1 OF 2

The defect is in the wiring harness that attaches to the air brake modulator valves. The wires for the "hold" and "exhaust" functions are reversed in the electrical connector.

RIGHT FRONT MODULATOR VALVE SHOWN

1. Locate the air brake modulator valves for both the front and rear axles.
2. The two (2) front brake valves are visible behind the cab deck grill opening at the front of the truck. They are mounted just under the front frame cross member. Locate and remove the three (3) wire connectors on the main wiring harness from each of the valves. This connector may only be removed by releasing the locking latch on the connector. This is done by lifting the latch bar to open the lock and pulling on the connector at the same time. A small screwdriver may be used for ease in opening the latch bar. Install the Modulator Valve Jumper harness connector by inserting it into the connector on the modulator valve body and firmly pressing until the connector stops and latches. Install the original wiring harness connector into the other end of the modulator valve jumper harness connector, pressing firmly until the connector stops and latches. (please see kit information- Sheet 1, attached)

INSTALL MODULATOR VALVE JUMPER HARNESS 53562728 BETWEEN ABS CHASSIS HARNESS AND EACH MODULATOR VALVE

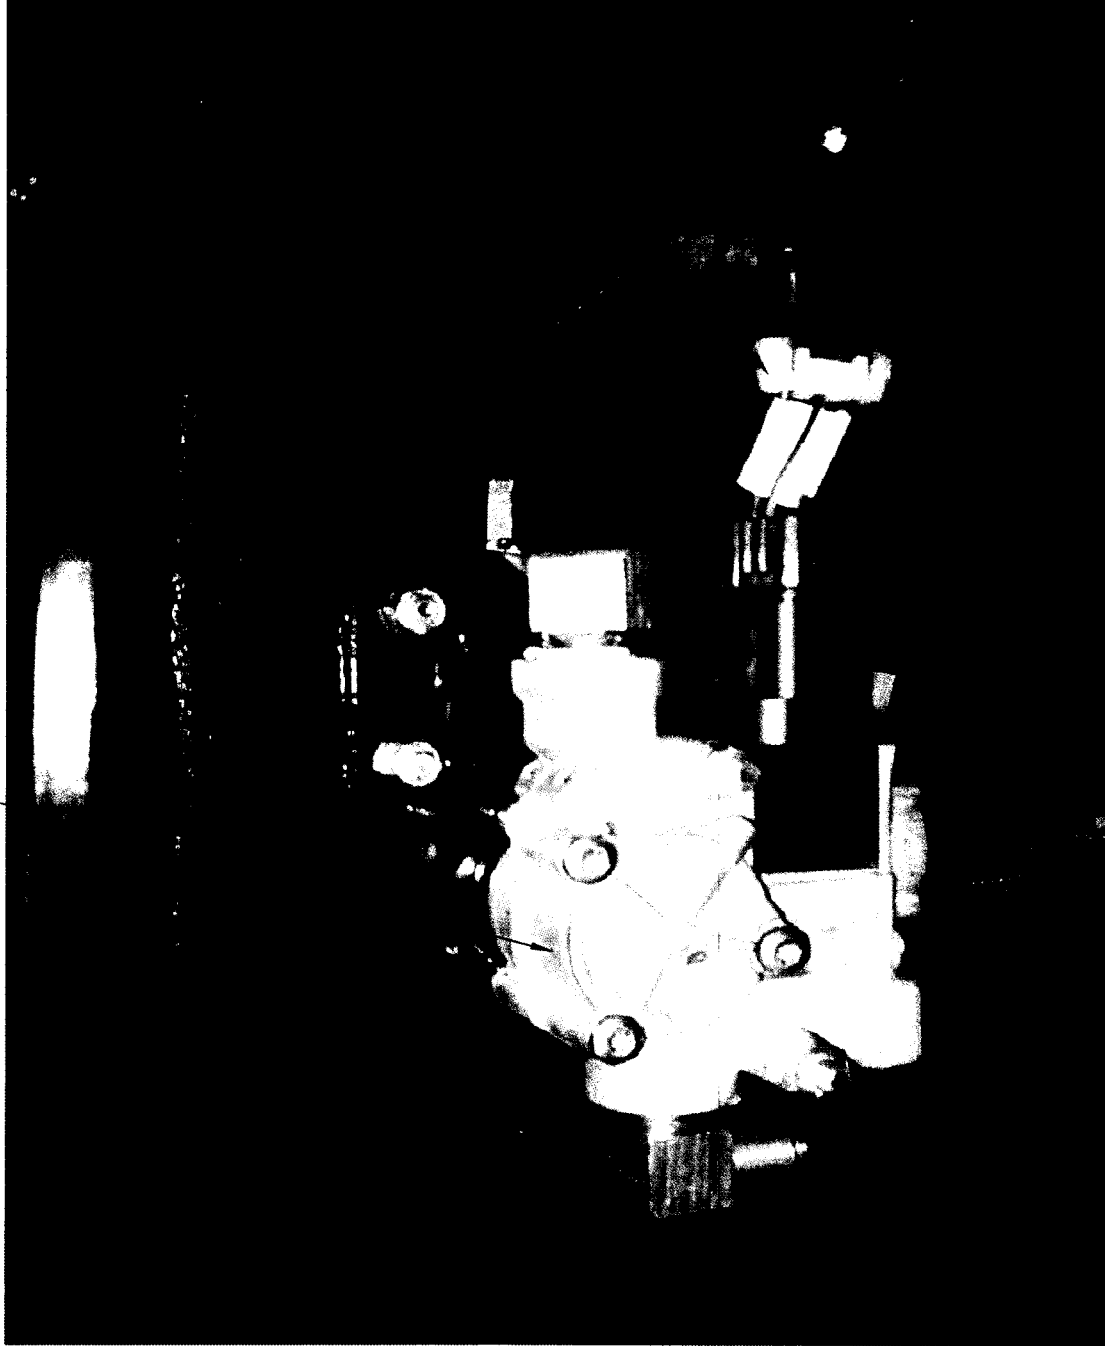
SHEET 2 OF 2

LEFT REAR MODULATOR VALVE SHOWN

3. The two (2) rear brake valves are located under the rear frame cross member and are only visible from beneath the truck. Locate and install the modulator valve jumper harnesses procedure as for the front. (please see kit information, Sheet 2, attached)

INSTALL MODULATOR
VALVE JUMPER HARNESS
53562728 BETWEEN ABS
CHASSIS HARNESS AND
EACH MODULATOR VALVE
