Ref: NHTSA Campaign Number 06V-306

Recall 06V-306

PROCEDURE TO REMEDY WIRING DEFECT

ABS MODULATOR VALVE JUMPER HARNESS INSTL

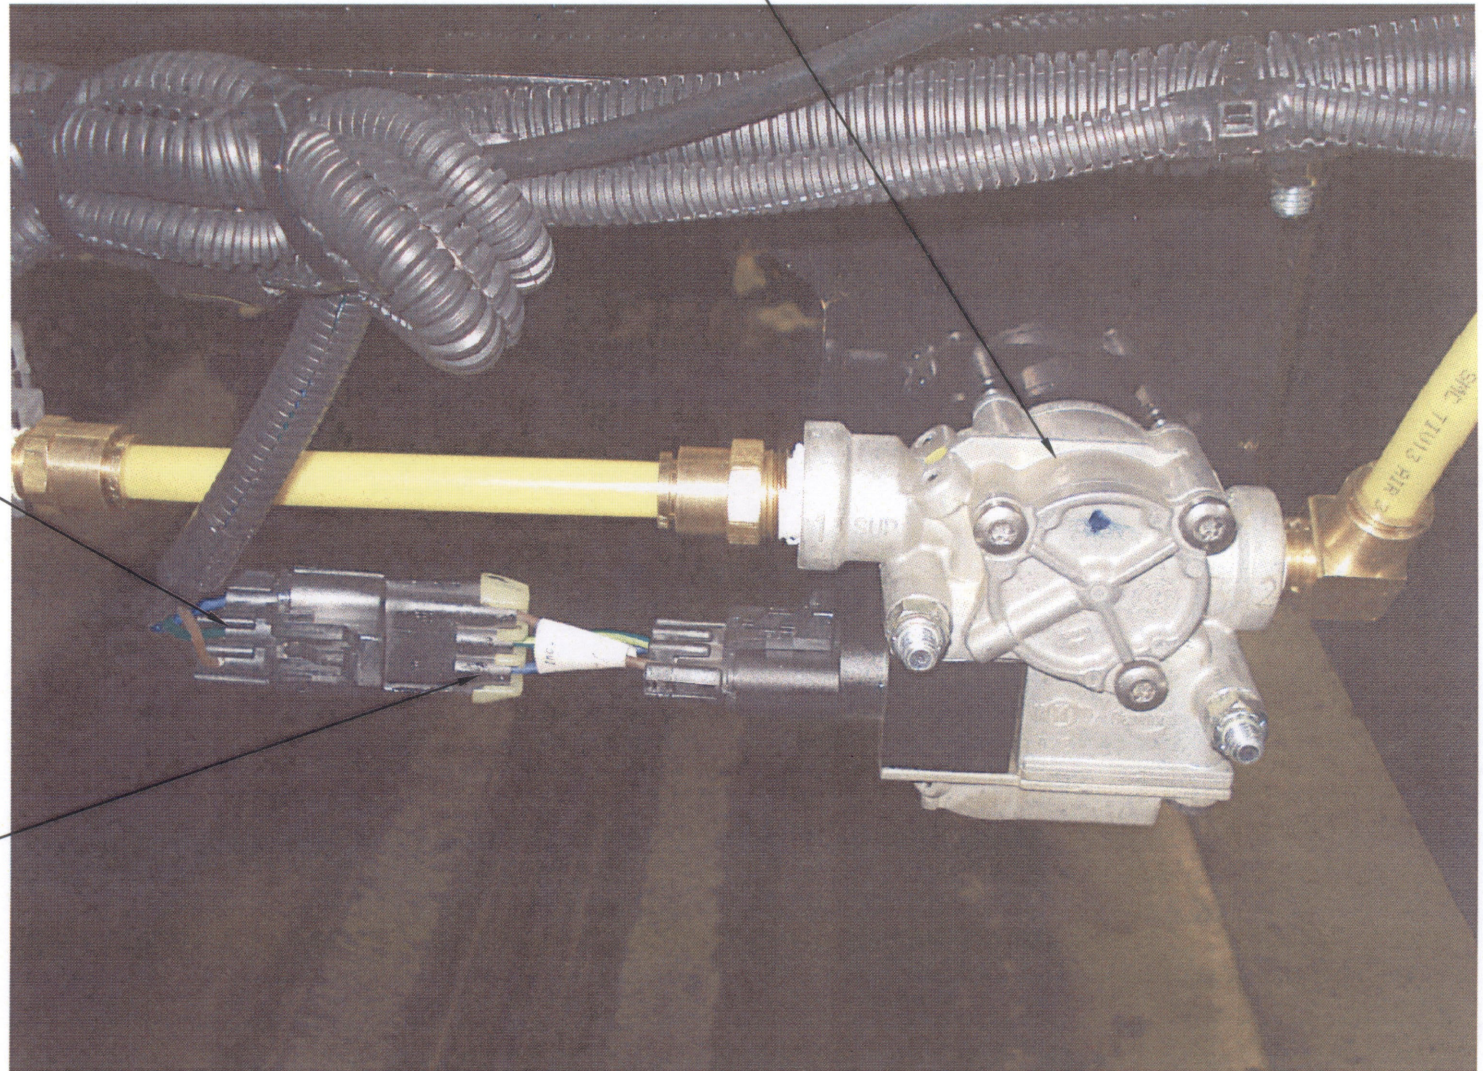
SHEET 1 OF 2

The defect is in the Anti-lock Brake System ("ABS"). The electrical wiring to the ABS modulator valves from the electronic control module ("ECM") is incorrect. The wires to the "Exhaust" and "Hold" connections on the ABS Modulator valves are reversed. In an anti-lock braking event this will cause the anti-lock braking system to malfunction. The anti-lock brake system performance will be degraded.

RIGHT FRONT MODULATOR VALVE SHOWN

1. Locate the ABS modulator valves for both the front and rear axles.
2. The two (2) front valves (Bendix Model M-30 or M-32) are visible behind the cab deck grill opening at the front of the truck. They are mounted just under the front frame cross member. Locate and remove the three (3) wire connectors on the main wiring harness from each of the valves. This connector may only be removed by releasing the locking latch on the connector. This is done by lifting the latch bar to open the lock and pulling on the connector at the same time. A small screwdriver may be used for ease in opening the latch bar. Install the Modulator Valve Jumper harness connector by inserting it into the connector on the modulator valve body and firmly pressing until the connector stops and latches. Install the original wiring harness connector into the other end of the modulator valve jumper harness connector, pressing firmly until the connector stops and latches.

CAUTION: ENSURE THAT THE WIRING HARNESS CONNECTOR THAT WAS REMOVED FROM THE VALVE IS INSTALLED IN ITS ORIGINAL VALVE POSITION

Example: Left front wiring harness must be attached to modulator valve jumper harness attached to left front modulator valve.

INSTALL MODULATOR VALVE JUMPER HARNESS 53562728 BETWEEN ABS CHASSIS HARNESS AND EACH MODULATOR VALVE

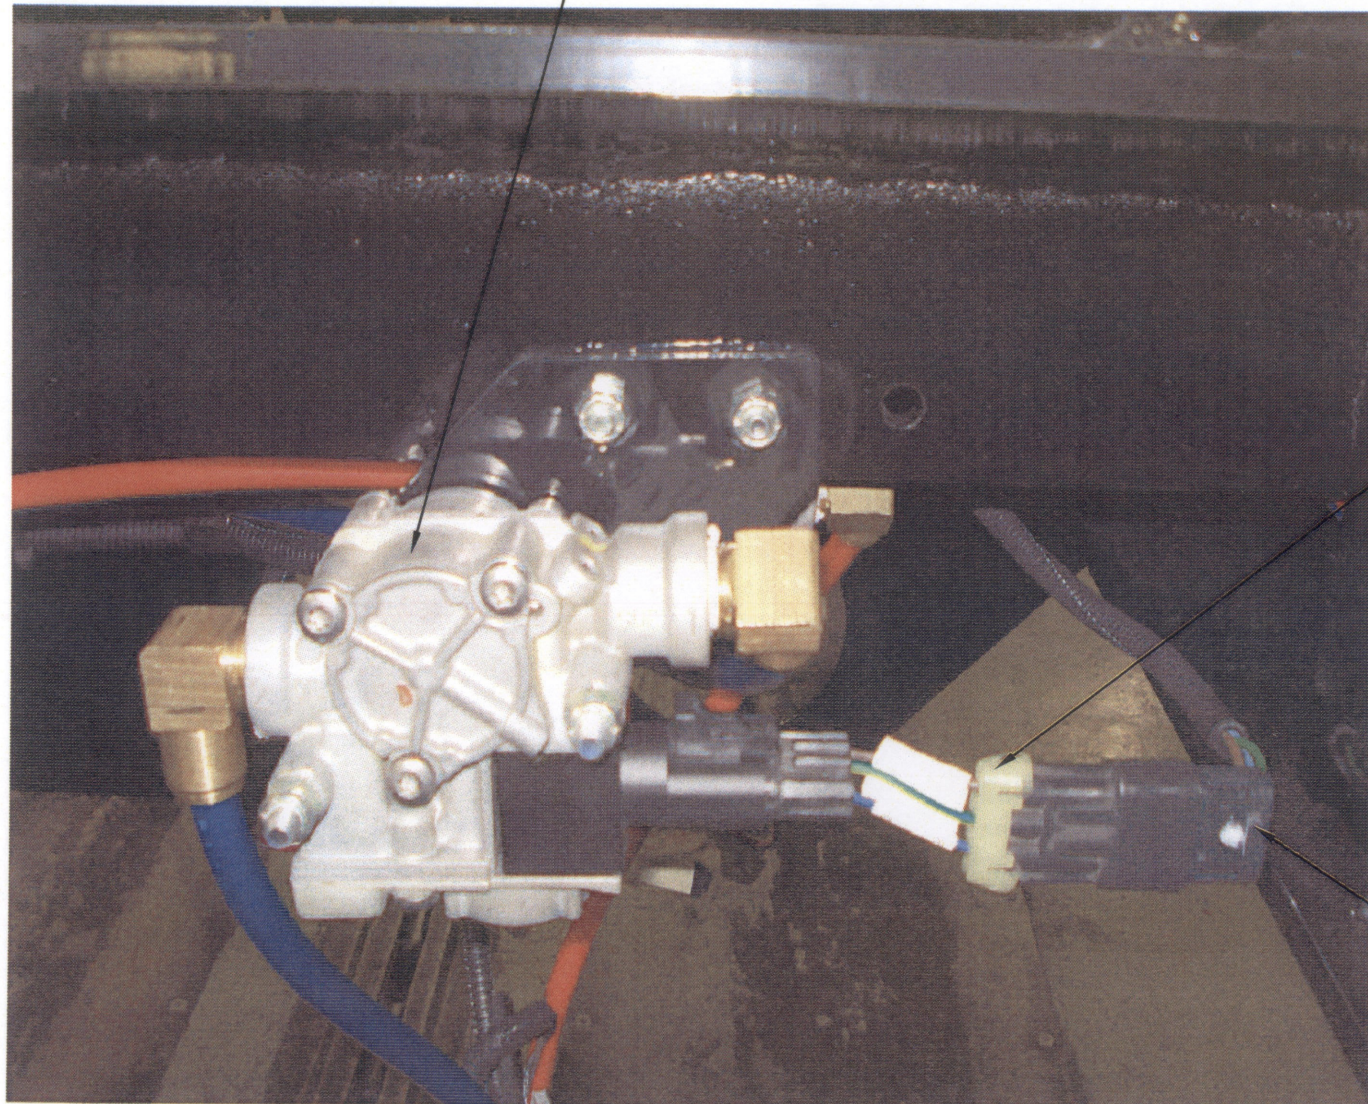
SHEET 2 OF 2

LEFT REAR MODULATOR VALVE SHOWN

3. The two (2) rear valves (Bendix Model M-30 or M-32) are located under the rear frame cross member and are only visible from beneath the truck. Locate and install the modulator valve jumper harnesses procedure as for the front. (please see installation information, Sheet 2, attached)

CAUTION: ENSURE THAT WIRING HARNESS CONNECTOR THAT WAS REMOVED FROM THE VALVE IS INSTALLED IN ITS ORIGINAL VALVE POSITION

INSTALL MODULATOR VALVE JUMPER HARNESS 53562728 BETWEEN ABS CHASSIS HARNESS AND EACH MODULATOR VALVE
