Re: Defect Information Report

In accordance with the provisions of 49 CFR 573 - Defect and Noncompliance Reports, Mitsubishi Motors North America, Inc. (MMNA) hereby furnishes this Defect Information Report, which contains details of a potential lower cross member defect in certain 2007 model year MMNA manufactured Eclipse and Eclipse Spyder vehicles.

SUBJECT:		No: SR-06-004	
FRONT CROSSMEMBER — SAFETY RECALL CAMPAIGN		DATE: September, 2006	
		MODEL: See below	
CIRCULATE TO:	<input type="checkbox"/> GENERAL MANAGER	<input checked="" type="checkbox"/> PARTS MANAGER	<input checked="" type="checkbox"/> TECHNICIAN
<input checked="" type="checkbox"/> SERVICE ADVISOR	<input checked="" type="checkbox"/> SERVICE MANAGER	<input checked="" type="checkbox"/> WARRANTY PROCESSOR	<input type="checkbox"/> SALES MANAGER

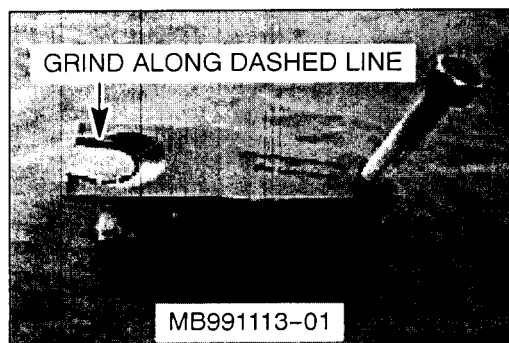
NOTE: If special tool MB991113-01 – ball joint remover is used, it will need to be modified. Grind the opening, in the area shown, just large enough to go around the ball joint.
