Safety Defect and Noncompliance Report Guide for Vehicles
PART 573 Defect and Noncompliance Responsibility and Reports¹

06V-338
(13 pages)

Subject: FCCC Front Axle Tie Rod Thread Engagement

July 2006
SF332AB

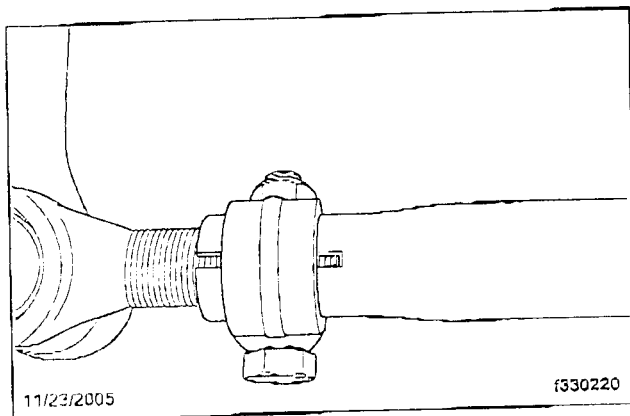
Fig. 1, Correct Tie Rod Thread Engagement

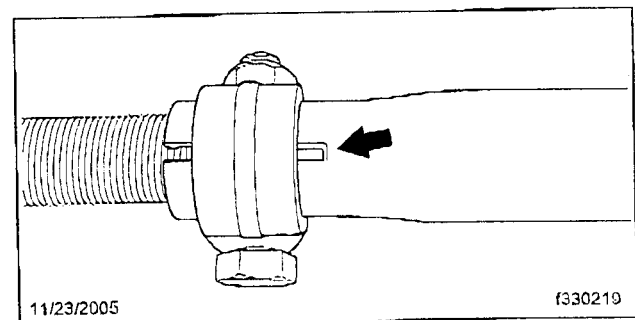
The tie rods were manufactured with threads that are too short, causing a gap between the crossbar and the tie rod. This gap may cause corrosion and cause the connection to fail.

Excessive corrosion, over a period of time could cause the crossbar to tie rod connection to fail, causing a lack of steering control and a potential accident.

Fig. 2, Incorrect Tie Rod Thread Engagement

The tie rod will be inspected and replaced if necessary with a longer tie rod assembly. If the tie rod is replaced, a toe-in alignment procedure will also be performed.

If the tie rod thread engagement is not correct on both ends, go to the tie rod assembly replacement.

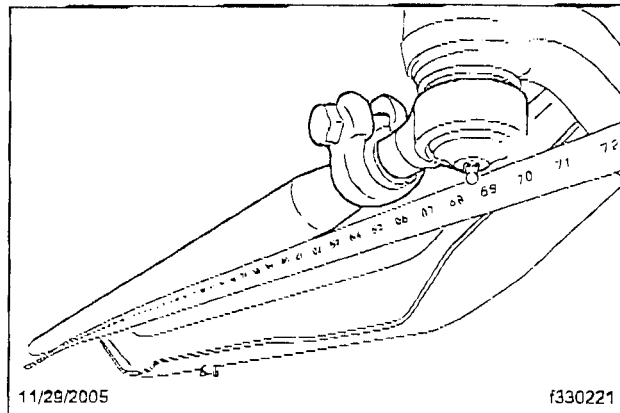
Fig. 3, Center-to-Center Distance Between Tie Rod End Grease Fittings

1. Measure and record the center-to-center distance between the tie rod end grease fittings. See Fig. 3.
