RE: Recall Number 06V-356 Defect Information Report (additional information)
(Hyundai Campaign 078)

Group	CAMPAIGN
Number	06-01-010
Date	OCTOBER, 2006
Model	2007 ENTOURAGE

Subject
**STOP LAMP SWITCH WIRING
 SERVICE CAMPAIGN 078**

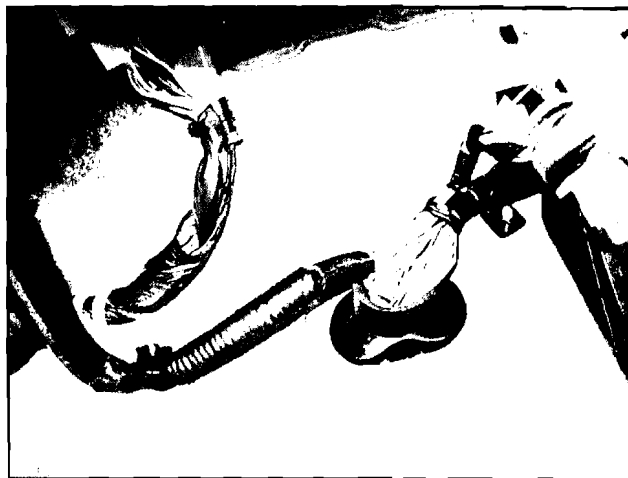
Some 2007 MY Entourage limited vehicles with the Power Adjustable Foot Pedal feature may have interference between the stop lamp switch wiring and the steering column universal joint.

3. Locate the stop lamp switch wiring as shown in photo.
