DEFECT INFORMATION REPORT: AMG-R0601

DEALER NOTIFICATION LETTER
SAFETY RECALL AMG R0601
STEERING GEAR ATTACHMENT

PRODUCT RECALL BULLETIN

Subject: PRODUCT RECALL AMG R0601 STEERING GEAR ATTACHMENT

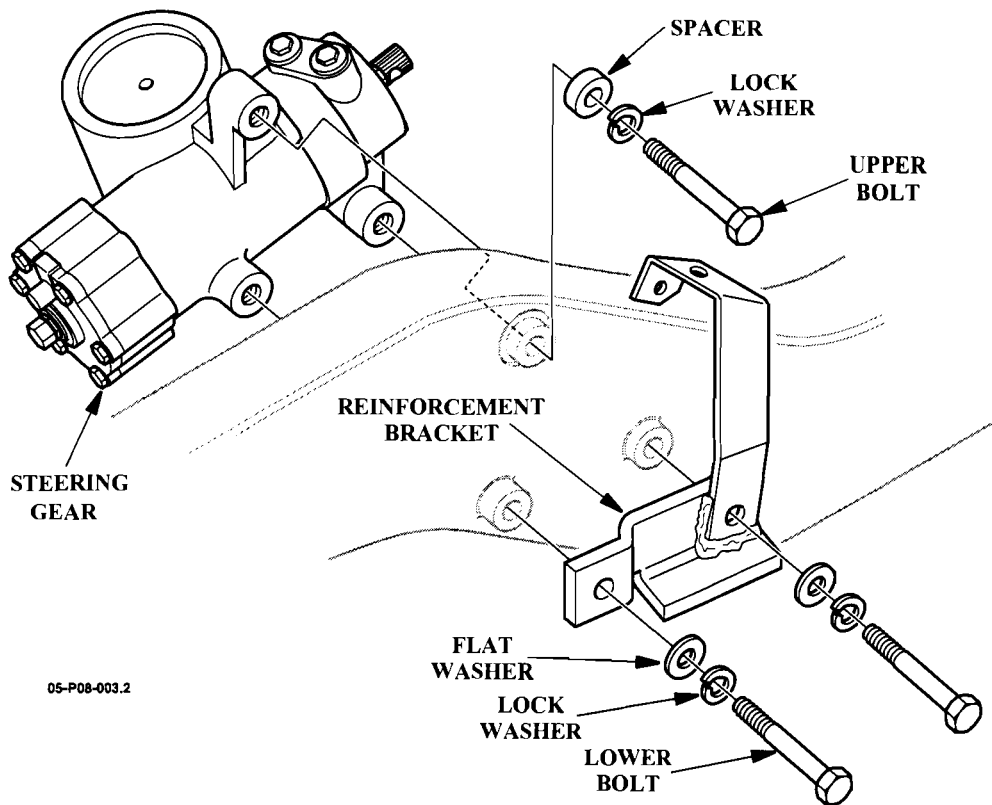
1. Perform a visual inspection of the hardware attaching the steering gear to the frame. The **upper bolt** requires a spacer and a split lock washer (See Figure 1). Both **lower bolts** use only a flat washer and a split lock washer.
2. If the spacer and washers are in the correct positions, apply 175 lb-ft. (237 N·m) of torque to all three bolts.
3. If any of the bolts rotate before the torque value is attained, remove all the bolts and clean all thread locking compound from the gear and the bolts.
4. Apply Loctite 242, or equivalent medium strength thread locker to the threads, place the spacer and washers on the bolts in the positions shown below and torque the bolts to 175 lb-ft. (237 N·m).

Figure 1: Steering Gear Attachment Hardware

1. If the spacer and washers are not in the correct positions, replace the steering gear and hardware (See Service Manual Section 8). Torque the bolts to 175 lb-ft (237 N·m).
