06V-414  
(10 pages)

RE: 2007 Mitsubishi Eclipse and Eclipse Spyder Gear Shift Key Lock Cable

SUBJECT:		No: <b>SR-06-005</b>	
<b>GEAR SHIFT KEY INTERLOCK CABLE — SAFETY RECALL CAMPAIGN</b>		DATE: <b>November, 2006</b>	
		MODEL: <b>See below</b>	
CIRCULATE TO:	<input type="checkbox"/> GENERAL MANAGER	<input checked="" type="checkbox"/> PARTS MANAGER	<input checked="" type="checkbox"/> TECHNICIAN
<input checked="" type="checkbox"/> SERVICE ADVISOR	<input checked="" type="checkbox"/> SERVICE MANAGER	<input checked="" type="checkbox"/> WARRANTY PROCESSOR	<input type="checkbox"/> SALES MANAGER

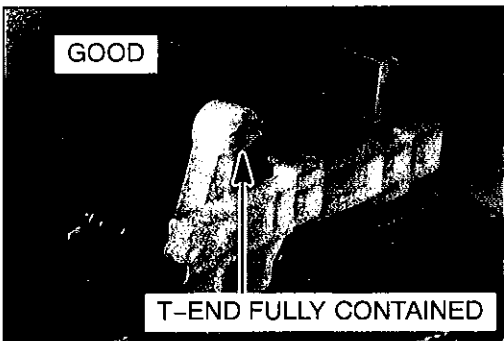
5. Inspect the T-end of the gear shift key interlock cable as described below.

- a. If the cable end is fully contained within the lever and snap lock, the cable DOES NOT need to be replaced.

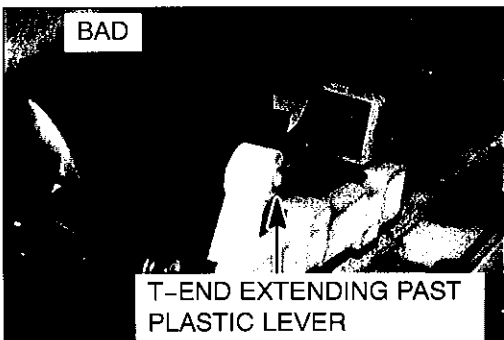
- b. If the T-end of the cable is visible (flush or extends past the white plastic lever), the cable must be replaced.

Follow the service manual procedure in Group 23A of the 2007 Eclipse/Eclipse Spyder service manual for replacing the gear shift key interlock cable.
