## **PART 573 Defect and Noncompliance Report3**

Furnish the manufacturer's identification code for this recall (if applicable): ER-SB-0008

Make and model: EarthRoamer XV-LT

This recall affects 2003-2006 EarthRoamer XV-LTs with Front Camper Mount Assembly revision B or C. Revision B or C mounts are limited to EarthRoamer XV-LT Unit Numbers: 1, 2, 3, 6, 7, 9, 10, 11, 13, 14, 18, 20, 22, 25, 26, 27 and 28

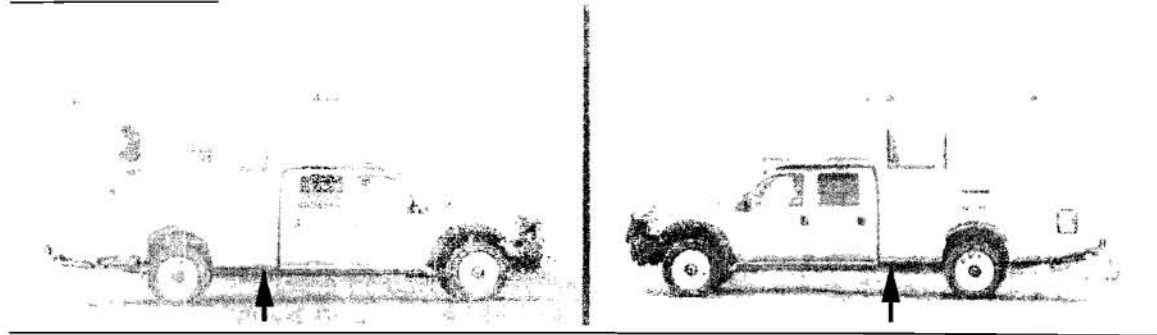
1. The front camper mount can be viewed by sliding under the camper, just aft of the cab of the truck.

2. The area to be inspected is located between the truck frame and fiberglass camper body fairing.

The welds that attach the frame plate to the camper mount need to be visually inspected for any signs of cracking. The photos in Attachment A show the front mount assembly prior to installation of the camper body to clearly illustrate each of the weld locations. There is also a photo included of an actual mount on a completed vehicle.

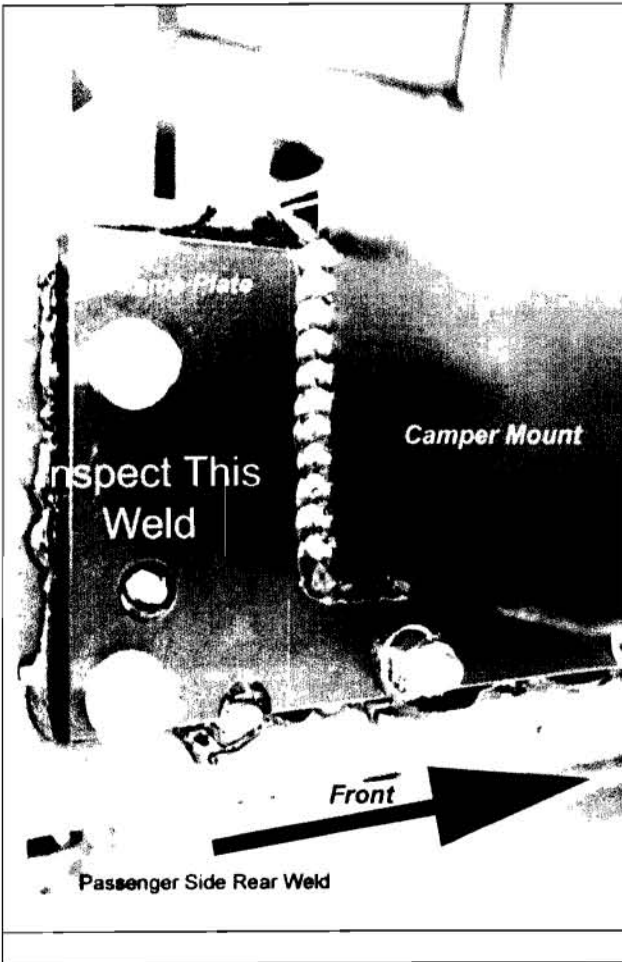
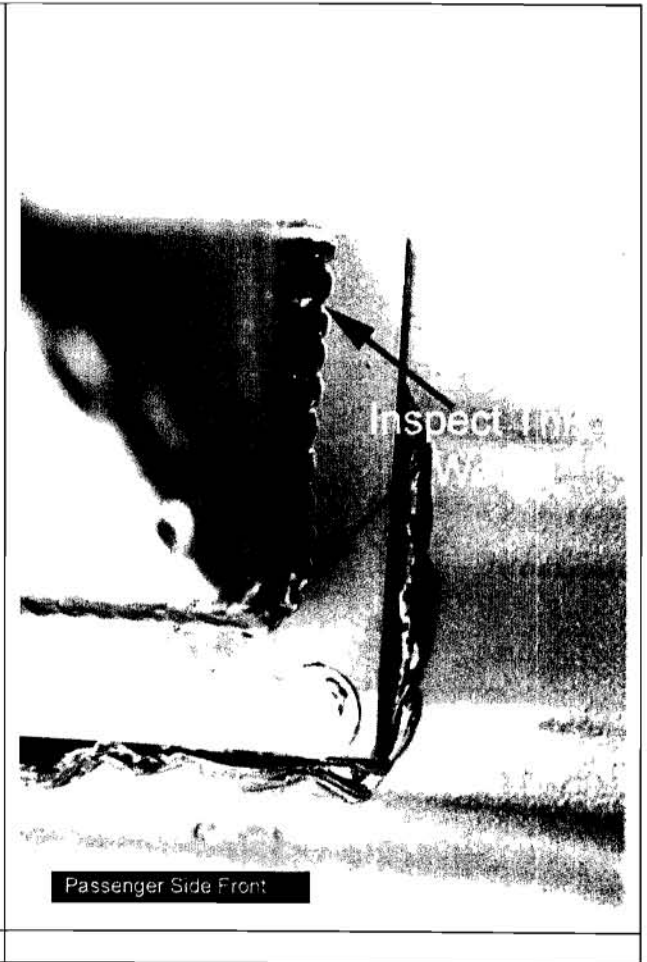
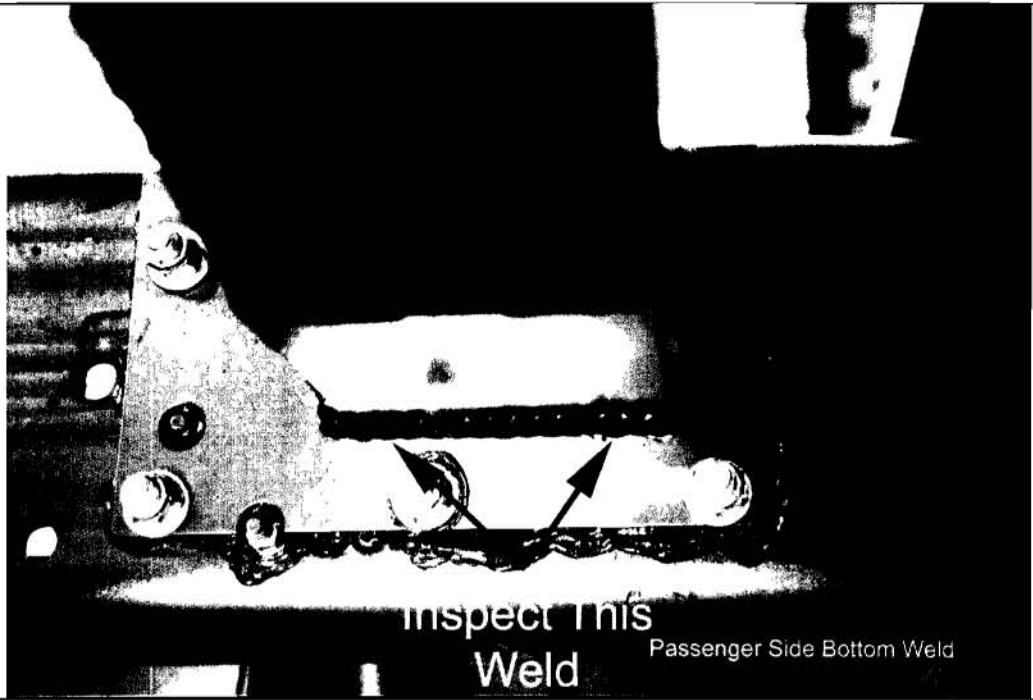
### Passenger Side

Camper mount before camper has been installed. These photos show revision D mounts with a continuous weld bead. Your mounts will be stitch welded.

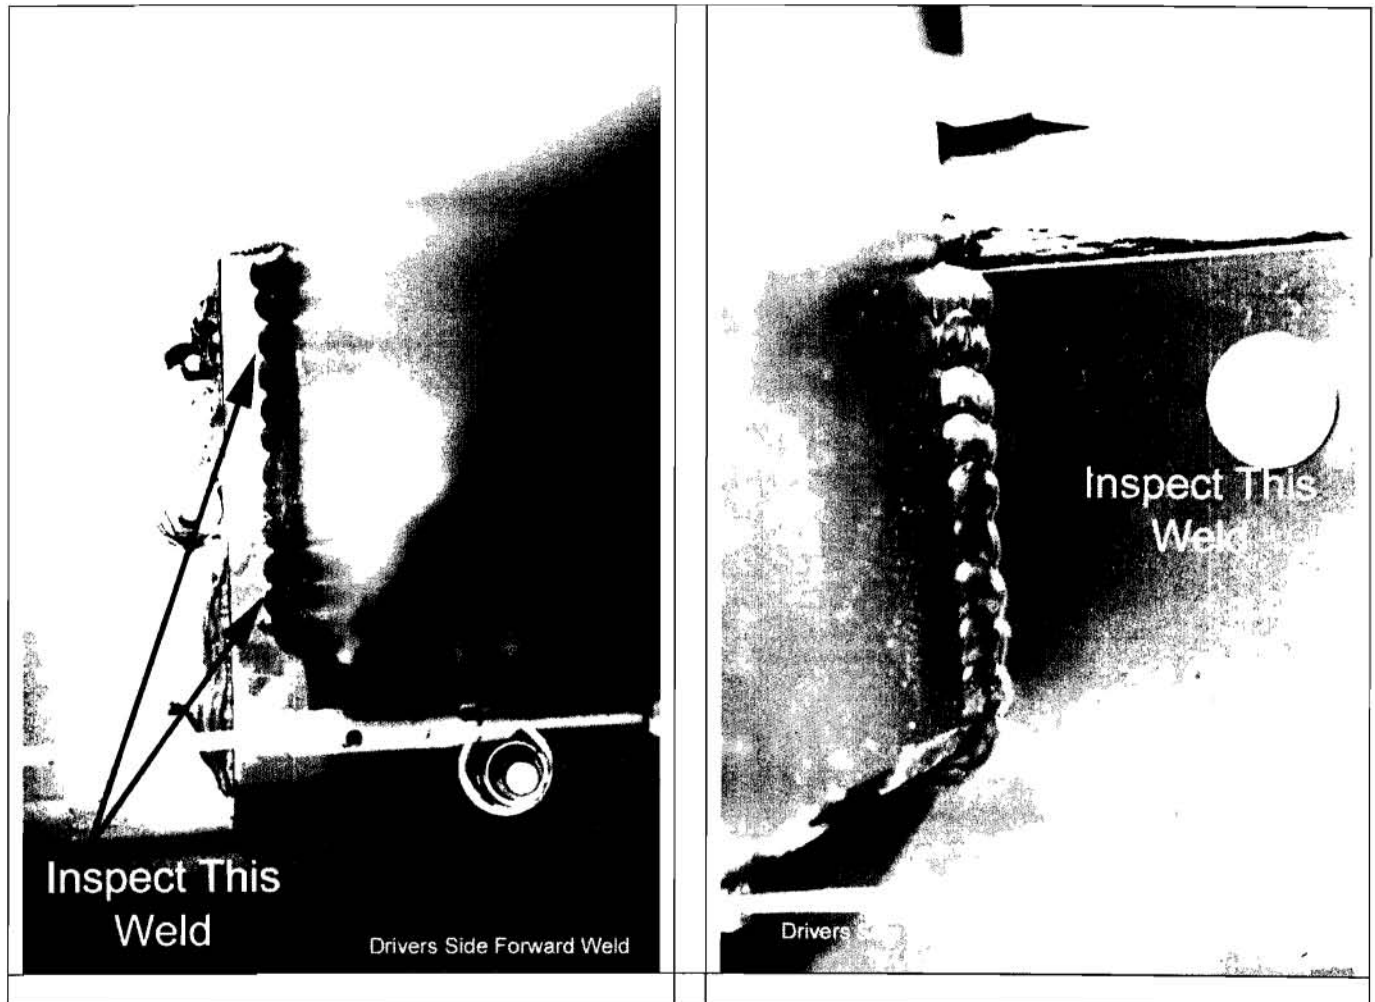
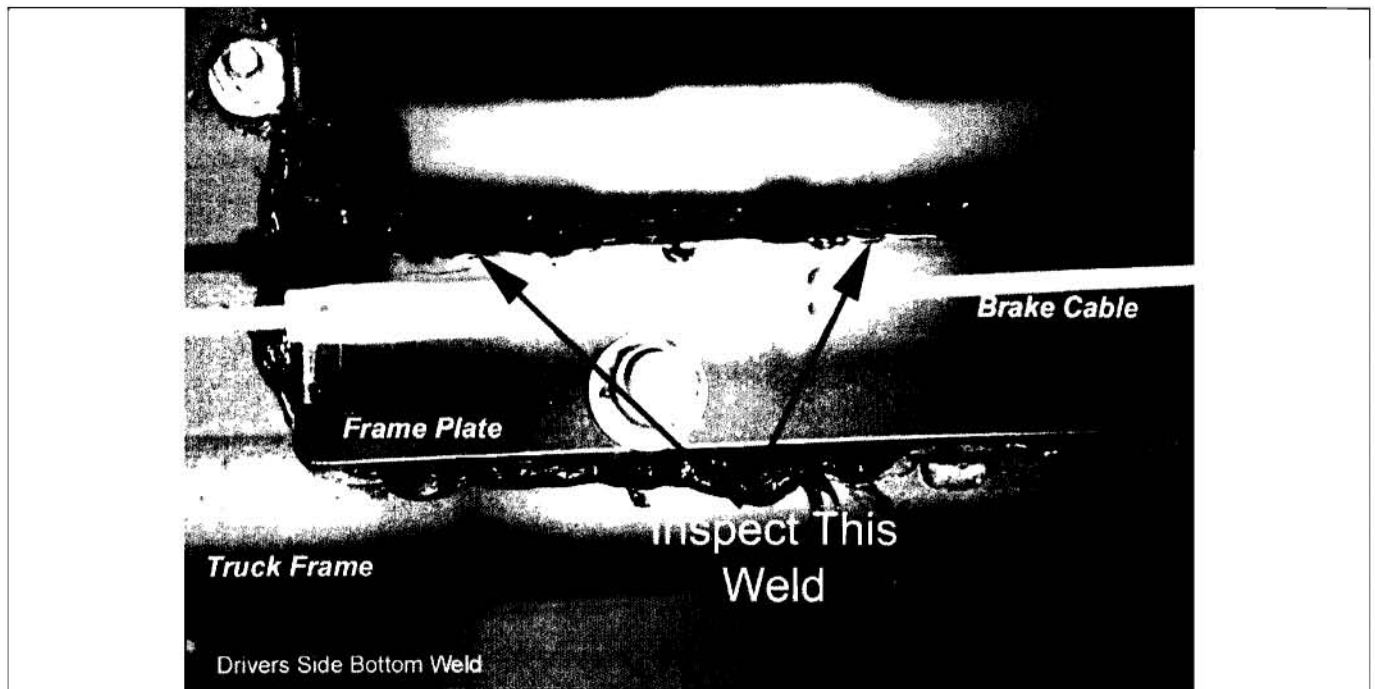
## Driver Side

Camper mount before camper has been installed. These photos show revision D mounts with a continuous weld bead. Your mounts will be stitch welded.

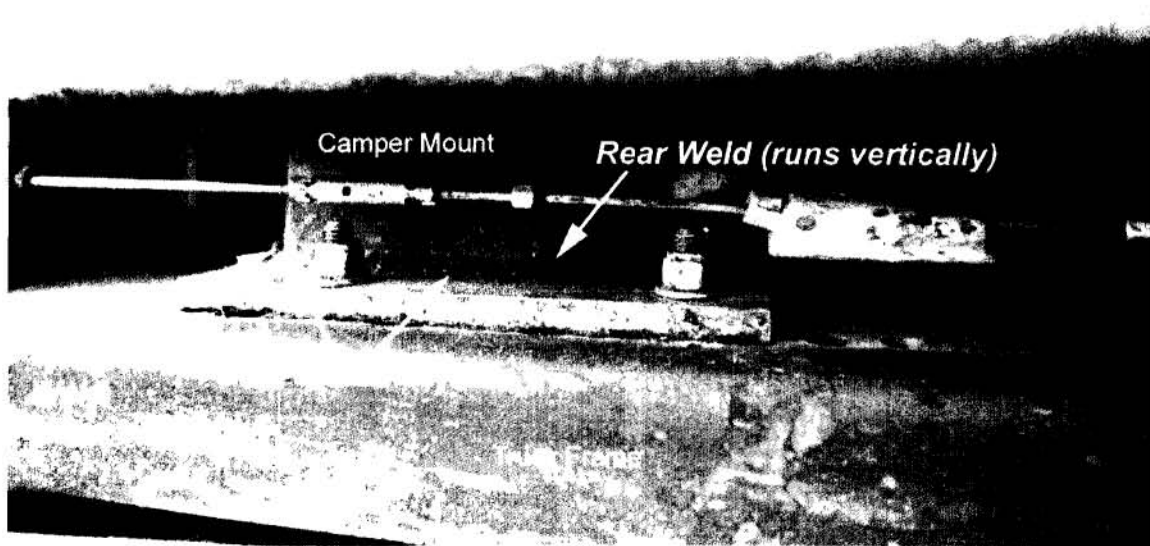
*Driver Side - View Looking Up*

**Camper mount after camper has been installed**

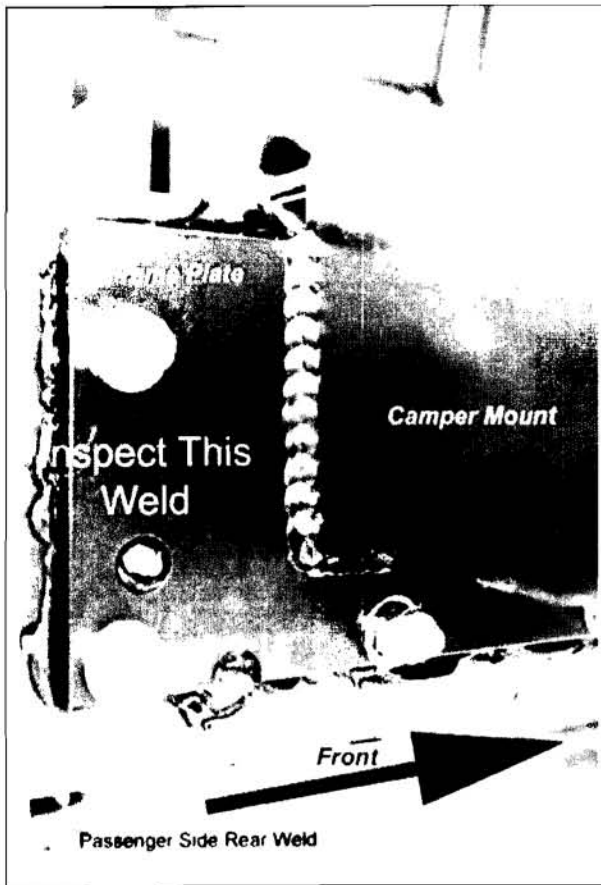
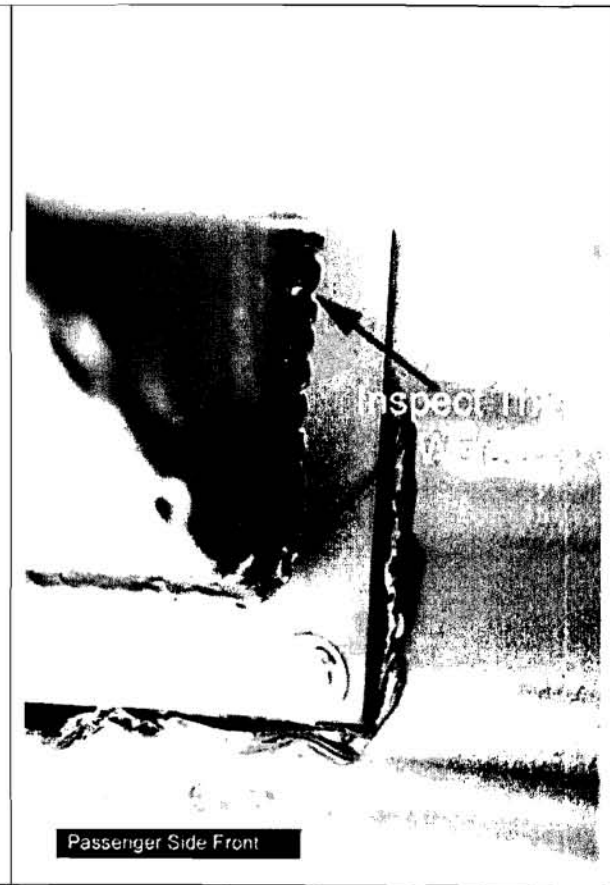
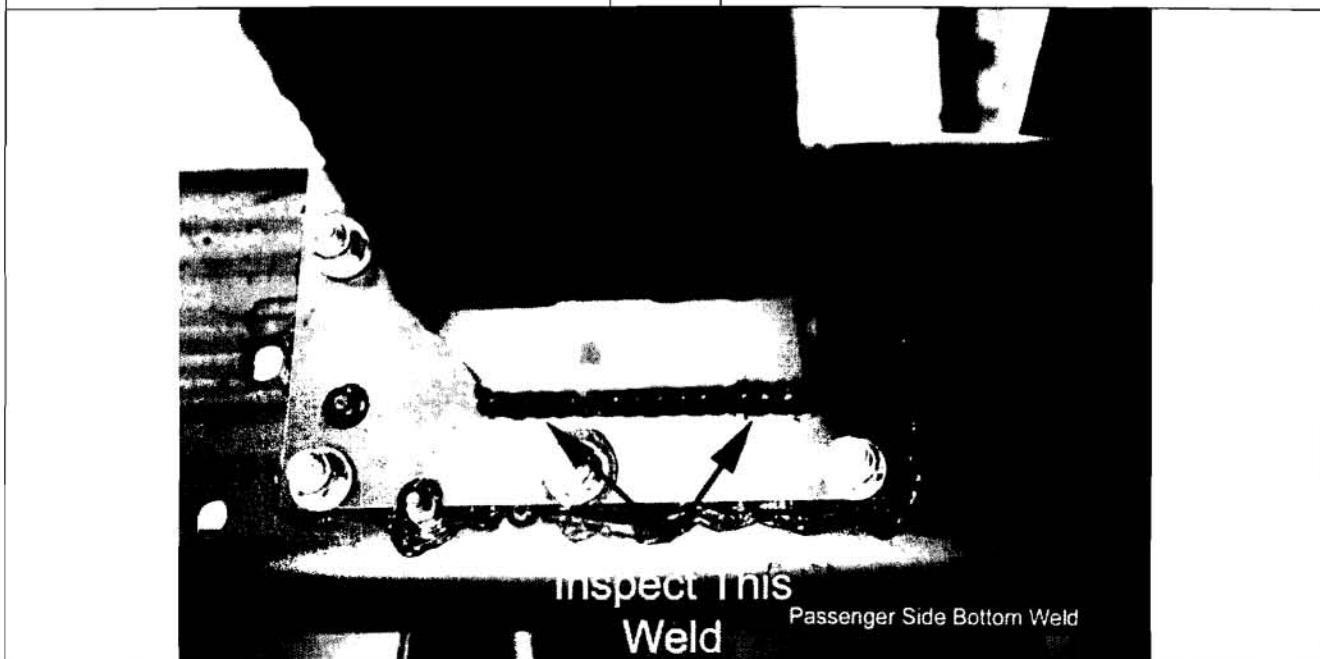
## Passenger Side

Camper mount before camper has been installed. These photos show revision D mounts with a continuous weld bead. Your mounts will be stitch welded.

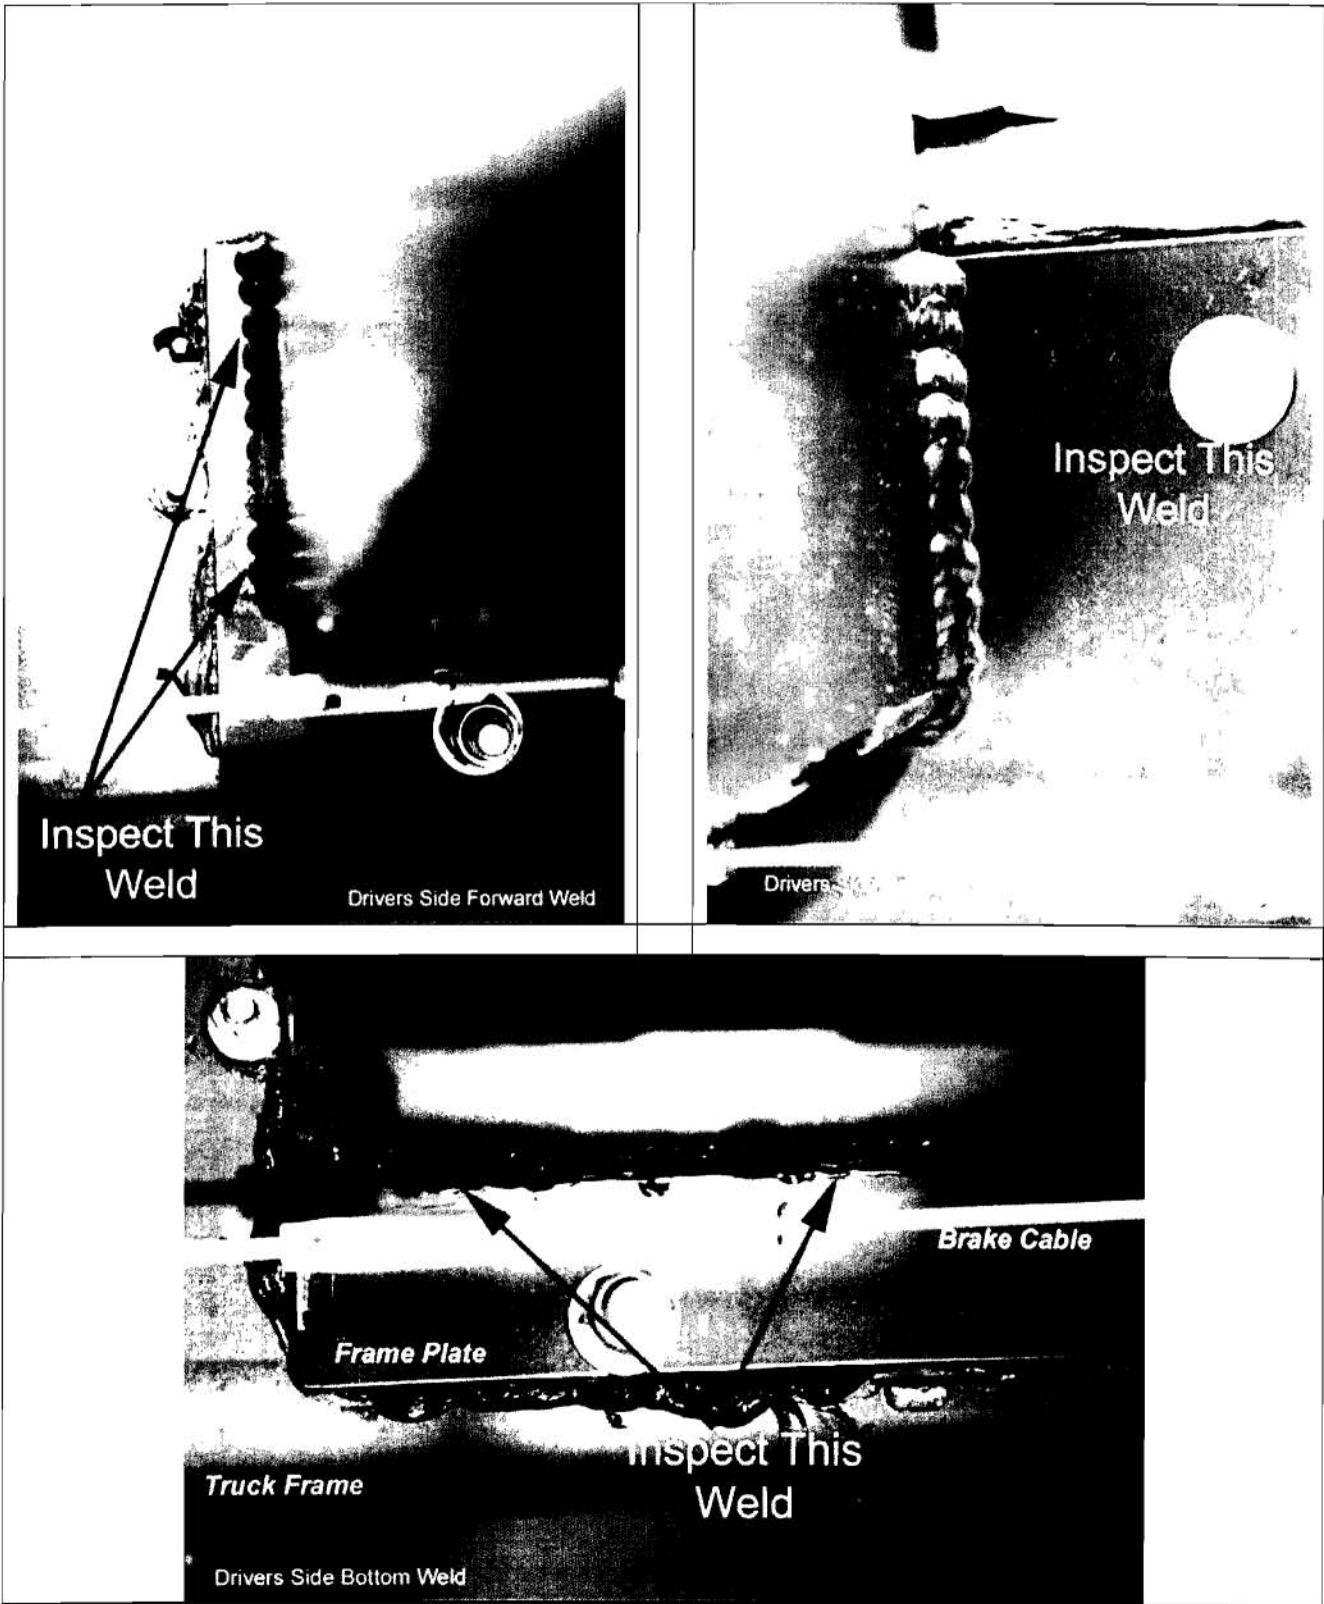
**Driver Side**

Camper mount before camper has been installed. These photos show revision D mounts with a continuous weld bead. Your mounts will be stitch welded.

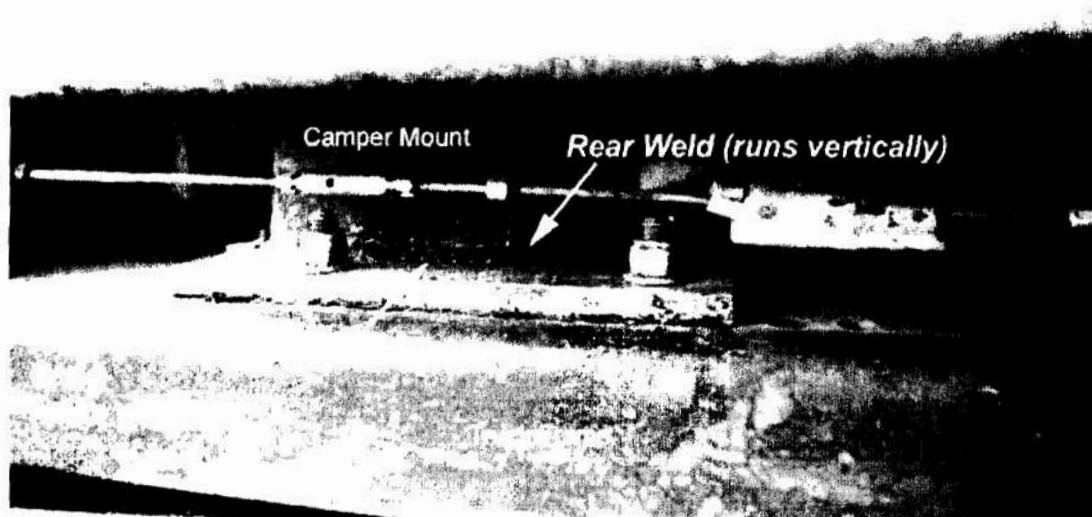
*Driver Side - View Looking Up*

## Camper mount after camper has been installed

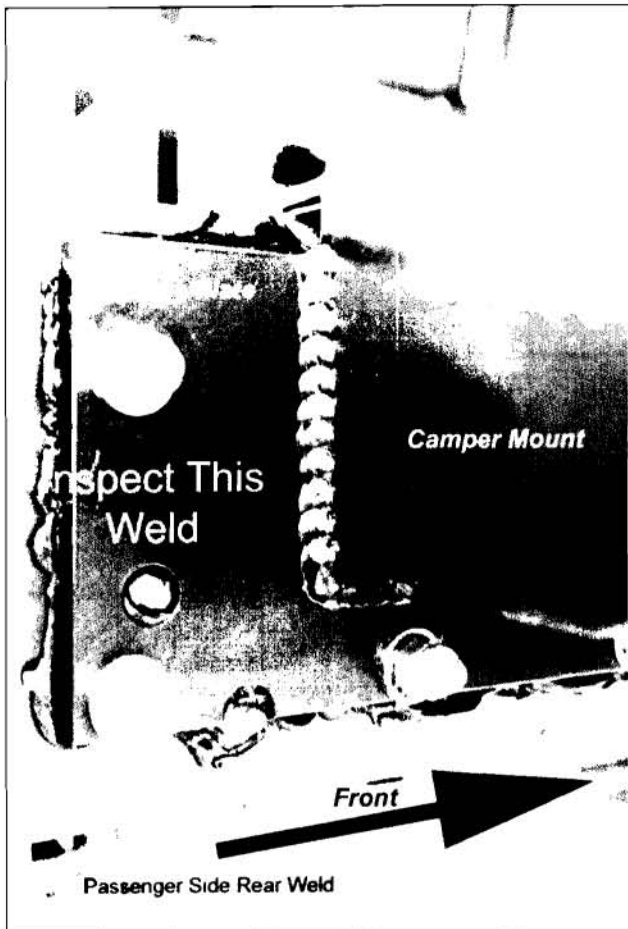
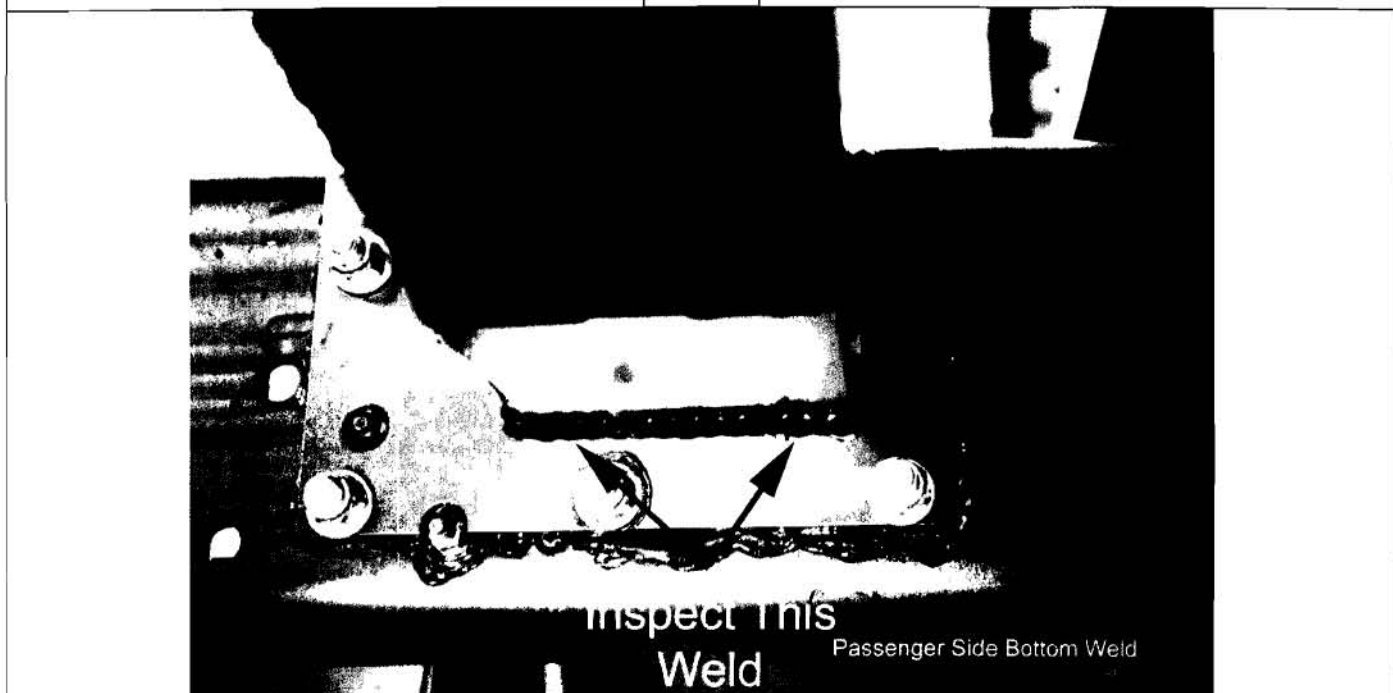
## Passenger Side

Camper mount before camper has been installed. These photos show revision D mounts with a continuous weld bead. Your mounts will be stitch welded.

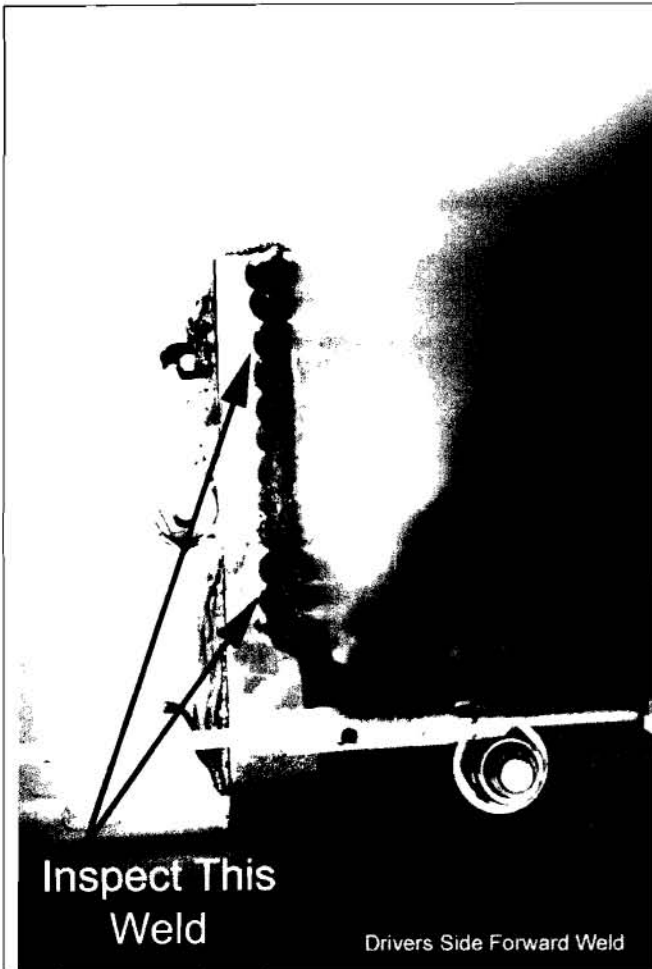
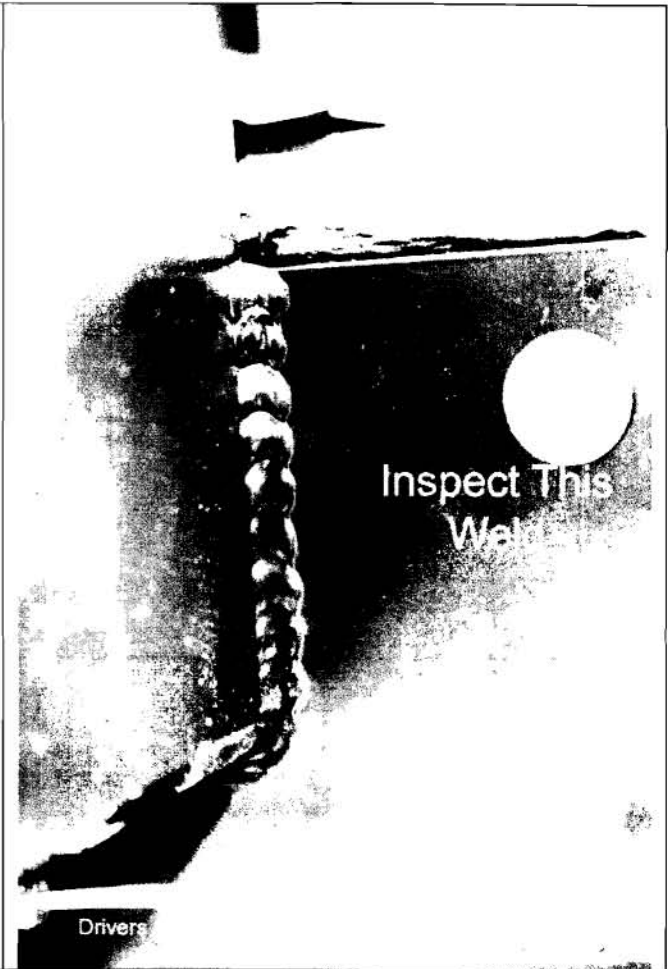
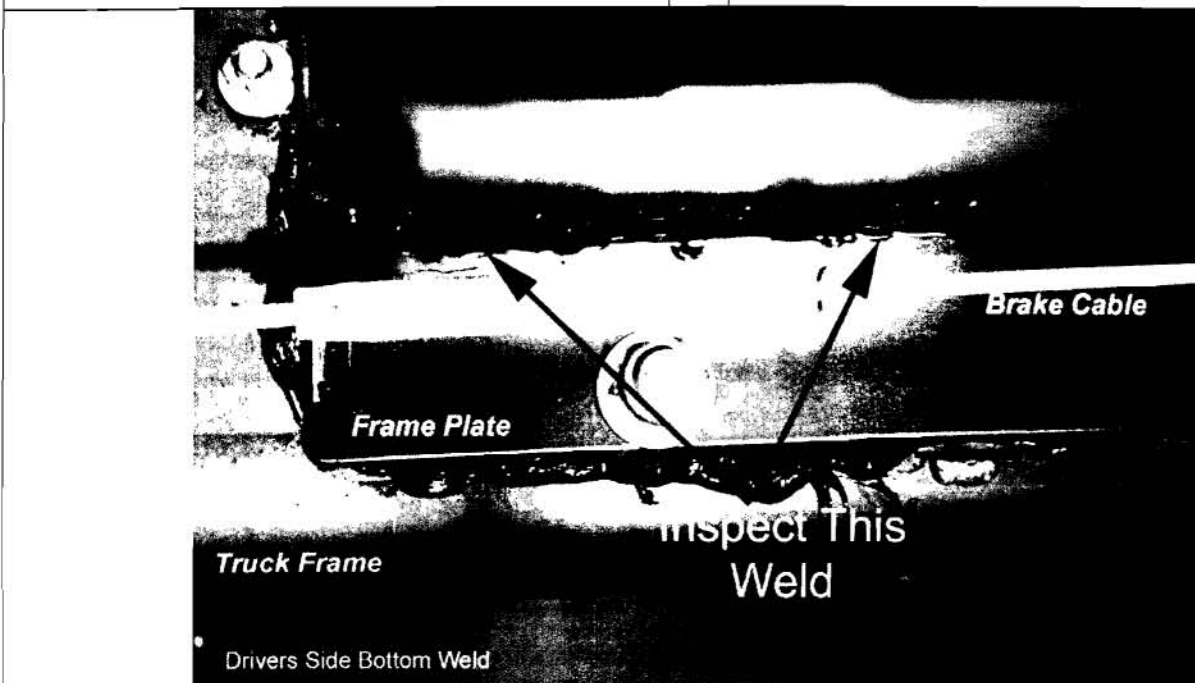
## Driver Side

Camper mount before camper has been installed. These photos show revision D mounts with a continuous weld bead. Your mounts will be stitch welded.

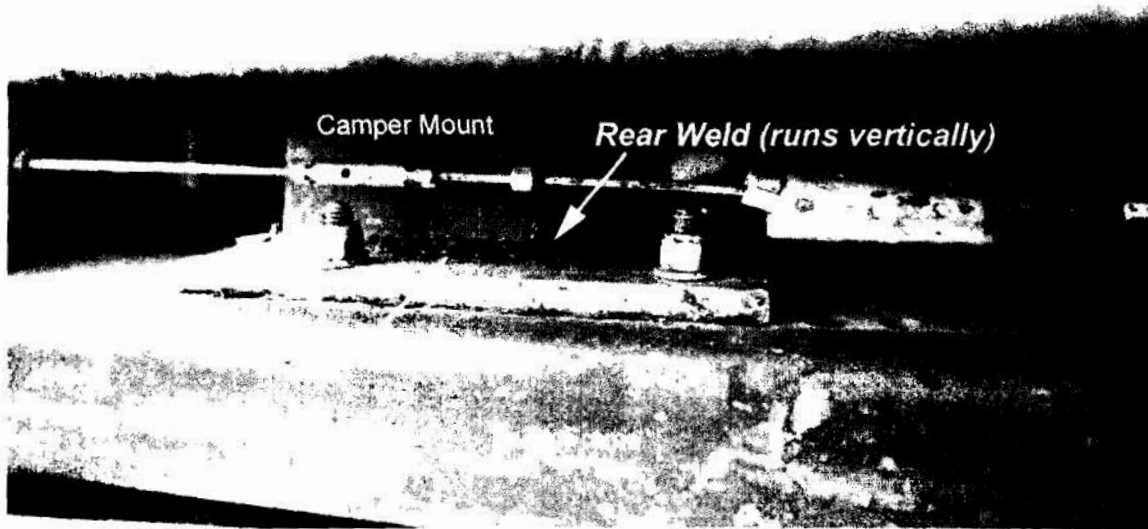
*Driver Side - View Looking Up*

## Camper mount after camper has been installed
