**Re: PART 573 NOTICE RE MCI G4500 TAG AXLE SWING ARM RECALL PLAN**

Safety Defect and Noncompliance Report Guide for Vehicles  
PART 573 Defect and Noncompliance Report

# Service Bulletin No.212

<b>MODEL</b> G4500 Series Coaches	<b>TYPE</b> Field Change Program	<b>SECTION/GROUP</b> 2B - Trailing Axle	<b>DATE</b> Dec. 04, 2003
<b>SUBJECT</b> TAG AXLE WELD REWORK			
<b>CONDITIONS</b>

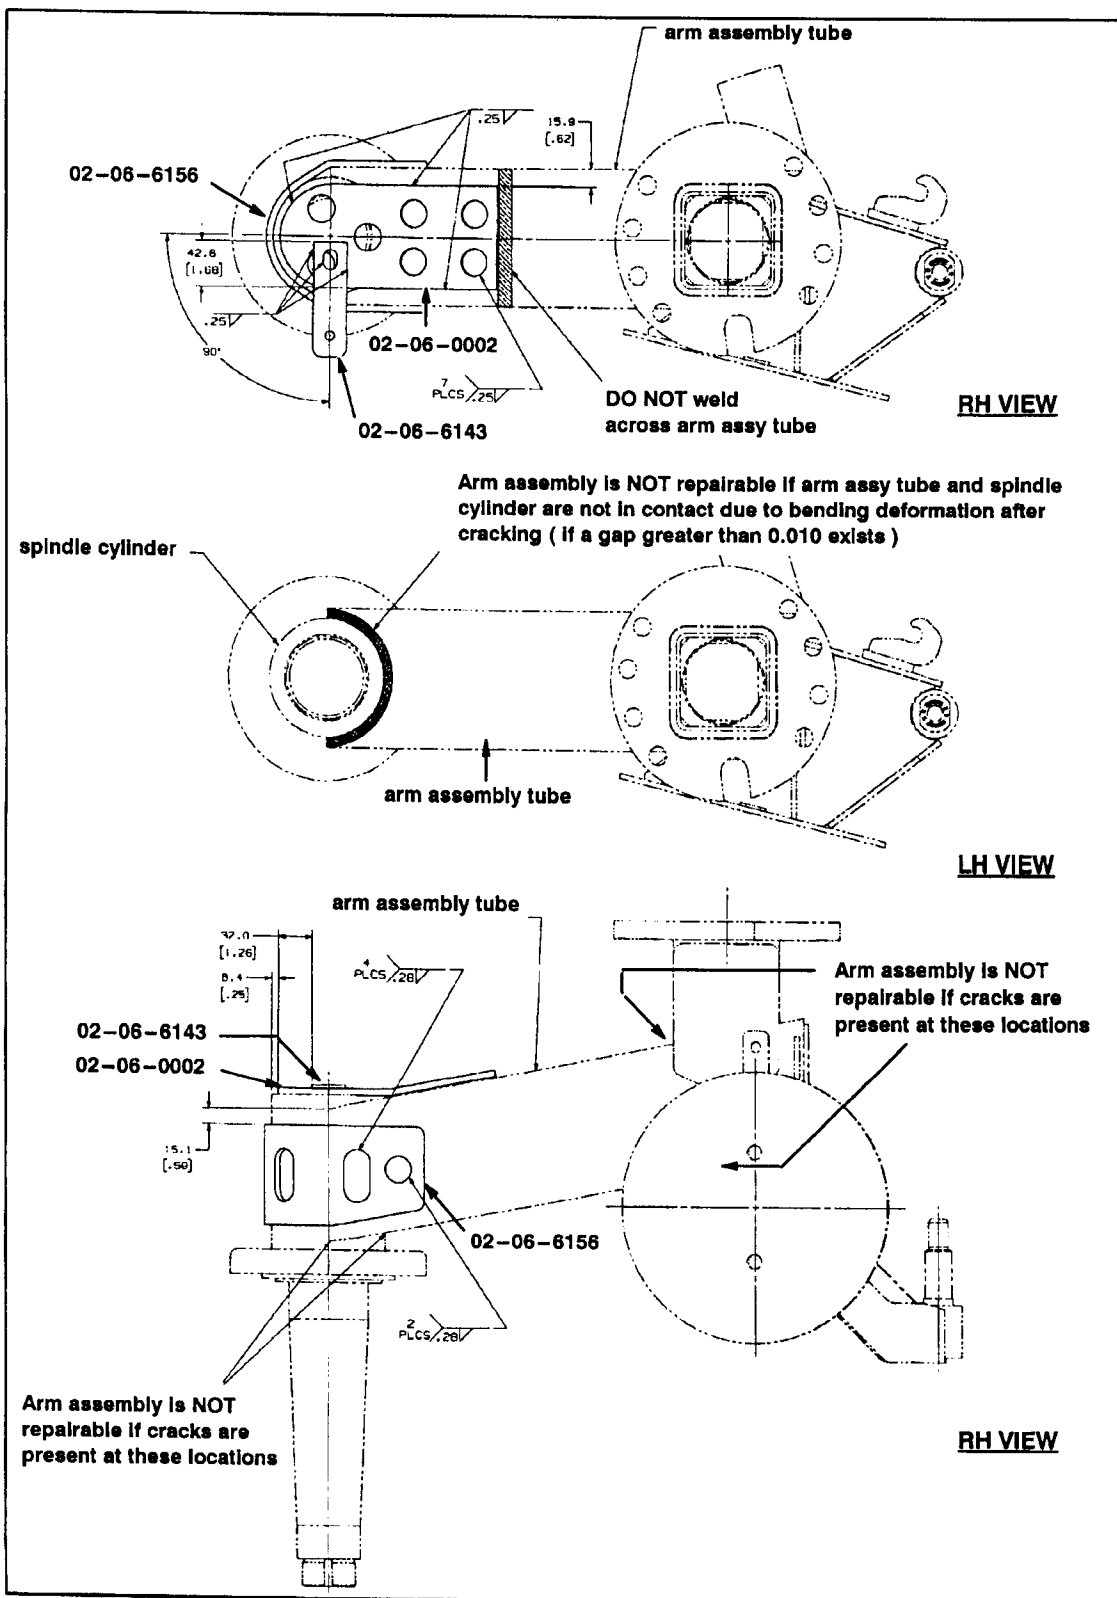
**Figure 4.**

*The tag axle arm assembly is NOT repairable if:*

- A. Cracks propagate thru the arm assembly tube.*
- B. Cracks are present at lower wheel spindle end of the arm assembly ( Figure 4 ).*
- C. Arm assembly tube and spindle cylinder are not in contact due to bending deformation after cracks are initiated ( if cracks are more than 0.010 inch ) ( Figure 4 ).*

10. Using a steel brush, clean the area around the crack to remove all the dirt, rust, grease and paint.
11. Upon inspection if a crack is present at the upper weld, grind and/or gouge out the crack, to create a u-groove sufficient to ensure complete joint weld penetration. Weld the crack, and grind smooth.
12. Remove and retain the brake hose bracket. Grind off the welded portion.

13. Position the plate ( part number 02-06-0002 ), ensuring that it sits flush and in full contact with the arm tube and spindle ( Figure 4 ).
14. Remove any sharp burrs on the inside edge of the hole in the plate ( part number 02-06-0002 ).

21. Perform a visual inspection of the final weld and note any defects that do not meet the requirements of AWS D1.1 Clause 4.8.1.

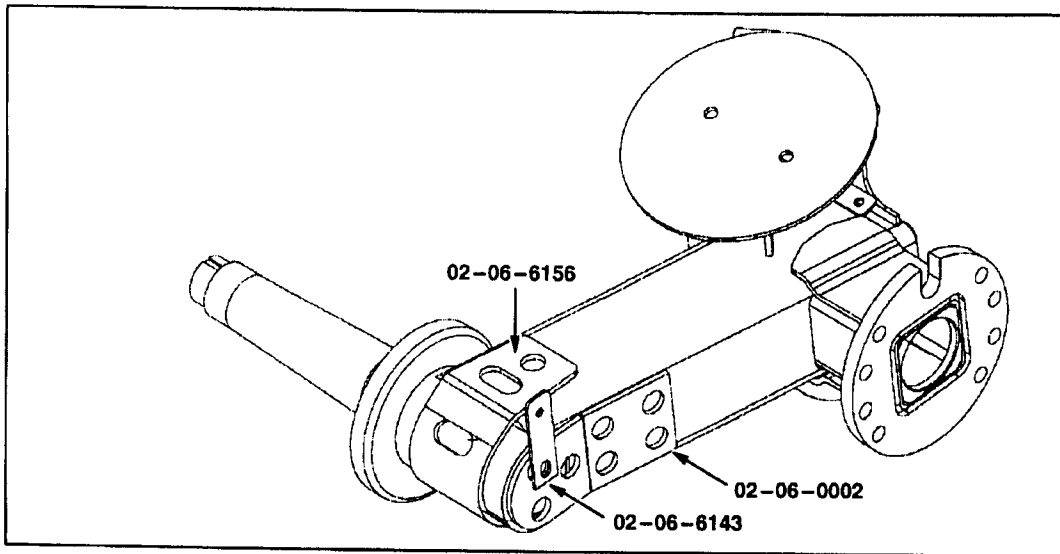
**Figure 5. Re-worked tag axle arm.**

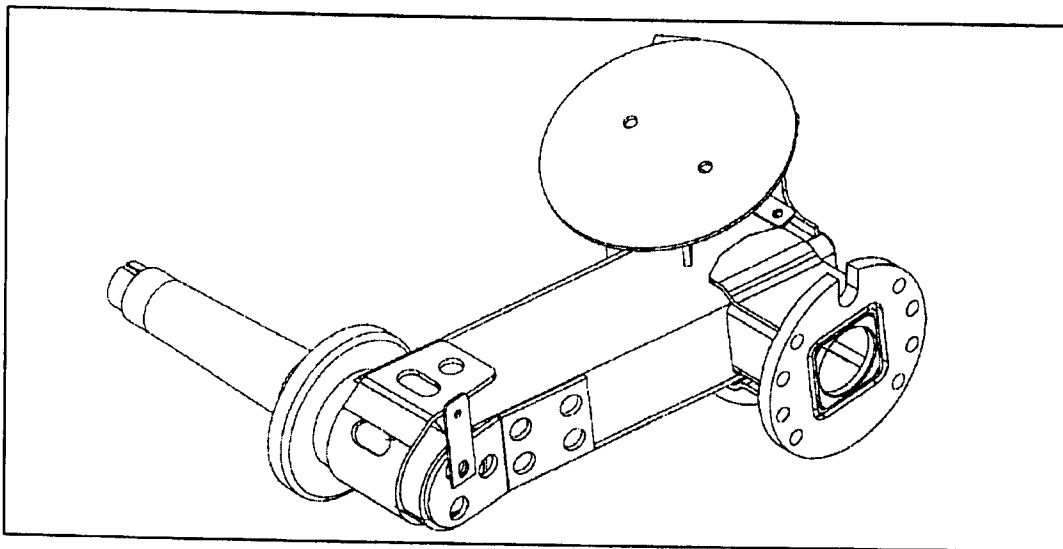
**Figure 9. Re-worked tag axle arm.**

16. Remove the air spring from the existing tag arm assembly. Install the air spring on the re-worked tag arm assembly ( part number 02-06-0001 / 02-06-0003 ).
