**Re: PART 573 NOTICE RE MCI G4500 TAG AXLE SWING ARM RECALL PLAN**

Safety Defect and Noncompliance Report Guide for Vehicles  
**PART 573 Defect and Noncompliance Report**

# Service Bulletin No.212

MODEL <b>G4500 Series Coaches</b>	TYPE <b>Field Change Program</b>	SECTION/GROUP <b>2B- Trailing Axle</b>	DATE <b>Dec. 04, 2003</b>
SUBJECT <b>TAG AXLE WELD REWORK</b>			
CONDITIONS

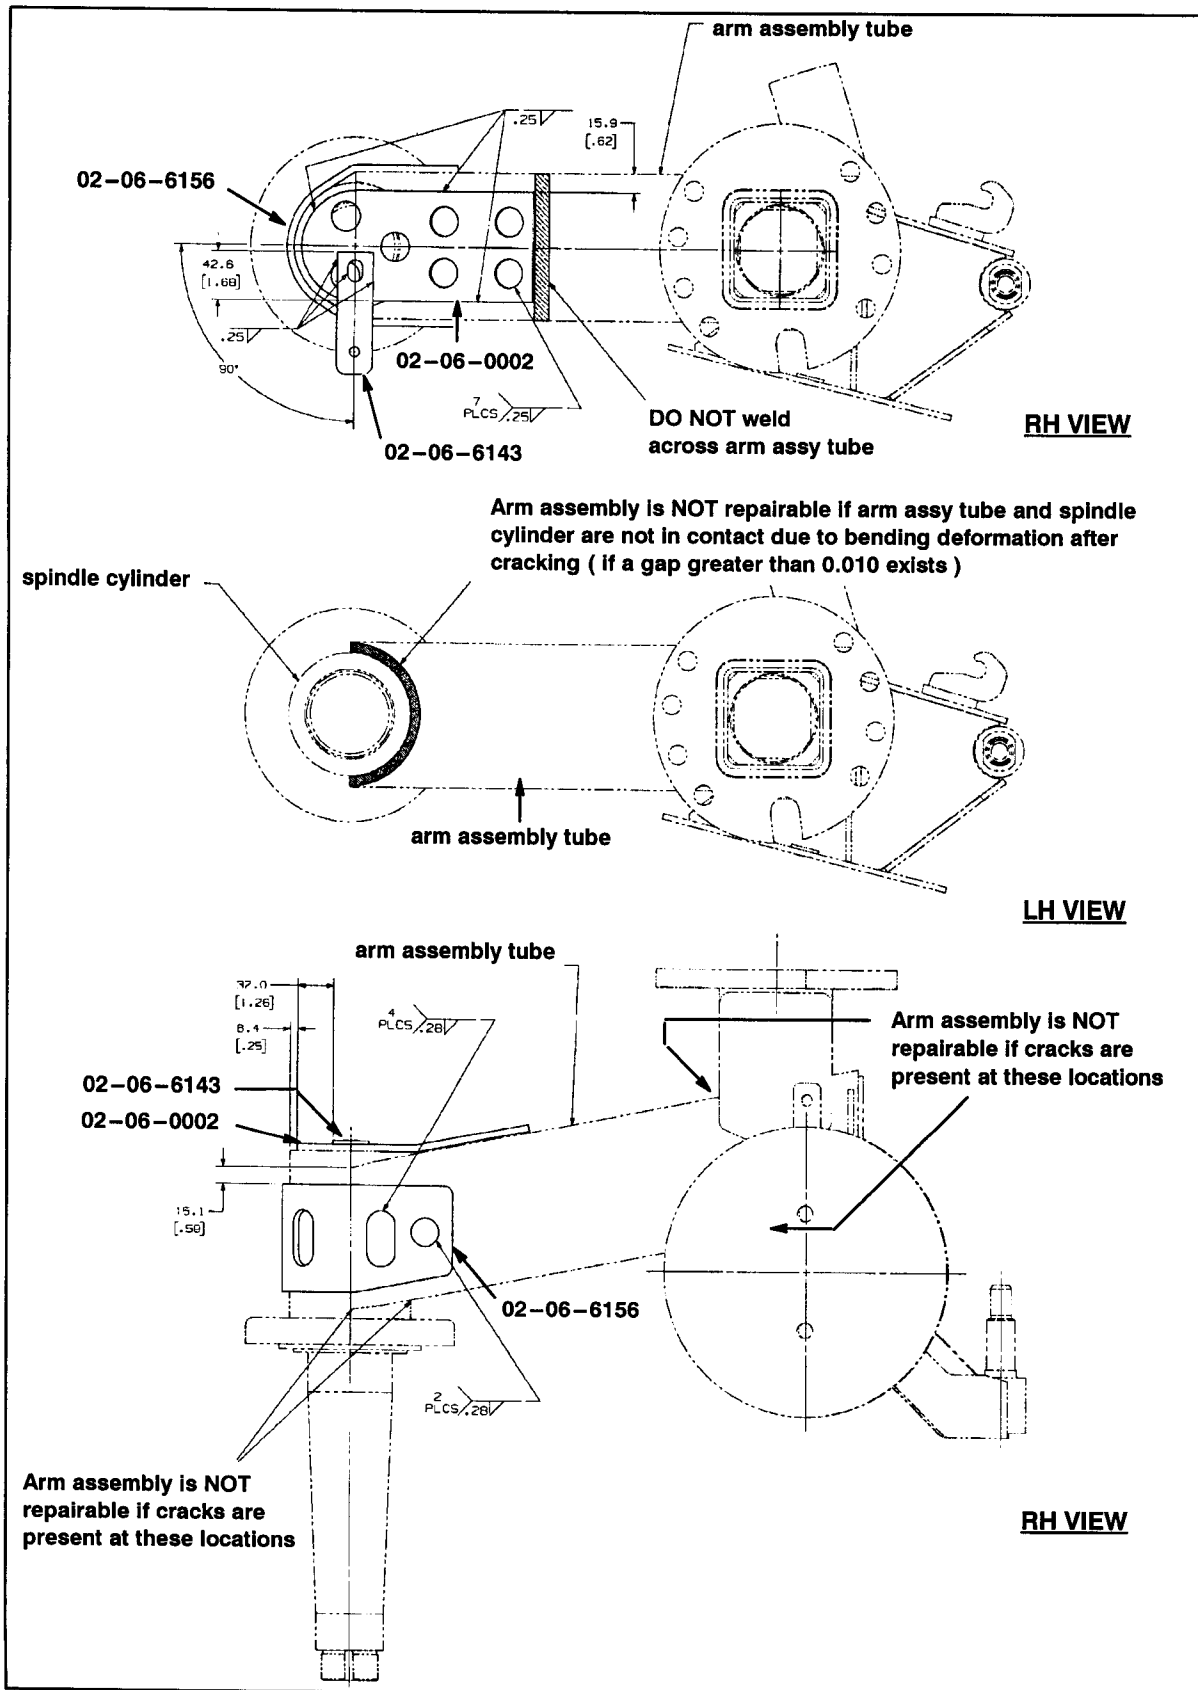
**Figure 4.**

*The tag axle arm assembly is NOT repairable if:*

- A. *Cracks propagate thru the arm assembly tube.*
- B. *Cracks are present at lower wheel spindle end of the arm assembly ( Figure 4 ).*
- C. *Arm assembly tube and spindle cylinder are not in contact due to bending deformation after cracks are initiated ( if cracks are more than 0.010 inch ) ( Figure 4 ).*

15. Position the plate ( part number 02-06-0002 ) and strap ( part number 02-06-6156 ) in place, ensuring proper fit and installation ( Figure 4 ). Using clamps, secure the plate and strap in position.

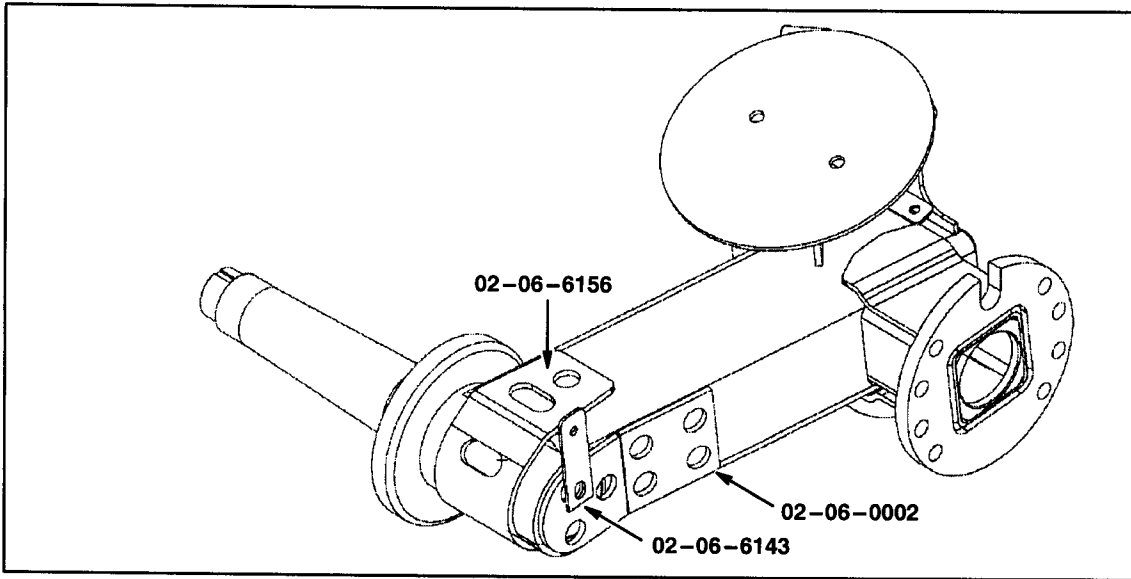
**Figure 5. Re-worked tag axle arm.**

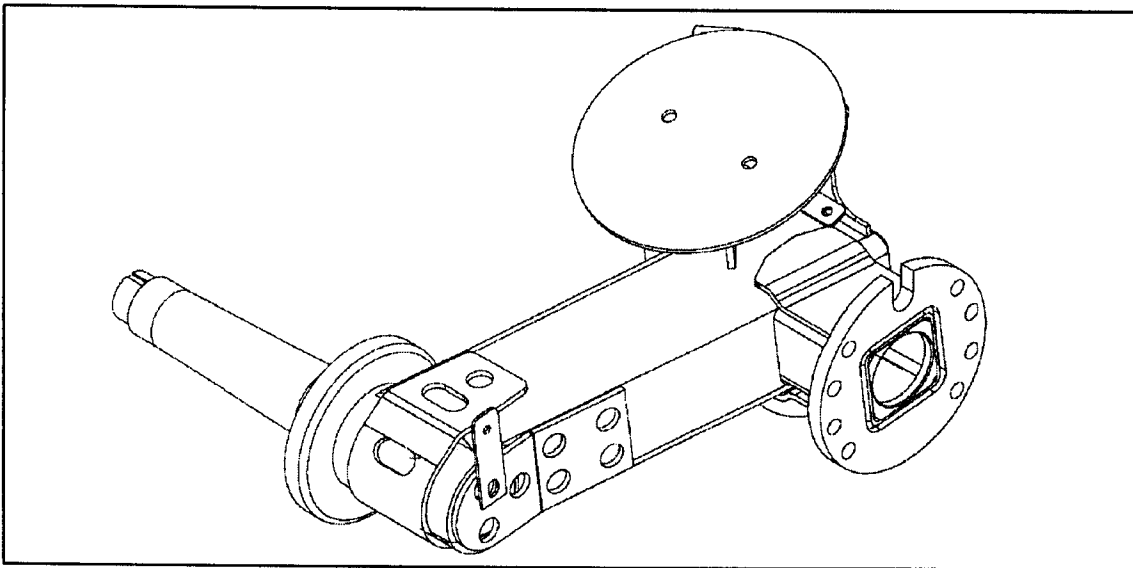
**Figure 9. Re-worked tag axle arm.**

16. Remove the air spring from the existing tag arm assembly. Install the air spring on the re-worked tag arm assembly ( part number 02-06-0001 / 02-06-0003 ).
