**Re: PART 573 NOTICE RE BOOST CONNECTOR**

Safety Defect and Noncompliance Report Guide for Vehicles  
**PART 573 Defect and Noncompliance Report**

# Service Bulletin No. 274

<b>MODEL</b> D Series Coaches	<b>TYPE</b> Field Change Program	<b>SECTION/GROUP</b> 7-Electrical	<b>DATE</b>
<b>SUBJECT</b> BOOST CONNECTOR			
<b>CONDITIONS</b>

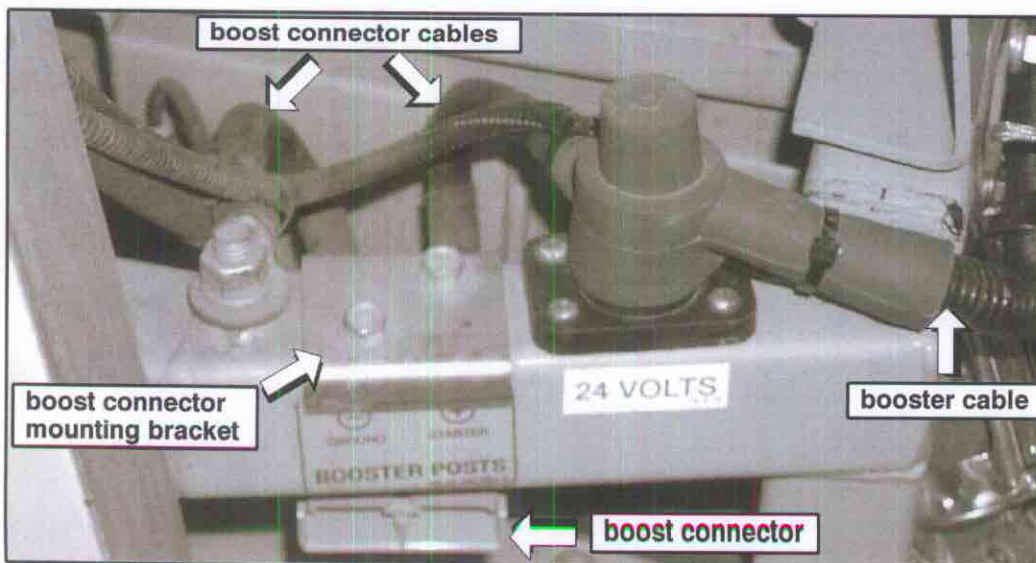
Motor Coach Industries, Inc. ("MCI") has determined that a defect which relates to motor vehicle safety may exist in certain MCI D series coaches that contain a boost connector. MCI has become aware that the boost connector's plastic housing may crack, which can allow the positive and negative leads to come in contact. In rare conditions, this may cause an overheat with arcing, and could result in a thermal event.

**Figure 1. Existing boost connector.**

5. Remove the two capscrews that secure the mounting bracket to the frame. Discard the mounting bracket and the existing boost connector.
