## Product Recall

Subject: RECALL 06V-151- Minotour - Braun Lift Floor Reinforcement

MODEL: MINOTOUR  
SUBJECT: BRAUN LIFT FLOOR REINFORCEMENTS  
PAGE: 1 OF 2

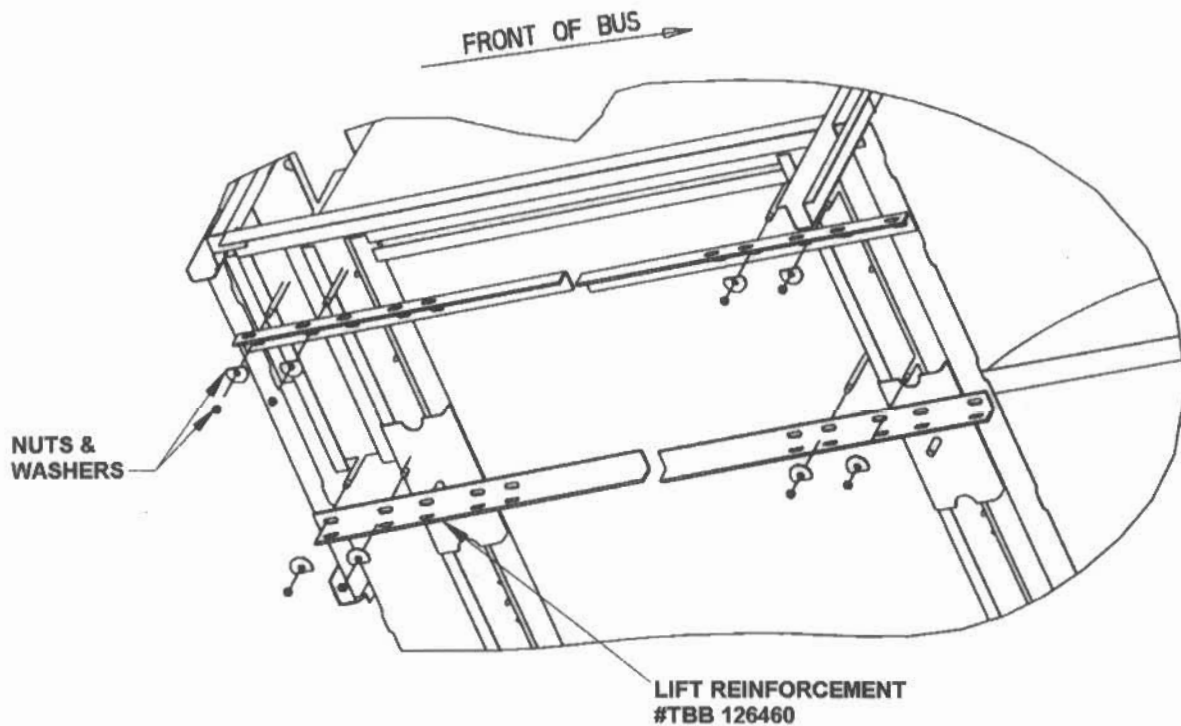
**Figure 1**

REINFORCEMENTS MUST BE ATTACHED TO FLOOR CROSSMEMBERS.  
REINFORCEMENTS CAN BE CUT TO FIT PROPERLY.

1. Secure unit to prevent rolling.
2. Remove eight (8) fasteners holding the platform down. Remove all nuts and washers and discard.
3. Clean area where reinforcements are to be installed.
4. Install the four (4) Lift Reinforcements, part #TBB 126460 using eight (8) Nuts, #TBB 27120377 and Lock Washers, part #TBB 27120381, and Flat Washers, #TBB 27446363. **Fig 1**

**Note: Fig. 1 is the primary installation. If this installation IS NOT possible, see Fig. 2.**

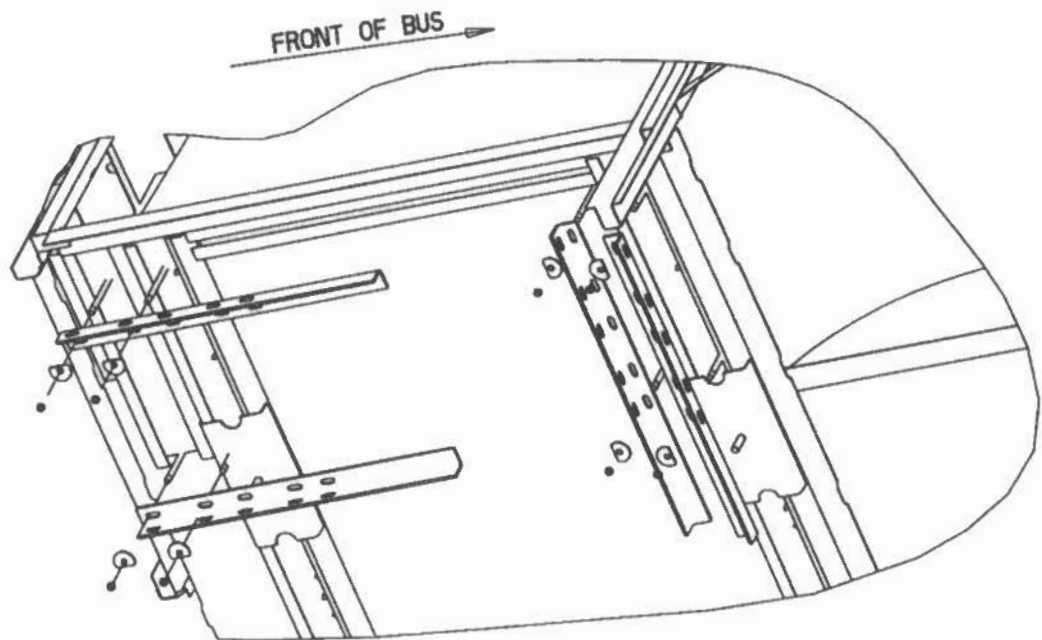
Figure 2

**ALTERNATIVE INSTALLATION**  
THIS INSTALLATION IS TO BE USED ONLY WHEN  
THE PRIMARY INSTALLATION IS NOT POSSIBLE.
