To: Area General Manager
From: Chuck Yaeger - National Customer Service Field Operations Manager
Subject: Special Service Campaign (SSC) 6LD
2004 -2005 Japan Produced RX 330 and Early 2006 RX 400h
Center Console (Floor Carpet Cover) Retaining Clips

TECHNICAL INSTRUCTIONS
FOR
SPECIAL SERVICE CAMPAIGN 6LD
CENTER CONSOLE (FLOOR CARPET COVER)
RETAINING CLIP REPLACEMENT
FOR
2004 THROUGH 2005 MODEL YEAR RX 330 AND
EARLY 2006 MODEL YEAR RX 400h

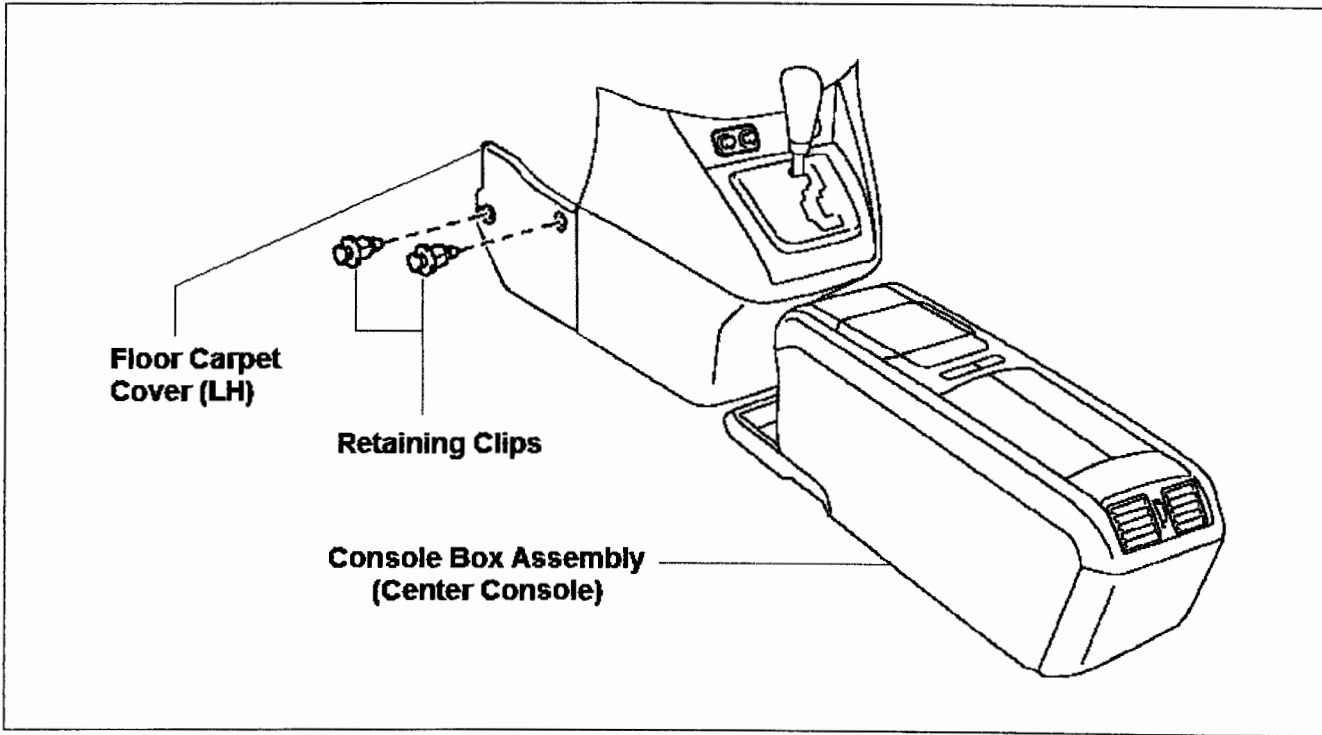
IV. COMPONENTS

In certain 2004 through 2005 model year Japan produced RX 330 and early 2006 model year RX 400h vehicles, due to improper installation, the two Retaining Clips for the driver's side forward Center Console (Floor Carpet Cover) can become loose. If both clips separate from the Floor Carpet Cover, the cover may lean toward the accelerator pedal, causing interference with the accelerator pedal rod.
