**Special Service Campaign (SSC) 60F
2004 Through 2005 Highlander And Early 2006 Highlander HV
Center Console (Floor Carpet Cover) Retaining Clips
*****URGENT*******

Volume: XIII
Number: TC06-010
Date: 07/11/2006
 Action
 Retain
 Information

SPECIAL SERVICE CAMPAIGN 60F

2004 THROUGH 2005 HIGHLANDER AND
EARLY 2006 HIGHLANDER HV

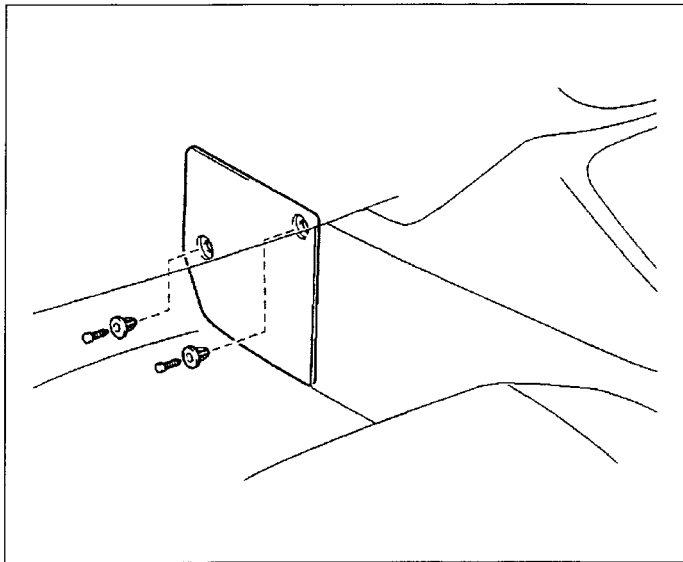
1. REMOVE THE CLIPS

In certain 2004 through 2005 model year Highlander and early 2006 model year Highlander Hybrid (HV) vehicles, due to improper installation, the two Retaining Clips for the driver's side forward Center Console (Floor Carpet Cover) can become loose. If both clips separate from the Floor Carpet Cover, the cover may lean toward the accelerator pedal, causing interference with the accelerator pedal rod.

- a) Remove, **destroy** and **discard** the 2 clips.
