### **Sprocket adaptor plate bolt substitution for 1999 models affected by Safety Recall V-06-07**

This information is specific to model year 1999 motorcycles with original equipment rear cast wheels. See detail below.

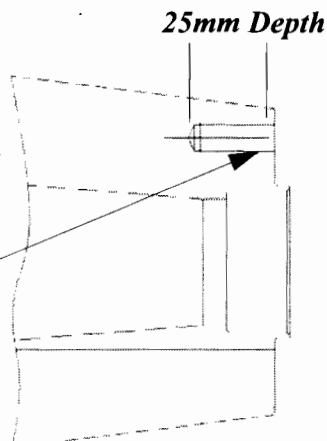
If you inspect a 1999 model and determine it needs the cushion drive rear hub as described on Safety Recall V-06-07, **you must order rear sprocket hub adaptor bolts P/N 7518032 (Qty 5) separately.** For model year 1999, the (5) M10x1.5 in the rear wheel hub for attachment of the rear sprocket have 20mm less thread depth than later model year Victory motorcycles. This shallower thread depth will not allow full engagement of the (5) new bolts (55mm long) included in kit 2876257.

1999 Wheel (RH hub)  
(5) M10x1.5 threaded holes  
(25mm depth) need different  
bolts 7518032

No counter-bore

- If you are installing the Cushion Drive kit on a 1999 model year motorcycle, discard the (5) bolts (PN 7518146 M10 x 55mm long) included in the kit.
- Order (5) replacement bolts (PN 7518032 M10 x 35mm long)

- Do not use liquid Loctite<sup>®</sup> on new bolts (PN 7518032), as these new bolts have a pre-applied locking agent.
- Cleanliness of wheel hub threads is still required per original instruction (PN 9921130)
- No change to torque requirements for these bolts.
- No other changes to instructions required.
