MERCEDES-BENZ USA, LLC

Re: Recall Campaign 2006120008 Check Accelerator Pedal Nut and Install As Necessary, Models 164 and 251 Model Year 2007

Re: Retail Hold Check Accelerator Pedal Nut, Install as Necessary, Models 164 and 251 Model Year 2007

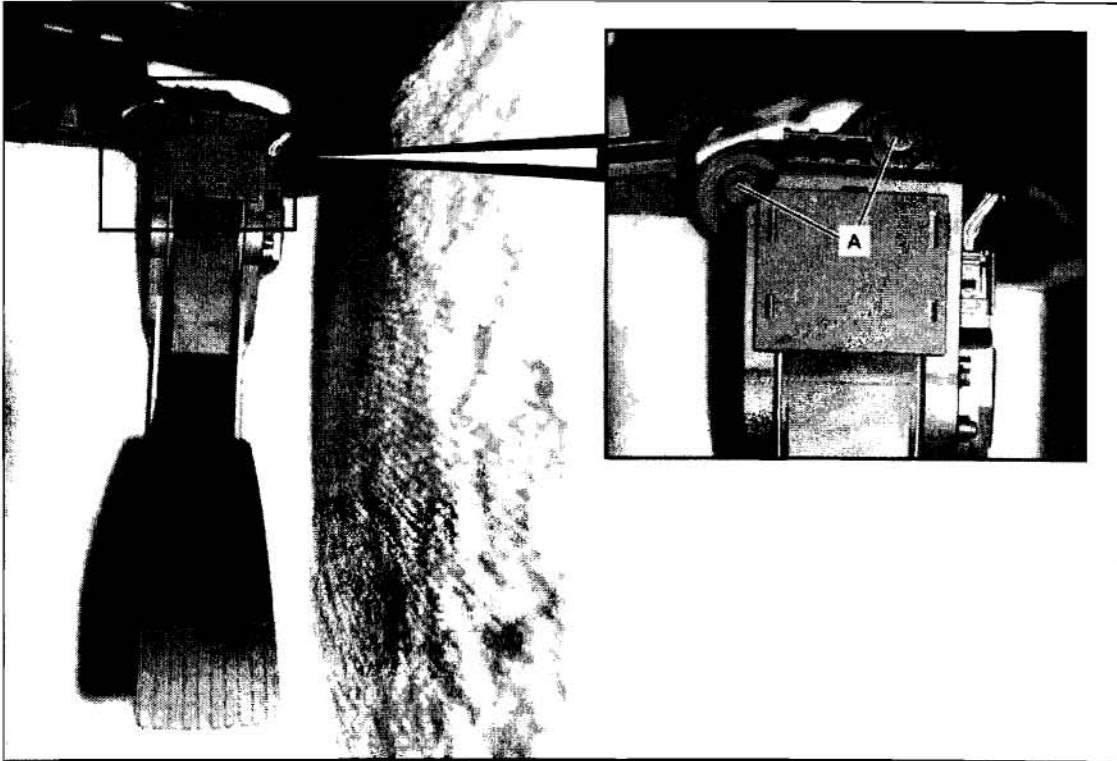
Figure 1

DCAG has determined that the accelerator pedal in some M and R-Class vehicles might not have been fully fastened to its mounting studs on a small number of vehicles. Due to the geometry and tension in the assembly, the mounting studs will maintain the position of the accelerator pedal on affected vehicles, but may, over time, not maintain a consistent pedal position, which could make it more difficult to operate the accelerator. All other functions of the vehicle (engine acceleration, deceleration, and braking) will, however, remain fully functional.

(shown on Model 251)

2. Model 164: Remove cover below instrument panel; refer to WIS document AR68.10-P-1500GZ.
3. Visually check if accelerator pedal nuts (A, Figure 1) have been installed.
 - If both nuts are installed: Proceed to step 4 (Model 164 only); this inspection has been completed.
 - If either nut is not installed: Install nut(s) (part # A 203 301 00 72) according to WIS document AR30.12-P-1321GZ (Model 164) or AR30.12-P-1321RT (Model 251).

Part number 203 301 0072 is the correct replacement nut. The part for this plastic nut shown in the EPC is incorrect in the 11/06 update. The EPC will be corrected as soon as possible, however dealers should make a note of the correct part number to be used as shown in this document.
