IC Corporation

06V-228

NON-COMPLIANCE RECALL 06505

September, 2006

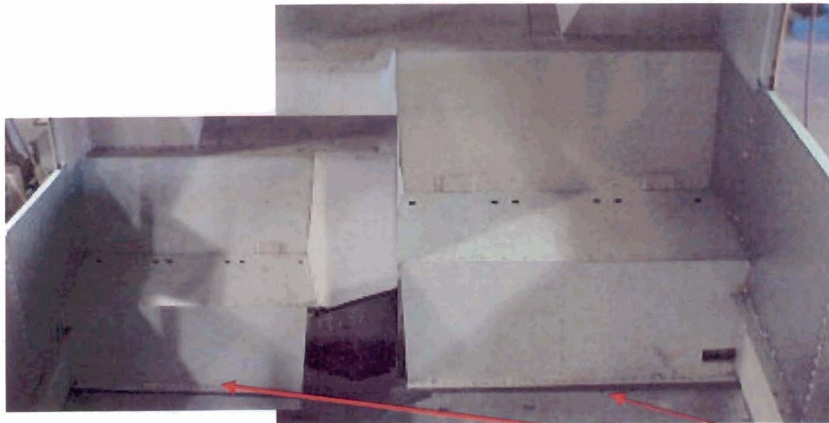
Bottom Davenport
Panel to Floor RE
Joint

The joint where the davenport meets the bus floor may not meet the required minimum joint strength. This has been determined to be noncompliant with FMVSS 221 (571.221 S5.1, 5.1.1, S6.2).

In the event of a vehicle crash, the defective joint may result in a lack of structural integrity, possibly resulting in an injury or death to the vehicle occupants.

This repair involves securing three flat retaining bars along the front of the davenport joint. The retaining bars are secured with 1 1/2" screws spaced at 1 1/8" installed through the floor covering, plywood (if applicable), the davenport closeout's lower flange, and into the floor's substructure. The davenport closeout's lower flange is typically not visible beneath the floor mat and plywood (if applicable). There is only one part number for one length of retaining bar. The two shorter retaining bars are made by cutting the longer bar to the appropriate length.
