IC Corporation

SAFETY RECALL 06512

February, 2007

There are four issues that may exist for the National Seat ABTS (All Belts To Seat) driver's seat that this recall will remedy.

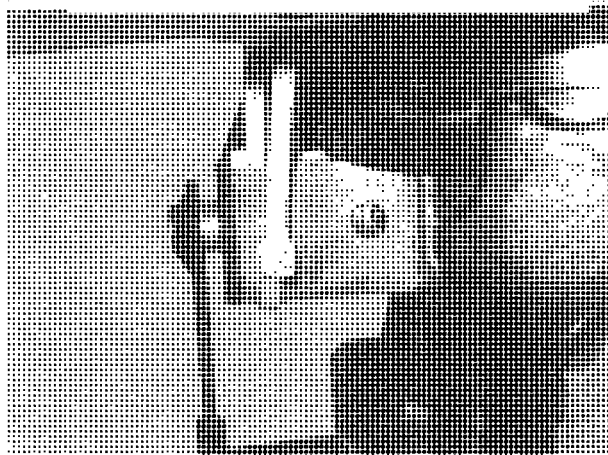
FIGURE 1.

NOTE: During the manufacturing process on manual seats without an up-stop mechanism, a plastic tie-strap is used to keep the seat height springs compressed (See FIGURE 1). Once the seat is assembled, this tie-strap must be removed to allow adjustment of the seat height. Before performing the following procedures, inspect the seat being modified and verify that the tie-strap has been removed. If necessary, remove the tie-strap.

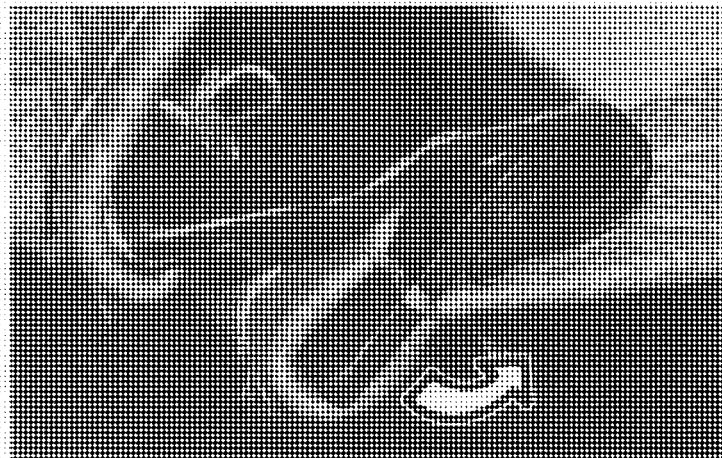
FIGURE 5. Two Piece Clip for Seat Back Cover (Rotate to Disengage)

4. Partially remove cover from upper seat back.
 - a. Front flap of cover is clipped to back flap of cover at bottom of seat back. The clip piece attached to the front flap must be pulled forward (rotated) to disconnect it from the clip piece attached to the back flap. See FIGURE 5.
 - b. Starting at the bottom, roll the cover up one or two rolls; then, grasping the rolled material, slip the cover upward until the upper left corner of the seat back is exposed. See FIGURES 6 & 7.

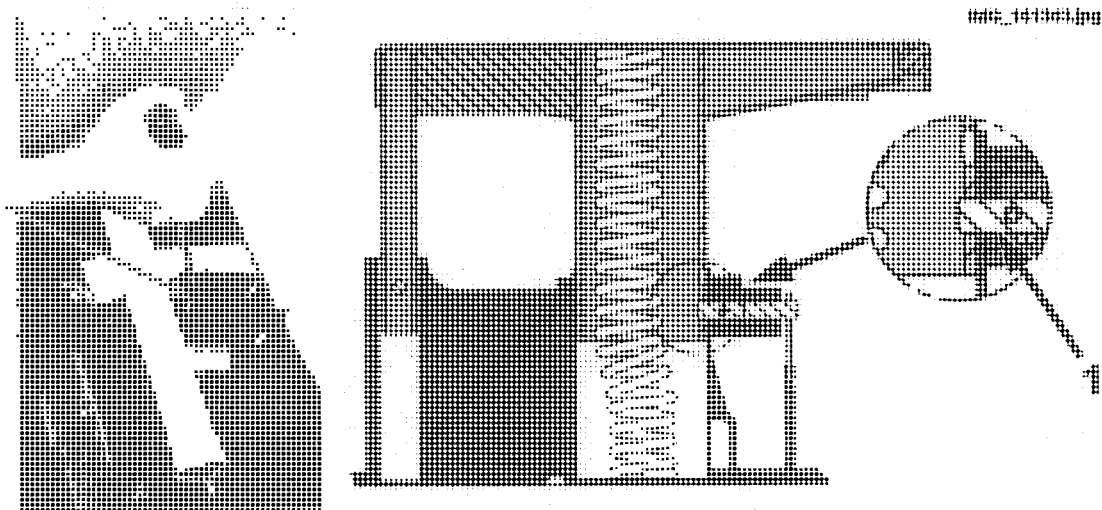
FIGURE 25.

1. SEAT HEIGHT LOCKING PIN

10. Through the opening at the top of the seat base cylinder, use a screwdriver to position the seat height springs away from the seat height locking pin. The springs should be adjusted so that they arc away from the locking pin (push over with screwdriver as shown on the left in FIGURE 25, push toward front of bus). This step creates the clearance needed to prevent interference between the seat height locking pin and the springs.

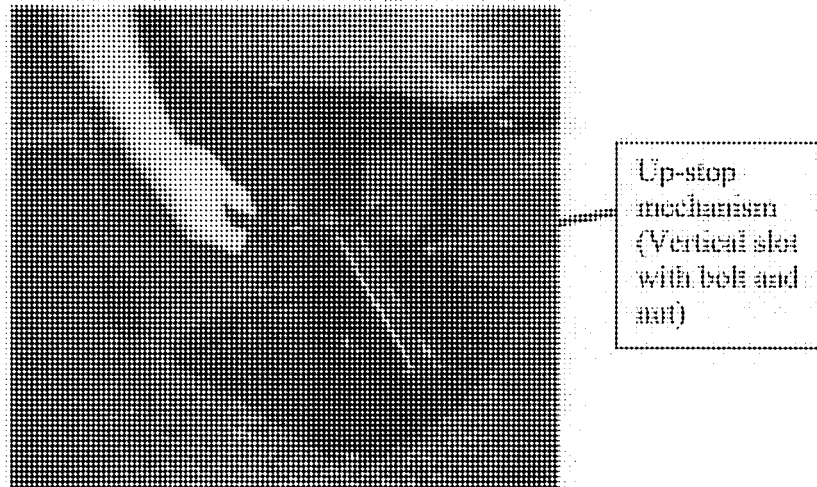
Up-stop
mechanism
(Vertical slot
with bolt and
nut)

Before Completing Repair 4, inspect the seat in order to determine if it has an up-stop mechanism. If your bus has this mechanism, Repair Procedure 4 will not have to be completed. See FIGURE 26.
