Re: Defect Information Report (FL-468), NHTSA 06V-006

Section 573.6 Non-Compliance Information Report
FL-468, VIP Steering Wheel NHTSA no. 06V-006
Supplement No.: 4

Subject: VIP Steering Wheels

Models Affected: Specific Freightliner Century S/T, Columbia, and Coronado vehicles built between October 1, 2000, and January 1, 2005, with certain Vehicle Improvement Products (VIP) steering wheels.

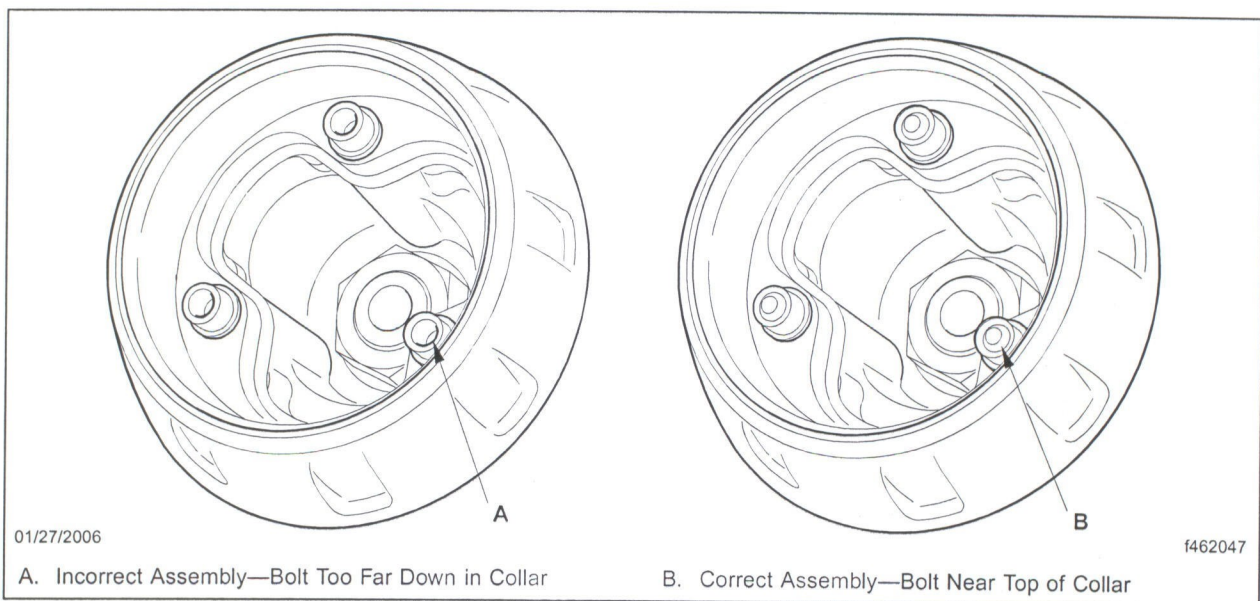
Fig. 2, Huck Fastener Inspection

One or more Huck fasteners securing the steering wheel assembly to the hub may be too short to provide adequate collar engagement on the pin. The steering wheel will feel loose on the hub for a period of time, with the possibility of a complete separation following. Steering wheel separation will result in a loss of steering control and possible vehicle crash.

6. Use the tip of your finger to test the three Huck fasteners for proper engagement. A fastener is acceptable when the dark-colored center bolt can be felt with your finger or seen to be at the upper end of the collar. A fastener is not properly engaged when it is felt with your finger or seen to be below the upper end of the collar. See Fig. 2.

If all three Huck fasteners are properly engaged, the steering wheel does NOT need to be replaced. Go to step 7.

If one or more of the Huck fasteners is not properly engaged, the steering wheel needs to be replaced. Take digital photos clearly showing the short Huck fastener(s). Go to "Steering Wheel Replacement" in these Work Instructions.
