## Product Recall

Subject: RECALL06V-014, 06-010 (Canada)- Front Spring Replacement - HDX

# Repair Procedure

SUBJECT: FRONT SPRING REPLACEMENT

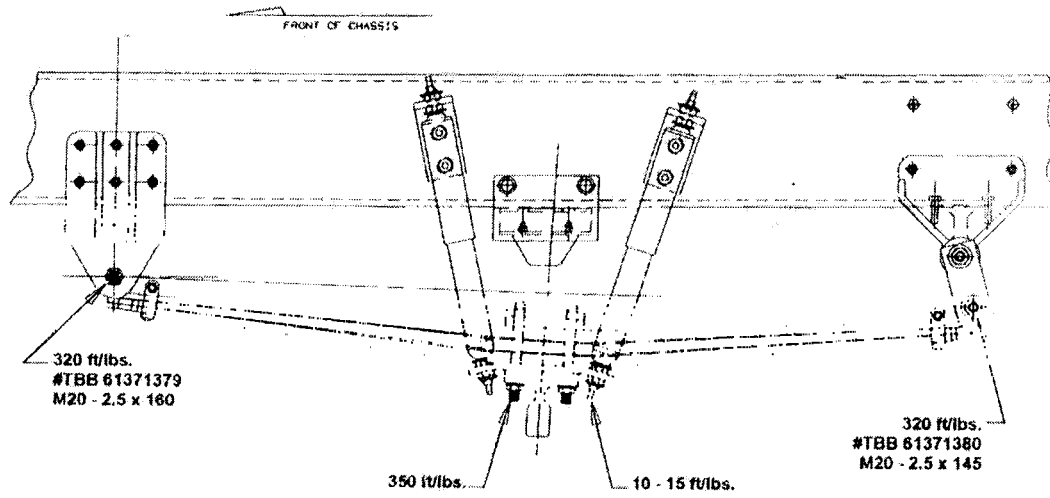
Fig. 1

Enclosed are copies of the customer notification letter and the repair procedure for Recall 06V-014. This recall involves certain Thomas HDX school buses manufactured from July 2005 through November 2005. The front spring eyes may crack. Vehicle steering control may be reduced if abnormal front suspension noises are ignored, possibly resulting in a crash and personal injury.

1. Make sure the wrap leaf is towards the front of the chassis. Make sure the shock absorber lower mounting plate has the holes on the outside.
2. Place spring in place on the axle, install U-bolts and tighten nuts only slightly.
3. Re-Install 3/4 - 10 x 6 Bolts in Spring Shackle, torque **320 ft/lbs. Fig. 1**
4. Torque front U-bolts to **350 ft/lbs. +/-50**, in gradual increments of **100 ft/lbs.** to prevent creating areas of high stress in the U-bolts and in the spring seating.
5. Reconnect front shock absorbers.
