To: Area General Managers
From: Jerry Marcotti - Service and Parts Operations Manager
Subject: Special Service Campaign (SSC) 6LA
Early 2004 Model Year RX 330 Rear, Left-Hand Side Seat Belt Buckle Anchor Bolt

Early 2004 Model Year RX 330 Rear, Left-Hand Side Seat Belt Buckle Anchor Bolt

TECHNICAL INSTRUCTIONS
FOR
SPECIAL SERVICE CAMPAIGN 6LA
EARLY 2004 MODEL YEAR RX 330
LEFT REAR SEAT BELT BUCKLE ANCHOR BOLT REPLACEMENT

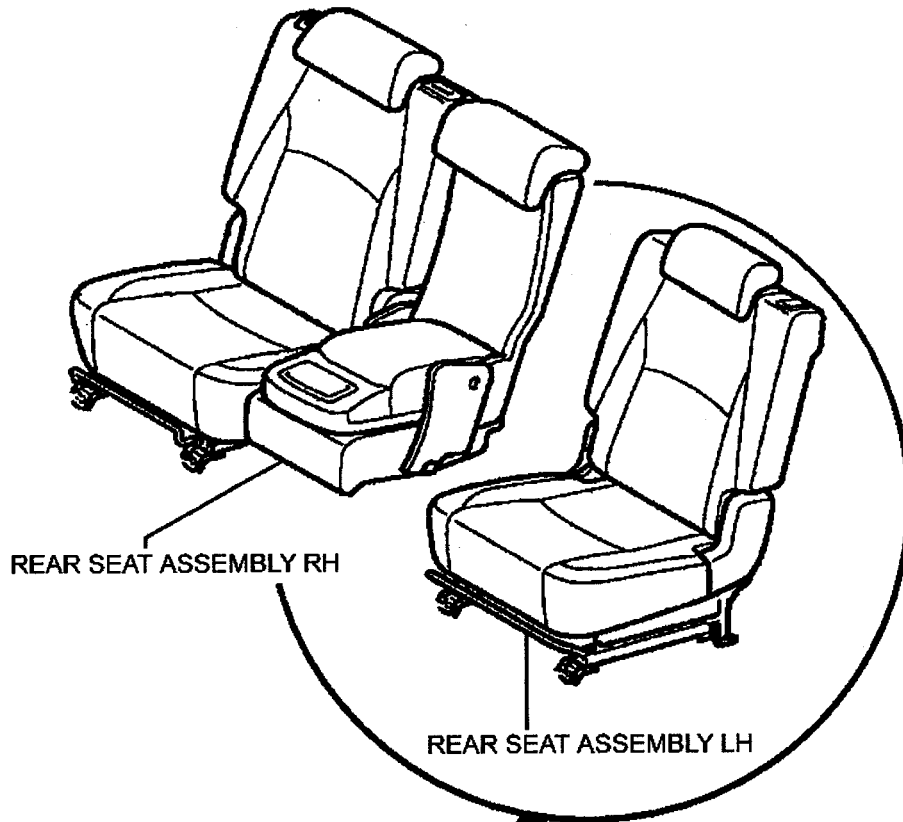
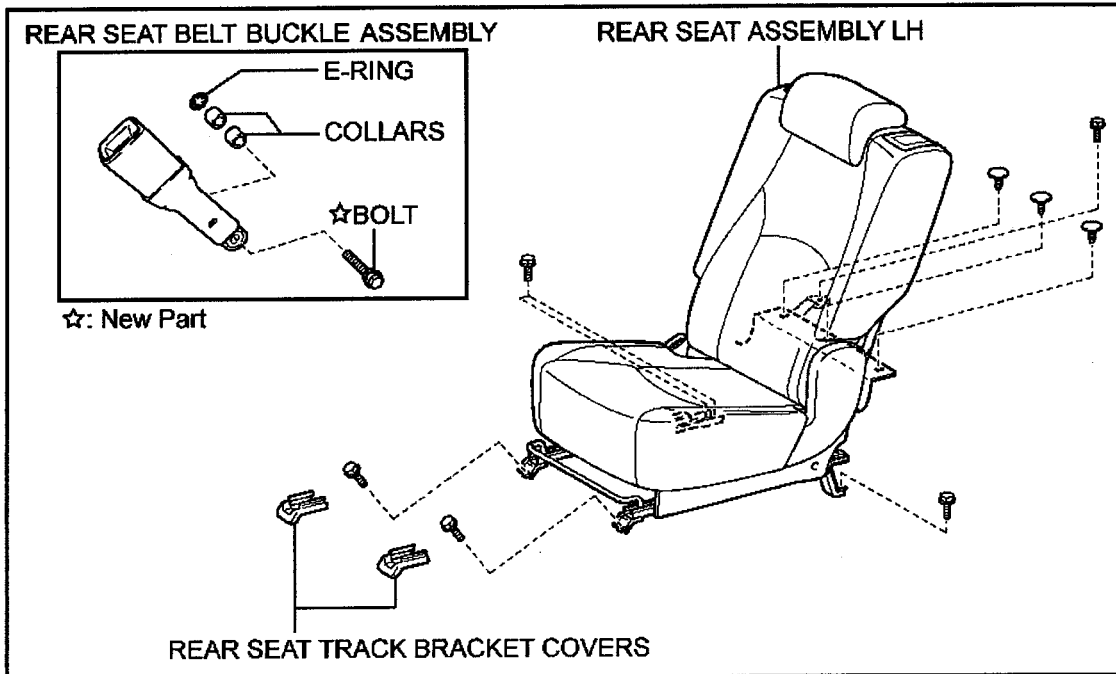
IV. COMPONENTS

ONLY THIS SEAT REQUIRES THE REPLACEMENT OF THE SEAT BELT ANCHOR BOLT!

In certain early 2004 Model Year Lexus RX 330 vehicles, there is a possibility that the anchor bolt for the Rear, Left-Hand Side Seat Belt Buckle (directly behind the driver's seat) does not have sufficient strength. Other seating positions are not affected.
