Campaign No. 2006080004, September 2006

SUBJECT: **MODEL 215, MODEL YEAR 2000-2002, 2004-2005**
MODEL 220, MODEL YEAR 2000-2002, 2004-2005
INSPECT INSTRUMENT CLUSTER AND REPLACE IF NECESSARY

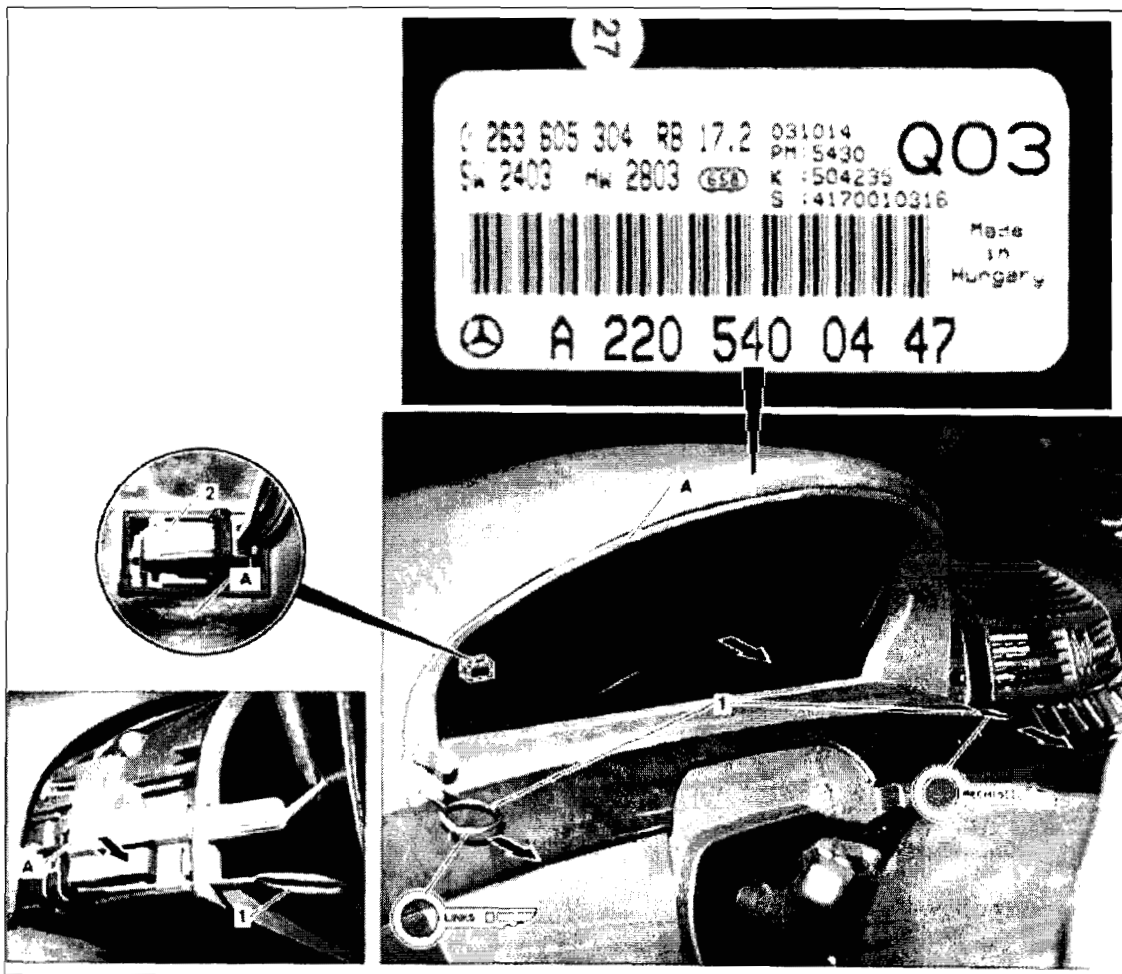
Figure 1

1. Move steering wheel out towards driver and down.
2. Remove instrument cluster (A, Figure 1) with connector (2) still attached.
 - Use removal keys (1, Figure 1; Special Tool W 963 589 01 05 00).

3. Check instrument cluster part number.
 - If part number does not match an affected part number below: Reassemble in reverse order; this campaign has been completed.
 - If part number matches an affected part number below: Proceed to Subject **B** to replace cluster.
