APR 11 7 13
DEFECT INVESTIGATION

Reference: NHTSA Identification Number 06V-036

Safety Recall F02 Oxygen Sensor Wiring

2006 (KJ) Jeep® Liberty 4x2

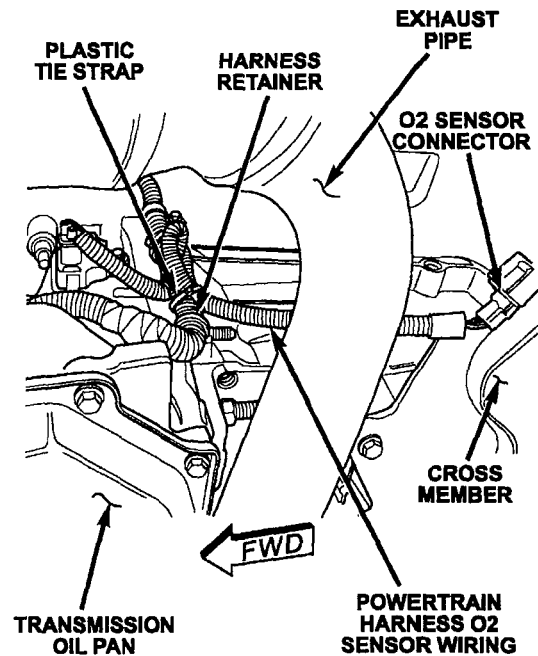
Figure 1

1. Raise the vehicle on a suitable hoist.
2. Locate the powertrain wire harness to the left (driver’s side) oxygen sensor connector. This wiring is at the rear of the transmission by the transmission extension housing and spans over the exhaust pipe. (Figure 1)

3. Inspect the wiring over the exhaust pipe for heat damage.
 - If the outer protective convolute and or wires have been damaged (melted), continue with **Section B – Wiring Harness Repair**.
 - If the outer protective convolute has not been damaged (melted), continue to Step 4.

4. Pull the powertrain harness oxygen sensor wiring towards the transmission leaving a slight droop to allow for engine/transmission movement.
5. Secure the excess length to the main trunk of the powertrain harness just above the harness retainer with the plastic tie strap (PN 04641780) as shown in Figure 1. Cut off the excess tie strap leader.
6. Lower the vehicle from the hoist and return the vehicle to the customer.
