## **IMPORTANT RECALL INFORMATION #60227**

SUBJECT: **RECALL CAMPAIGN #60227**  
Quality Axle Hub and Drum Assemblies

# Recall Bulletin 60227

Install Hub  
and Drum  
Assemblies  
with Properly  
Hardened  
Wheel Studs

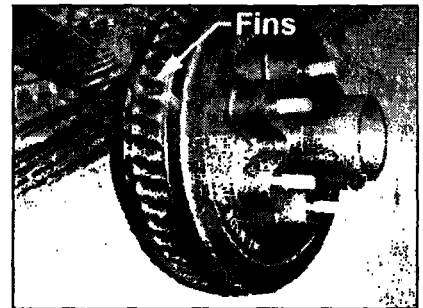
Figure 2

Certain travel trailers with serial numbers listed in this bulletin, have been equipped with improperly hardened axle wheel studs. Properly tightened wheel studs may break at any time.

1. Park the conventional or fifth wheel travel trailer on a hard flat surface. Block one wheel, fore and aft, on each side of the conventional or fifth wheel travel trailer.
2. Examine the outside perimeter of the brake drum. If the brake drum has a smooth perimeter, as shown in Figure 1, no further action is necessary. If the brake drum has fins as shown in Figure 2, proceed with the next step.
3. Locate the axle label on the topside of the axle beam. Axle labels matching the serial numbers shown in Figure 3, must have both Hub and Drum Assemblies replaced. Proceed with the Correction section of this Bulletin. If the travel trailer axles have axle label serial numbers different than what is shown in Figure 3, no further action is necessary.

To correct this safety defect, it is necessary to inspect and replace the travel trailer hub and drum assemblies as described in the enclosed Recall Service Bulletin #60227.

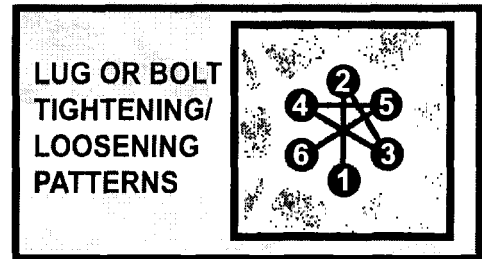
Figure 5

**IF NOT PROPERLY TIGHTENED, LOOSE LUG NUTS CAN DAMAGE THE STUD AND/OR WHEEL. IF DRIVEN IN THIS CONDITION FOR ANY EXTENDED PERIOD, SEVERE WHEEL DAMAGE COULD OCCUR AFFECTING THE HANDLING OF THE TRAVEL TRAILER.**

34. Place the wheels on the wheel mounting surface of the Hub and Drum Assemblies. Reinstall the wheel lug nuts, removed in Step 9, with the tapered end of the lug nuts toward the wheel. Tighten each lug nut by hand until the wheels are held against the wheel mounting surfaces. Lower the tires to the ground. Tighten the lug nuts to an initial 60 ft.-lbs. of torque and then to the final torque specification of 80-90 ft.-lbs. Follow the lug tightening sequence identified in Figure 5.
