TORQUE CHECK OF 2006 ROCKET III, ROCKET III CLASSIC AND ROCKET III SPECIAL EDITION HANDLEBAR BOLTS

OFFICIAL RECALL NOTICE
N.H.T.S.A. No. 06V-063
SERVICE BULLETIN 371

Recall Action Notice Service Bulletin 371

Handlebar Clamp Bolt Torque Check

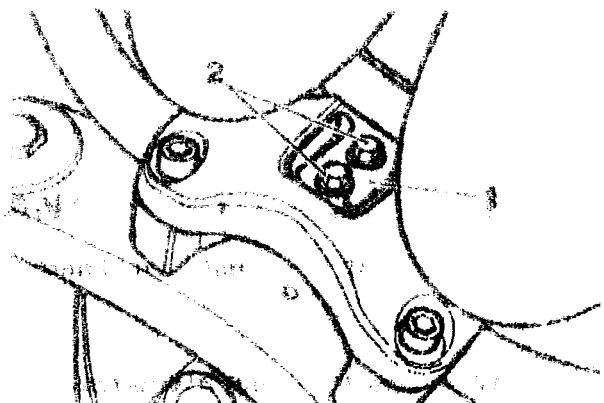
- Instrument bracket
- Screws

- Support the instrument, undo and remove the two screws securing the instrument bracket to the handlebar clamp then lift the instrument and bracket assembly clear.

- Position the instrument and bracket assembly to the handlebar clamp and secure with the two screws. Tighten the screws to 9 Nm.
- Carefully fit the chrome cover to the instrument bracket.

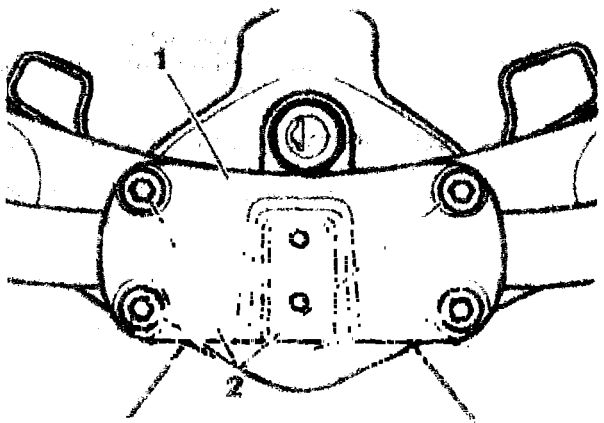
- Handlebar clamp
- Handlebar clamp bolts

From VIN 241570, the design of the handlebar clamp on the above models changed. The new handlebar clamp requires that the clamp bolts be tightened to 45 Nm.

Although this information was released in Technical News Issue 84, it is possible that the handlebar clamp bolts on some motorcycles from VIN 241570 have been tightened to the incorrect torque.

- Ensure that all four handlebar clamp bolts are tightened to 45 Nm.
