Date: April 3, 2006
Subject: 06019 \ Product Safety Recall
Tailgate Support Cable Replacement
Models: 1999-2000 Chevrolet Silverado
1999-2000 GMC Sierra
To: All Chevrolet and GMC Dealers
Attention: Service Manager, Parts Manager and Warranty Administrator

Recall Bulletin

PRODUCT SAFETY RECALL

SUBJECT: Tailgate Support Cable Replacement

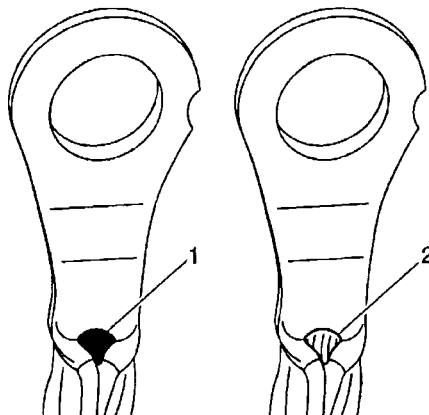
1545570

Important: In the above illustration, the clear sealant (1) is shown as black in color. This was done for illustration purposes only. If sealant is present on the support cables it will be clear or hazy (cloudy) in appearance.

3. Inspect the end (eyelet) of the support cable that attaches to the tailgate for sealant covering the end of the cable strands.
 - If there IS a clear type sealant (1) over the end of the cable strands, the support cable needs to be replaced. Reconnect the support cable to the pickup box and perform this same inspection on the left support cable. After inspecting both cables, proceed to the section titled, "Hinge Inspection."
 - If there IS NOT a clear type sealant (2) over the end of the cable strands, that support cable does NOT need to be replaced. Reconnect the support cable to the pickup box and perform this same inspection on the left support cable. After inspecting both cables, proceed to the section titled, "Hinge Inspection."

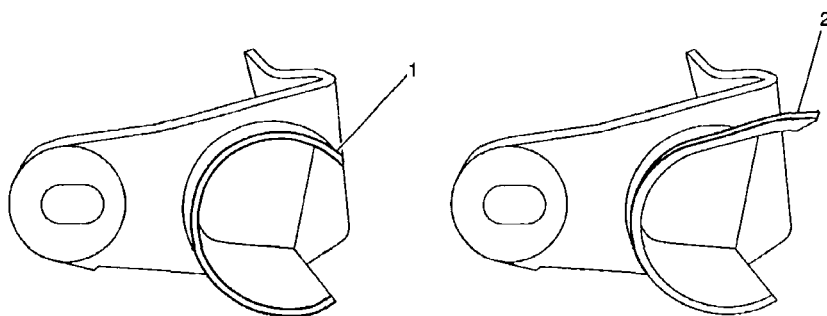
1538698

3. With the right side of the tailgate disengaged from the pickup box, inspect the hinge on the right side of the tailgate for damage. The illustration above shows an undamaged hinge (1), and a damaged or bent hinge (2).
 - If the hinge is NOT damaged, no repair is needed to the hinge. Proceed to the section titled, "Support Cable Replacement" and replace any support cables that HAD sealant in the earlier inspection. If neither of the support cables require replacement, no further action is required.
 - If the hinge IS damaged or bent, the hinge needs to be replaced. Proceed to the section titled, "Hinge Replacement".

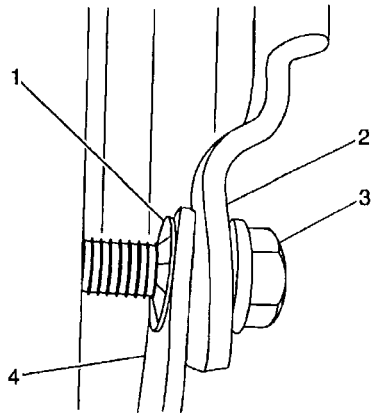
1466543

Important: If the support cable (2) has NOT been replaced previously, there will be a toothed nut (1) located between the latch (4) and the tailgate that will prevent the bolt (3) from being removed in the next step. The nut is an assembly aid used in the assembly plant. The nut does NOT need to be reinstalled or replaced when installing a new support cable in this recall.
