DaimlerChrysler Corporation

Reference: NHTSA Identification Number 06V-067

Safety Recall F10 - Windshield Wiper Motor

2005-2006 (HB) Dodge Durango

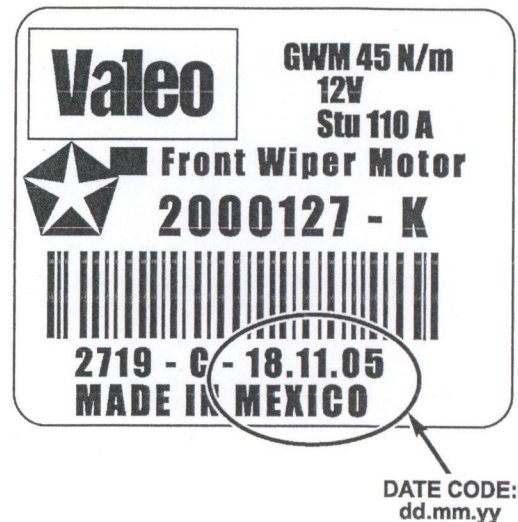
Figure 4

10. Lift the cowl grill in the center and read the wiper motor date code (Figure 4).

➤ If the date code (dd.mm.yy) is:

21.03.05 (21Mar05) through
15.05.05 (15May05)

21.09.05 (21Sep05) through
28.10.05 (28Oct05),

continue with **Section B – RS Wiper Motor Replacement**

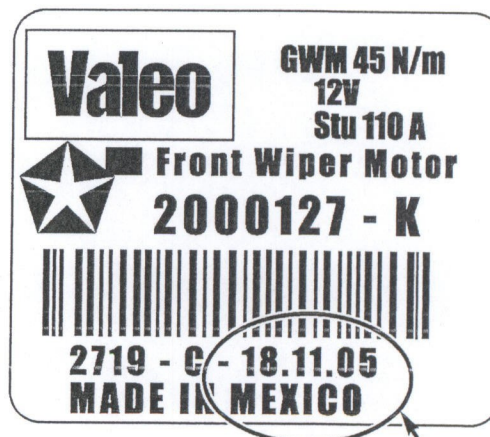
Figure 16

➤ If the date code (**dd.mm.yy**) is:

21.03.05 (21Mar05) through
15.05.05 (15May05)

21.09.05 (21Sep05) through
28.10.05 (28Oct05),

the date code is illegible,

discard the old wiper motor.

➤ If the date code is not within the two date ranges, reuse the old motor.
