Dealer Service Instructions for:

# **Safety Recall F11**

## **Right Front Door Latch Reinforcement Plate**

2006 (KJ) Jeep® Liberty

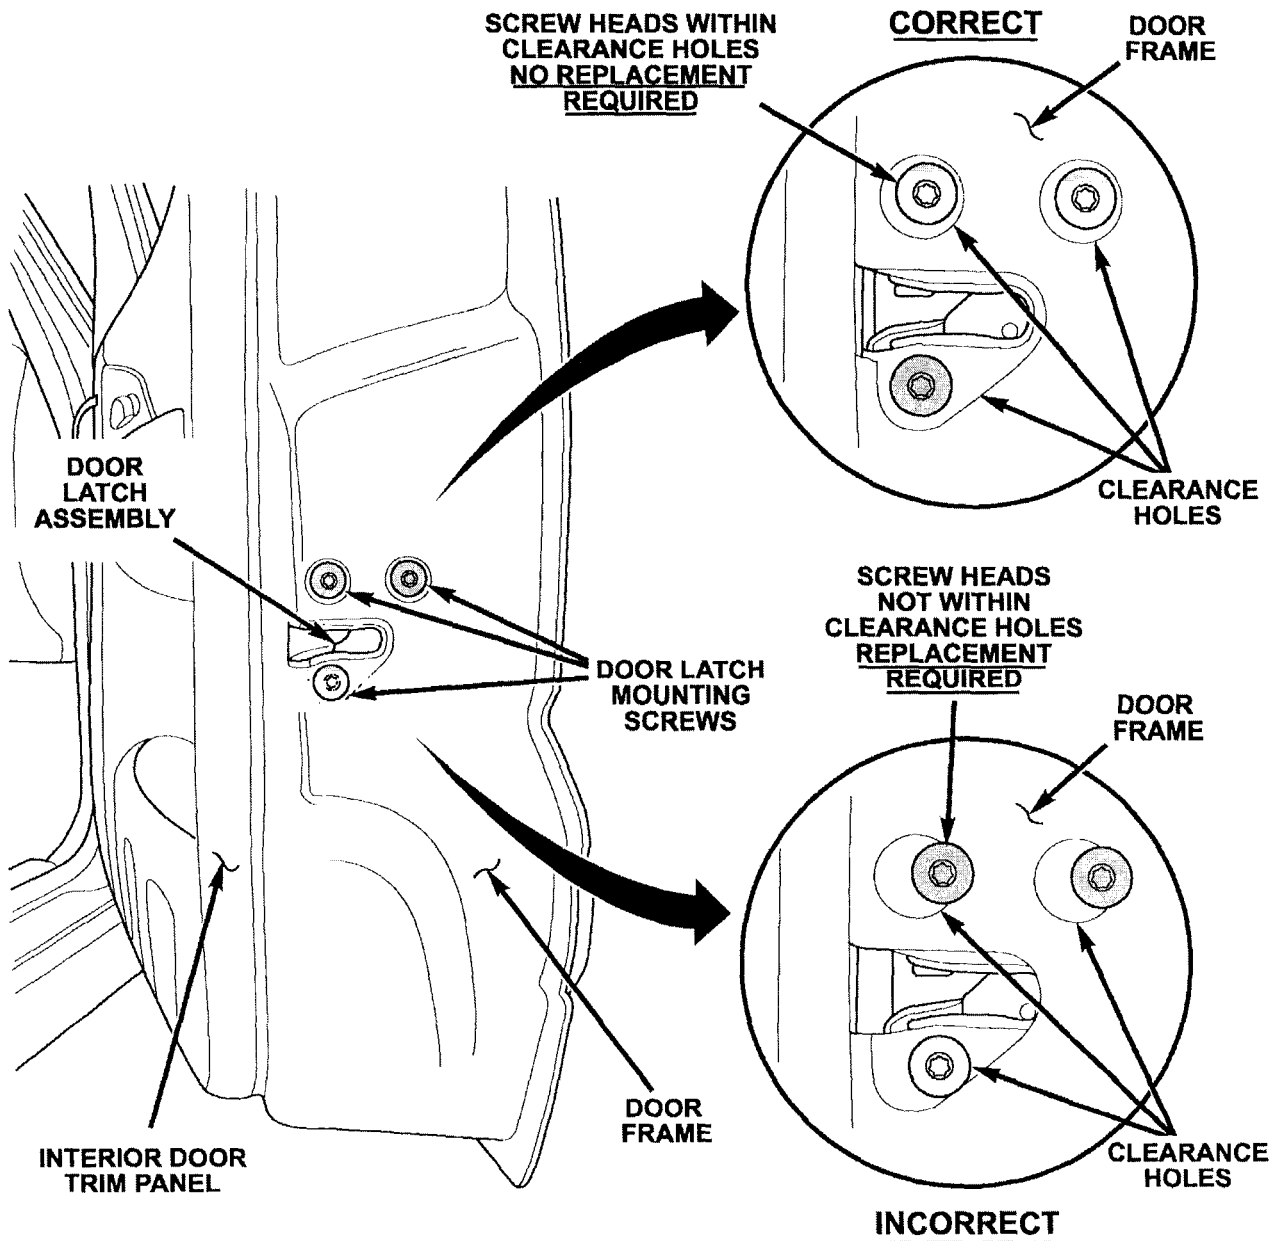
Figure 1 – Right Front Door

Open the right front (passenger door) and inspect the latch screw head locations on the door frame and check the secondary latch operation.

- If the screw heads are within the clearance holes (Figure 1) and the primary and secondary latch operates properly, no further action is required.
- If the screw heads are not within the clearance holes (Figure 1) and/or the secondary latch does not engage, replace the door latch reinforcement plate. Continue with **Section B. Door Latch Reinforcement Plate Replacement**.
