TOYOTA CUSTOMER SERVICES

Volume: XIII
Number: TC06-003
Date: 03/28/2006
 Action
 Retain
 Information

SUBJECT: SPECIAL SERVICE CAMPAIGN (SSC) – 60B (SAFETY RECALL)
(SUPPLEMENTAL RESTRAINT SYSTEM (SRS) AIRBAG REPLACEMENT)

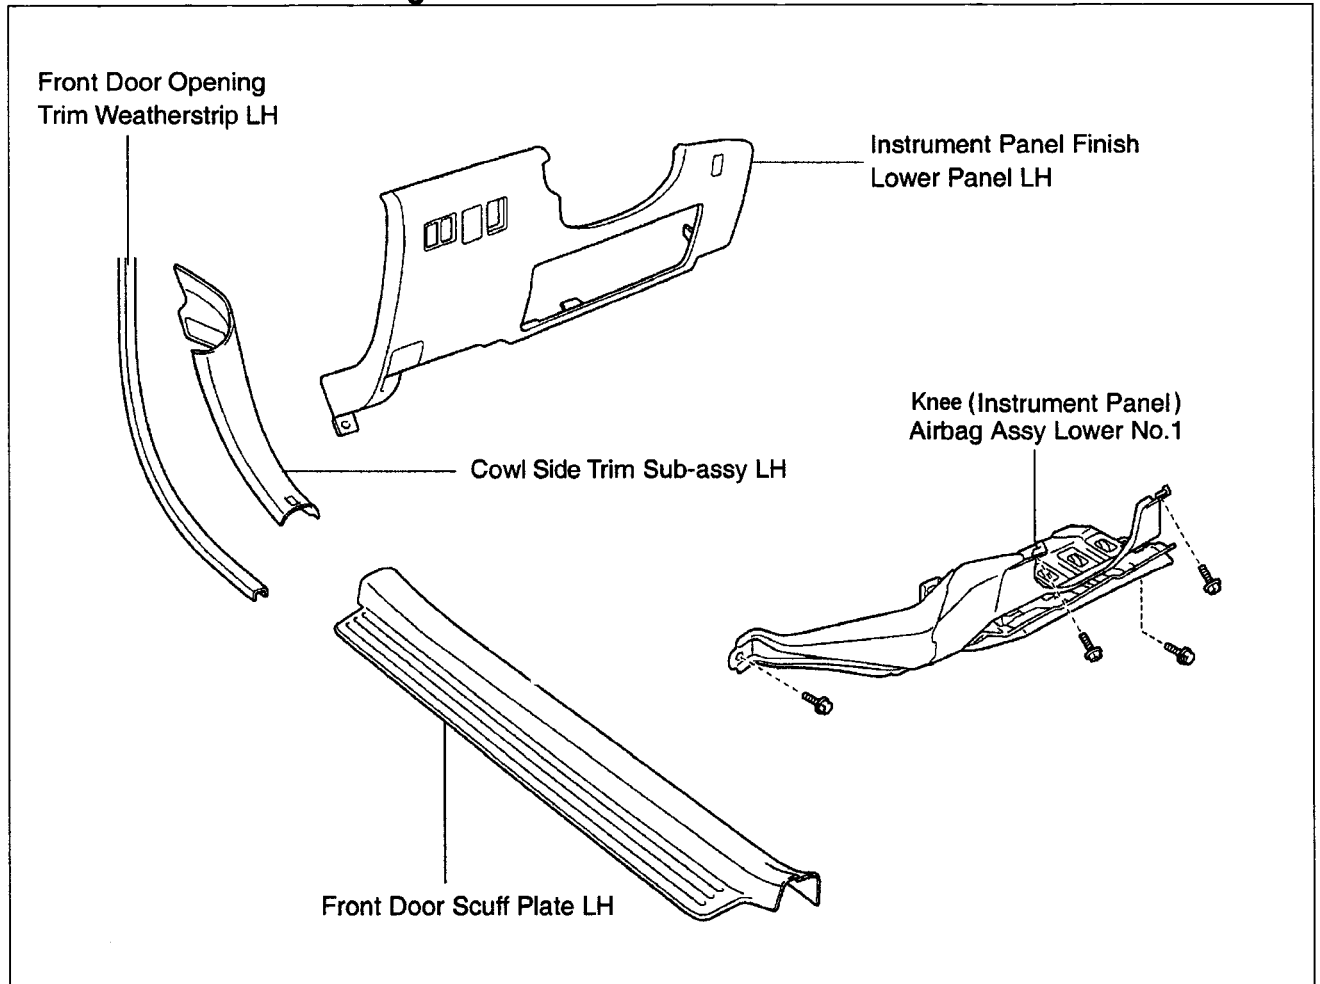
• Driver Side Knee Airbag

Due to improper assembly of the airbag inflator, which is incorporated into the SRS airbag assembly (Side Airbag, Curtain Side Airbag or Driver Knee Airbag), some inflators were produced with an insufficient amount of the heating agents necessary for proper airbag deployment. In this condition, the expansion force of the gas may be insufficient to properly inflate the airbag when the SRS system is activated during a collision.

- A. Replace the driver knee airbag following the procedures outlined in the Supplemental Restraint System section of the appropriate Repair Manual for the vehicle you are working on.

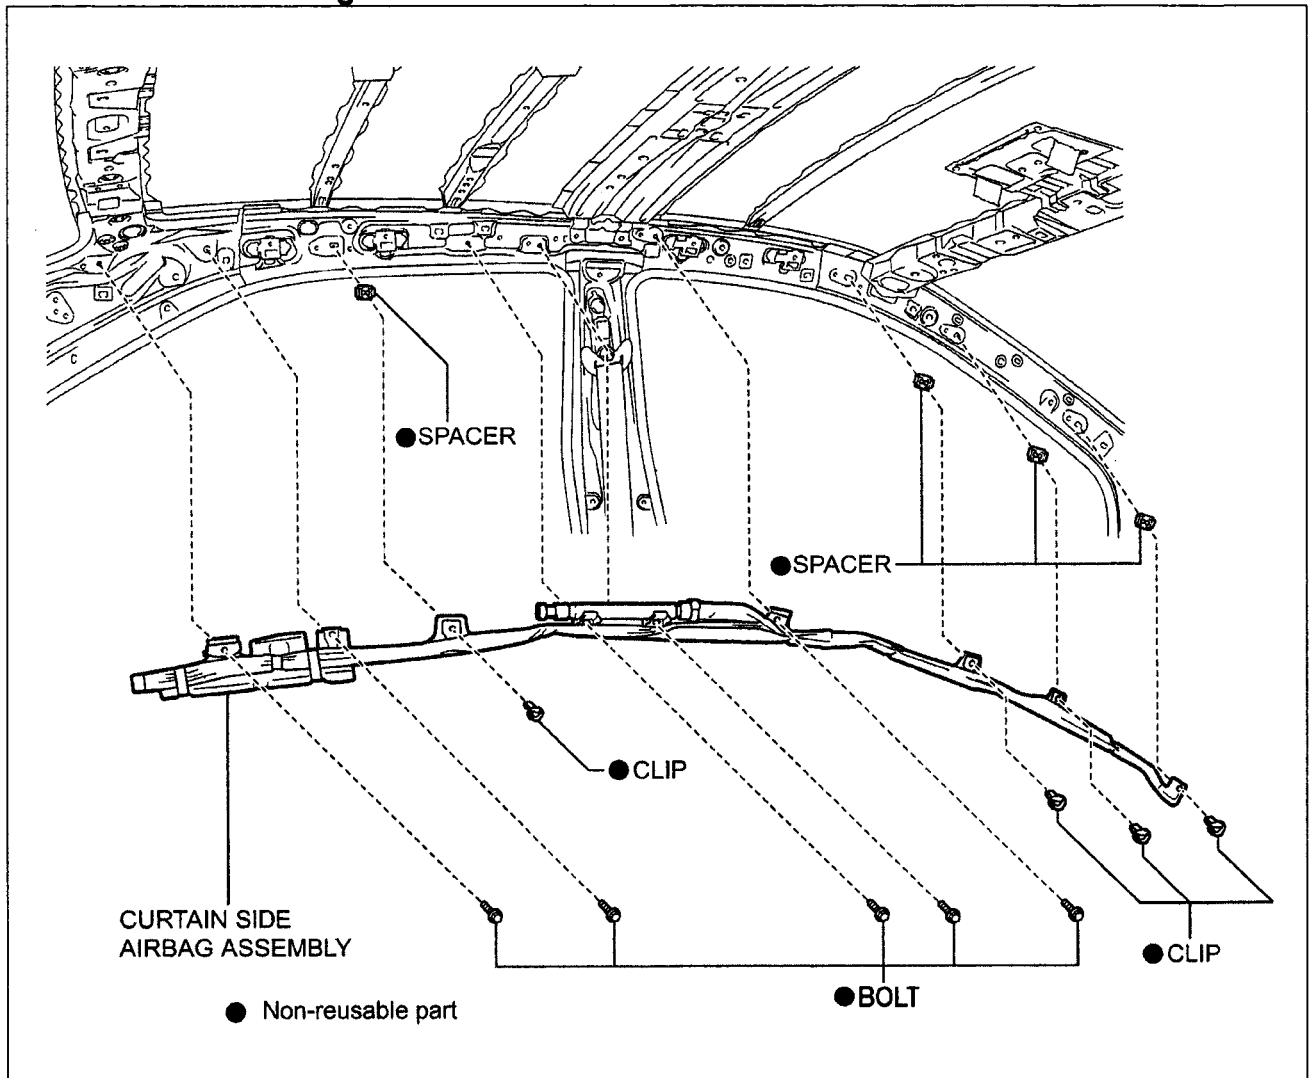
- **Curtain Side Airbag**

Due to improper assembly of the airbag inflator, which is incorporated into the SRS airbag assembly (Side Airbag, Curtain Side Airbag or Driver Knee Airbag), some inflators were produced with an insufficient amount of the heating agents necessary for proper airbag deployment. In this condition, the expansion force of the gas may be insufficient to properly inflate the airbag when the SRS system is activated during a collision.

- A. Replace the curtain side airbag following the procedures outlined in the Supplemental Restraint System section of the appropriate Repair Manual for the vehicle you are working on.

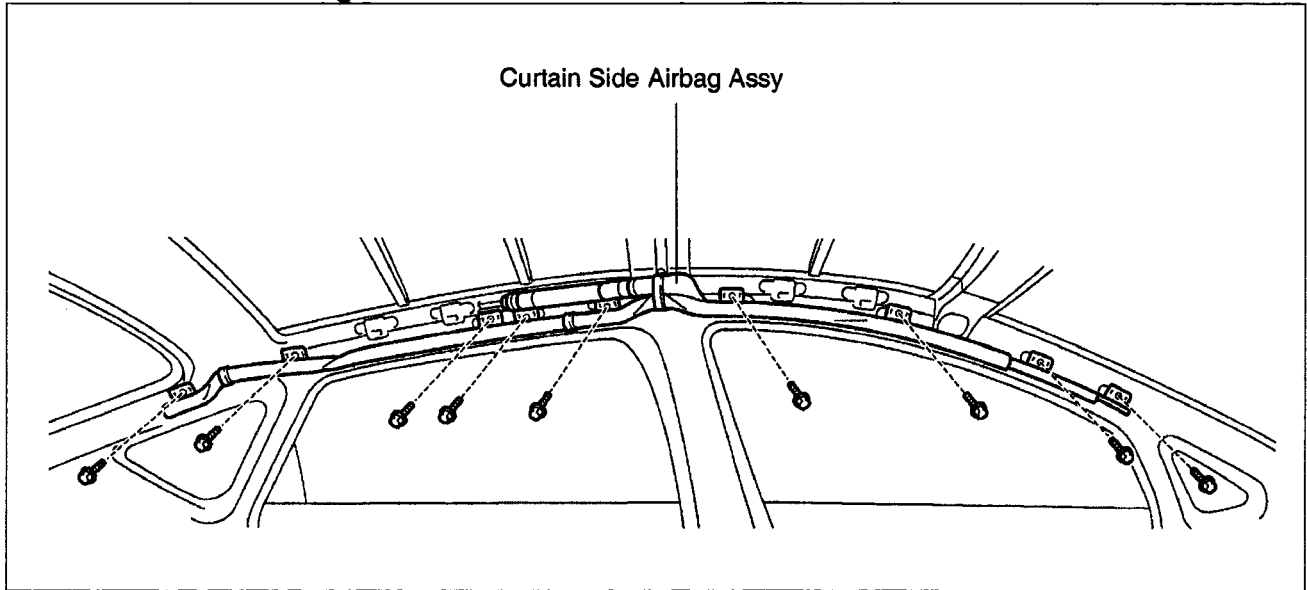
- **Curtain Side Airbag**

Due to improper assembly of the airbag inflator, which is incorporated into the SRS airbag assembly (Side Airbag, Curtain Side Airbag or Driver Knee Airbag), some inflators were produced with an insufficient amount of the heating agents necessary for proper airbag deployment. In this condition, the expansion force of the gas may be insufficient to properly inflate the airbag when the SRS system is activated during a collision.

- A. Replace the curtain side airbag following the procedures outlined in the Supplemental Restraint System section of the appropriate Repair Manual for the vehicle you are working on.

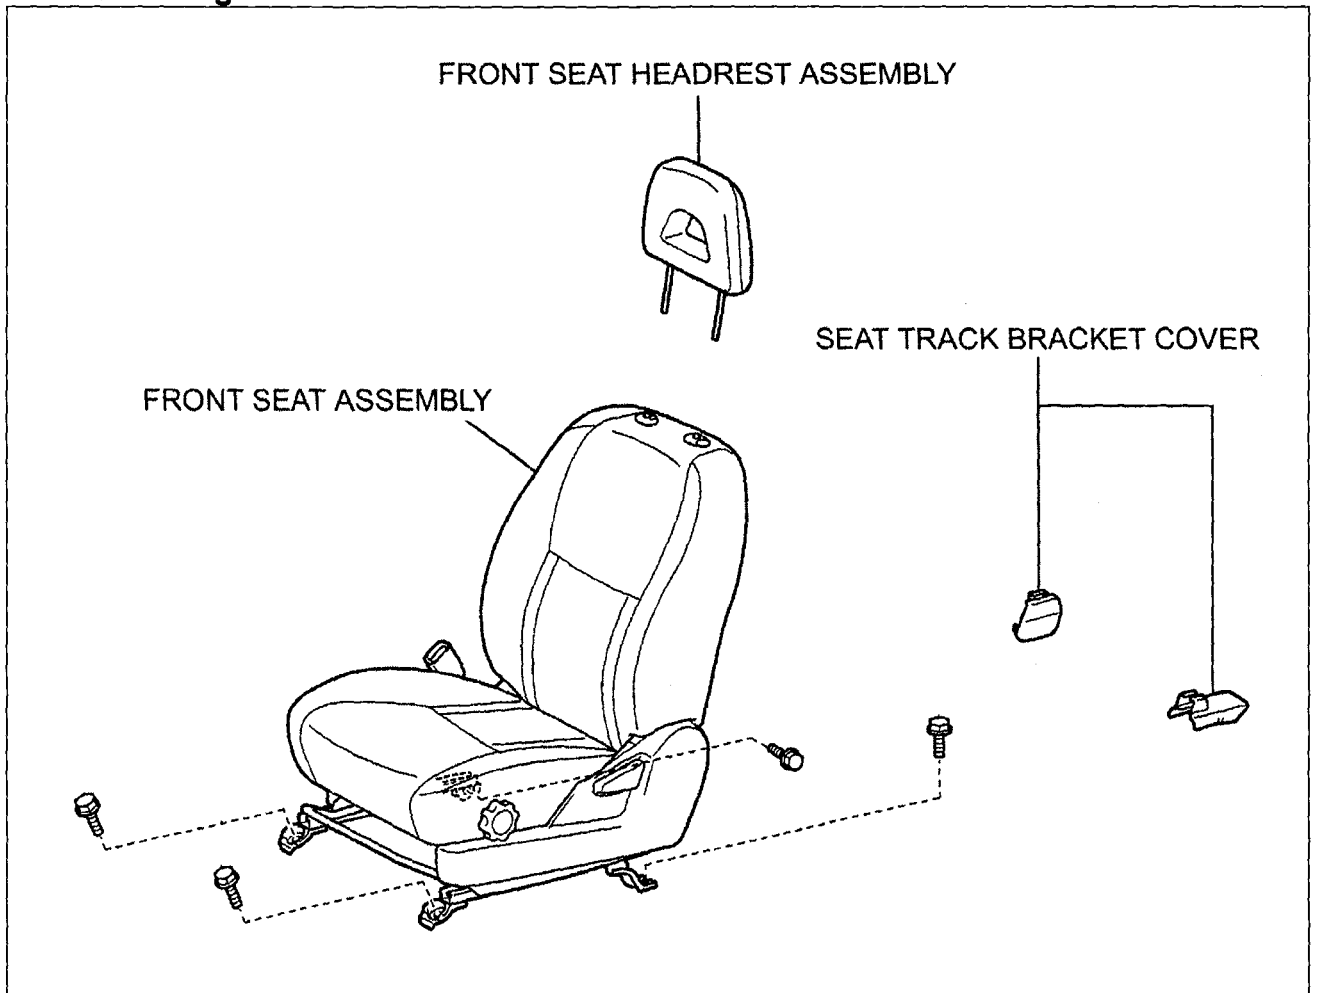
- Side Airbag

Due to improper assembly of the airbag inflator, which is incorporated into the SRS airbag assembly (Side Airbag, Curtain Side Airbag or Driver Knee Airbag), some inflators were produced with an insufficient amount of the heating agents necessary for proper airbag deployment. In this condition, the expansion force of the gas may be insufficient to properly inflate the airbag when the SRS system is activated during a collision.

- A. Replace the side airbag following the procedures outlined in the Body: Front Seat section of the appropriate Repair Manual for the vehicle you are working on.

To replace the side airbag, the entire seat must be replaced.

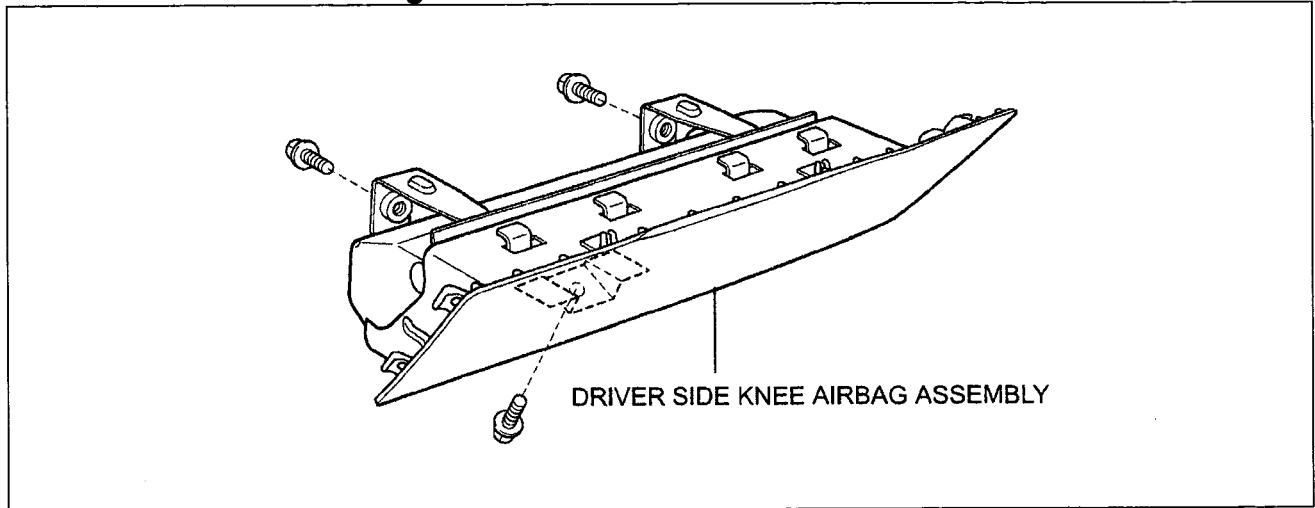
- Driver Side Knee Airbag

Due to improper assembly of the airbag inflator, which is incorporated into the SRS airbag assembly (Side Airbag, Curtain Side Airbag or Driver Knee Airbag), some inflators were produced with an insufficient amount of the heating agents necessary for proper airbag deployment. In this condition, the expansion force of the gas may be insufficient to properly inflate the airbag when the SRS system is activated during a collision.

- A. Replace the driver knee airbag following the procedures outlined in the Supplemental Restraint System section of the appropriate Repair Manual for the vehicle you are working on.

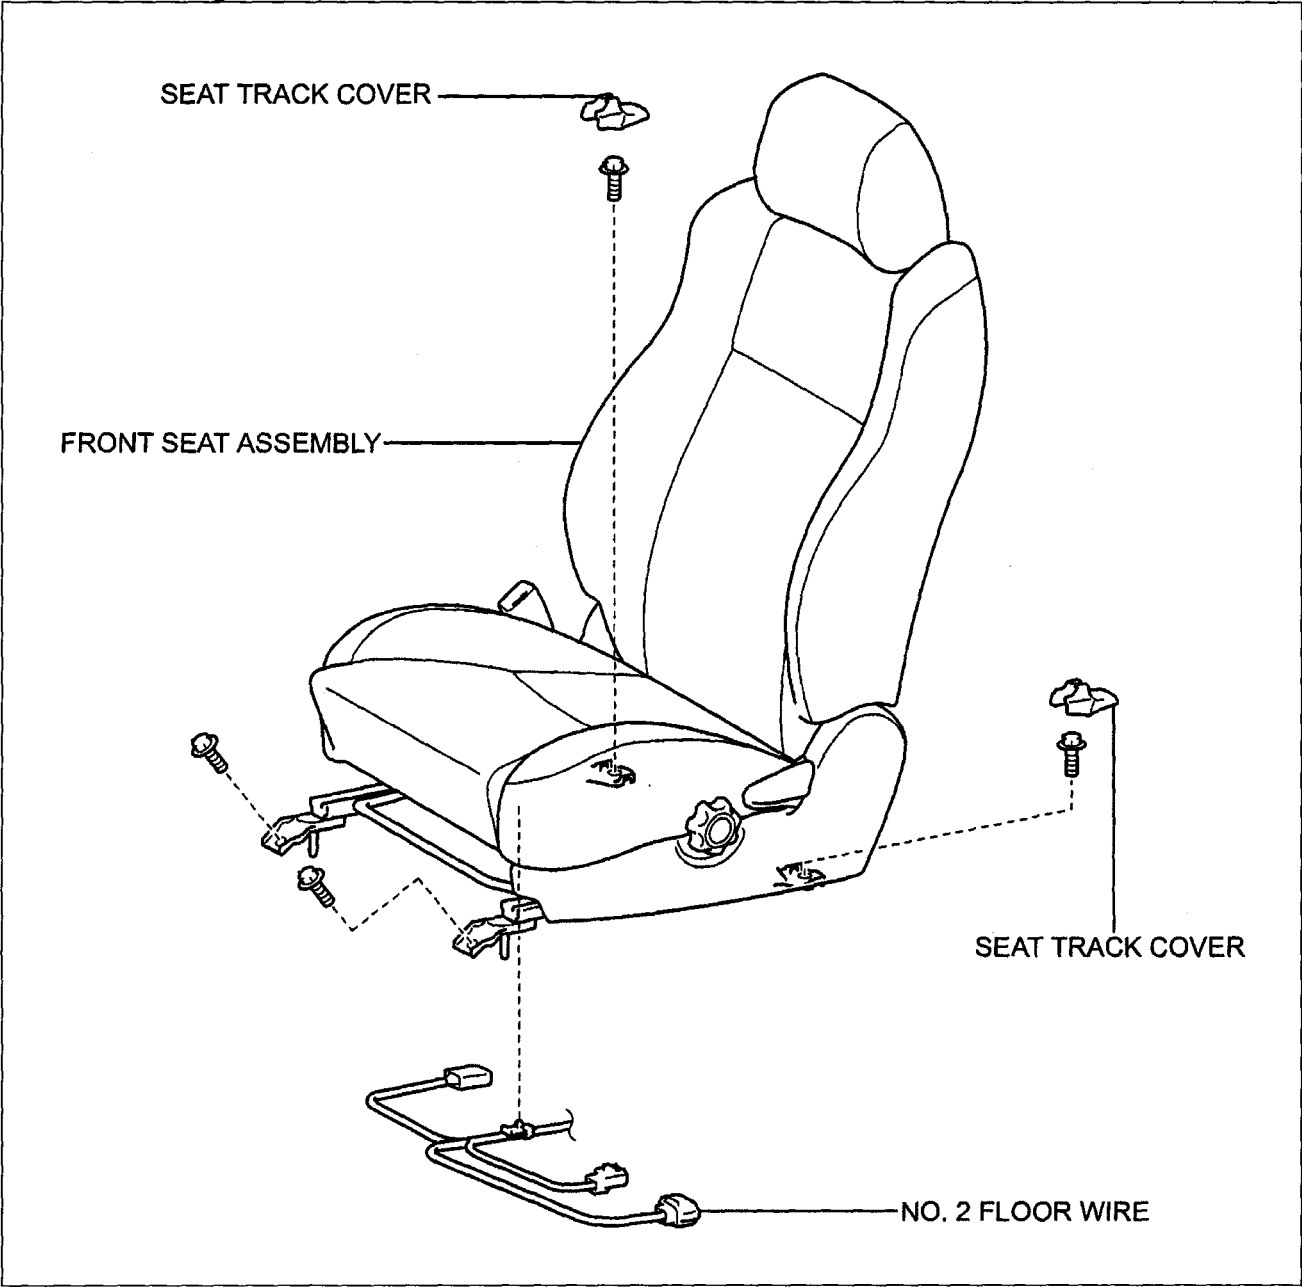
- Side Airbag

Due to improper assembly of the airbag inflator, which is incorporated into the SRS airbag assembly (Side Airbag, Curtain Side Airbag or Driver Knee Airbag), some inflators were produced with an insufficient amount of the heating agents necessary for proper airbag deployment. In this condition, the expansion force of the gas may be insufficient to properly inflate the airbag when the SRS system is activated during a collision.

- A. Replace the side airbag following the procedures outlined in the Seat: Front Seat section of the appropriate Repair Manual for the vehicle you are working on.

To replace the side airbag, the entire seat must be replaced.
