Campaign No. 2006040002, June 2006

SUBJECT: **MODEL 251, MODEL YEAR 2006**
INSPECT STARTER WIRING HARNESS; REPAIR OR REPLACE IF NECESSARY

Mercedes-Benz
2006 R-Class

Safety Recall #2006040002

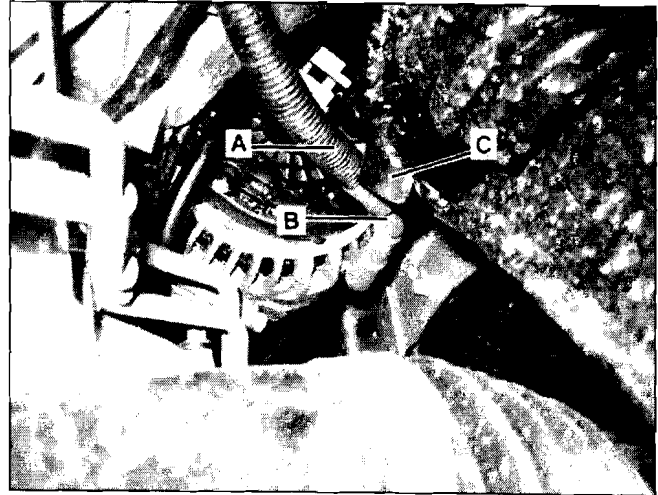
Figure 1

1. Raise vehicle on lift; refer to WIS document AR00.60-P-1000RT.
2. Inspect starter wiring harness corrugated tube (A, Figure 1) and red insulation (B) for damage in area of engine support shield (C).
 - If the starter wiring harness corrugated tube and insulation are not damaged: perform **SUBJECT B**.
 - If the starter wiring harness corrugated tube is damaged: perform **SUBJECT C**.
 - If the starter wiring harness corrugated tube and red insulation are damaged: perform **SUBJECT D**.
