Re: 49 CFR Part 573; Recall of Mercedes-Benz R-Class (251) Starter Wiring Harness

Re: Update Recall Campaign 2006 040002 - Starter Wiring Harness, Model 251 MY 2006

Campaign No. 2006040002, July 2006

SUBJECT: **MODEL 251, MODEL YEAR 2006
 INSPECT STARTER WIRING HARNESS; REPAIR OR REPLACE IF NECESSARY**

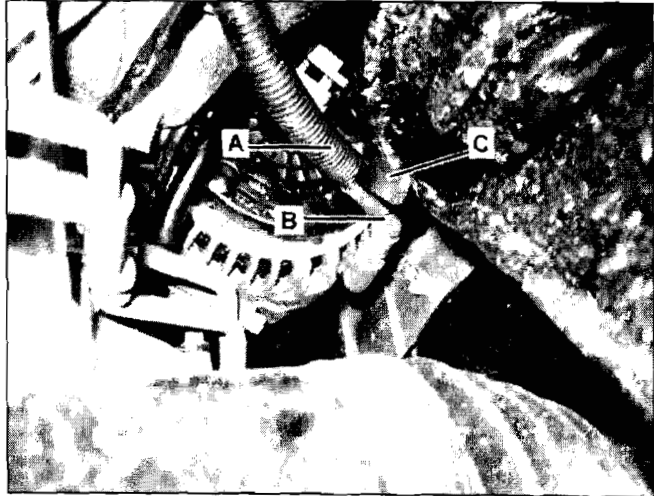
Figure 1

1. Raise vehicle on lift; refer to WIS document AR00.60-P-1000RT.
2. Inspect starter wiring harness corrugated tube (A, Figure 1) and red insulation (B) for damage in area of engine support shield (C).
 - If the starter wiring harness corrugated tube and insulation are not damaged: perform **Subject B**.
 - If the starter wiring harness corrugated tube is damaged: perform **Subject C**.
 - If the starter wiring harness corrugated tube and red insulation are damaged: perform **Subject D**.
