Re: 49 CFR Part 573; Recall of Mercedes-Benz R-Class (251) Starter Wiring Harness

Re: Recall Campaign 2006 040002 – Starter Wiring Harness, Model 251 MY 2006

Campaign No. 2006040002, May 2006

TO: ALL MERCEDES-BENZ CENTERS
SUBJECT: **MODEL 251, MODEL YEAR 2006**
INSPECT STARTER WIRING HARNESS; REPAIR OR REPLACE IF NECESSARY

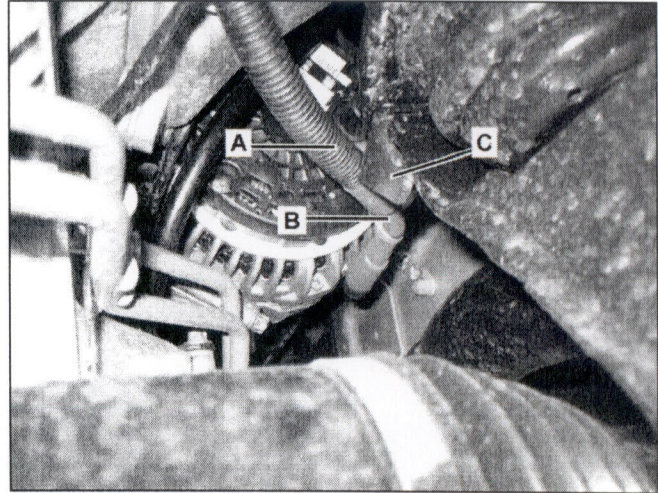
Figure 1

1. Raise vehicle on lift; refer to WIS document AR00.60-P-1000RT.
2. Inspect starter wiring harness corrugated tube (A, Figure 1) and red insulation (B) for damage in area of engine support shield (C).
 - If the starter wiring harness corrugated tube and insulation are not damaged: perform **SUBJECT B**.
 - If the starter wiring harness corrugated tube is damaged: perform **SUBJECT C**.
 - If the starter wiring harness corrugated tube and red insulation are damaged: perform **SUBJECT D**.
