SAFETY RECALL BULLETIN

AUTOCAR SAFETY RECALL A-0602 NHTSA RECALL 06V-100

SUBJECT: STEERING SHAFT YOKE BOLT

AFFECTED: CERTAIN AUTOCAR MODEL WX AND WXR HEAVY-DUTY CLASS 8 VEHICLES BUILT BETWEEN FEBRUARY 6, 2006 AND MARCH 3, 2006 WITHIN VIN RANGE 203014 TO 203377

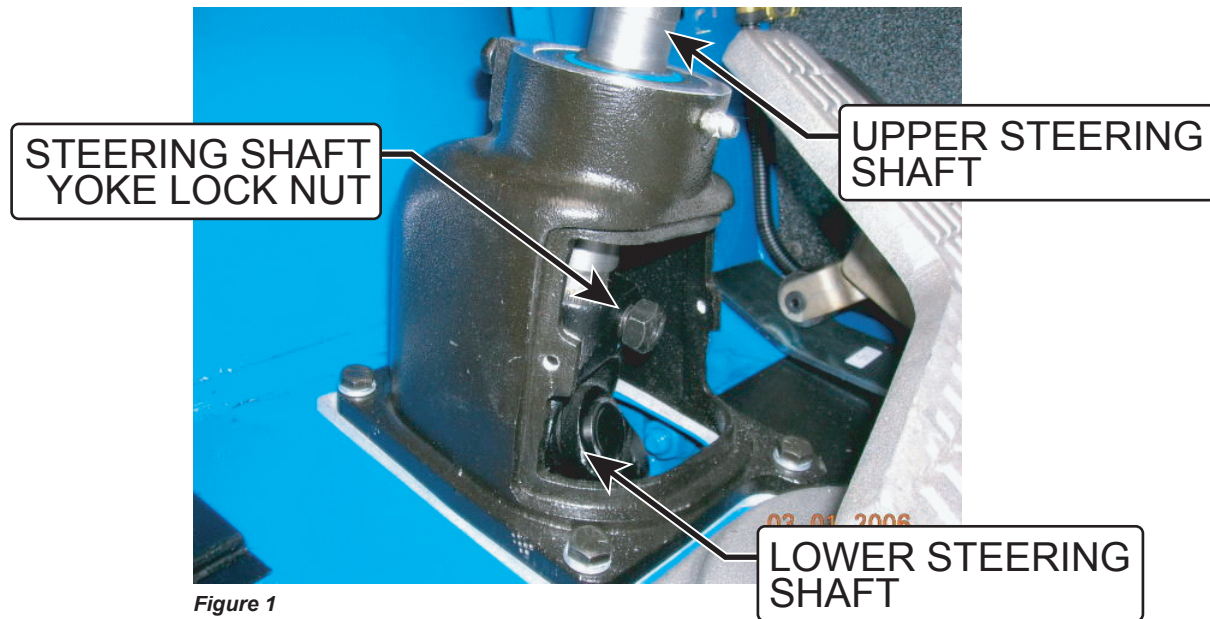
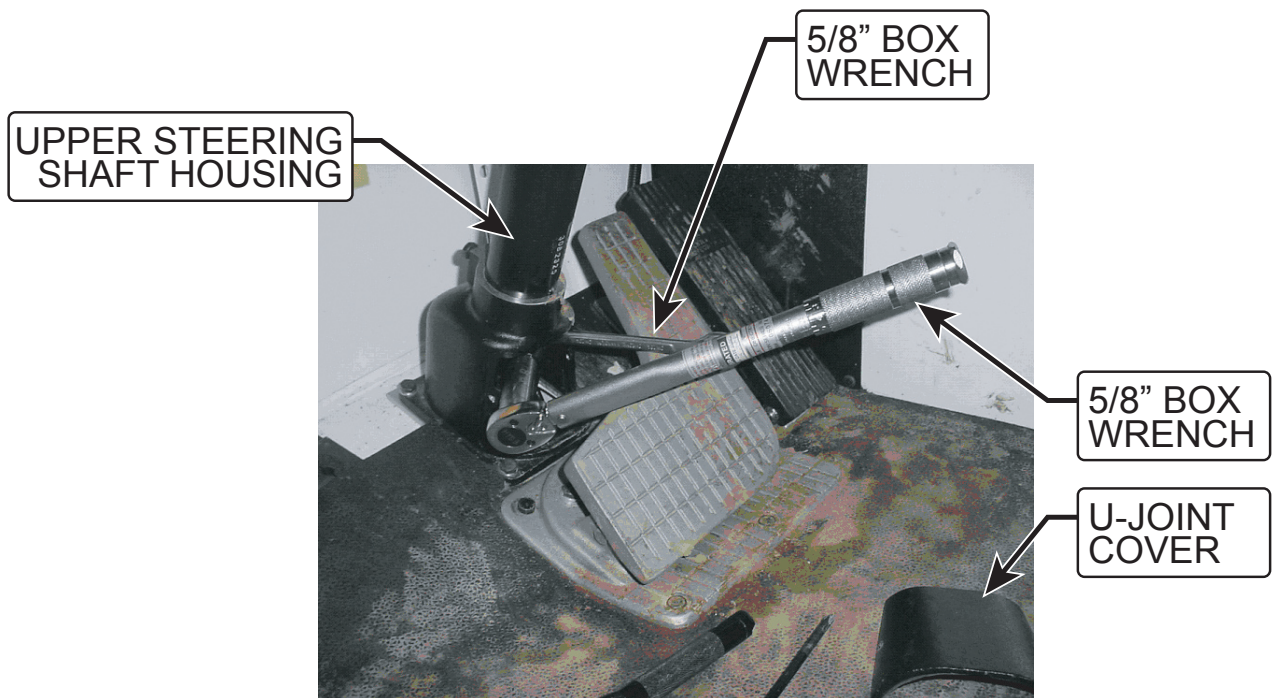
On certain the affected vehicles, the bolt on the steering shaft may not be tightened to the correct specification, and the possibility exists that due to the loose nut, the yoke bolt could slide out partially and limit the rotation on the steering shaft. A loss of steering control may increase the risk of a crash.

- Step 1:** Turn the battery disconnect switch to the **OFF** position.
- Step 2:** Locate the steering shaft universal joint cover plate at the bottom of the steering column inside the cab (see **Figures 1** and **2** on the following page).
- 2a.** For WX and WX dual drive trucks, this is behind the brake pedal in the left-hand foot well
- 2b.** For WXR trucks, this is behind the brake pedal in the right-hand foot well
- Step 3:** Remove the two Phillips-head screws holding the cover plate in place, then remove the cover plate to expose the steering shaft universal joint.
