May 12, 2006

SUBJECT: Compliance Recall 06C12
Certain 2005 Escape & Mariner Vehicles Without Side Air Curtains or Moonroof -
Headliner Inspection and Modification

CERTAIN 2005 ESCAPE AND MARINER VEHICLES WITHOUT SIDE AIR CURTAINS OR MOONROOF — HEADLINER INSPECTION AND MODIFICATION

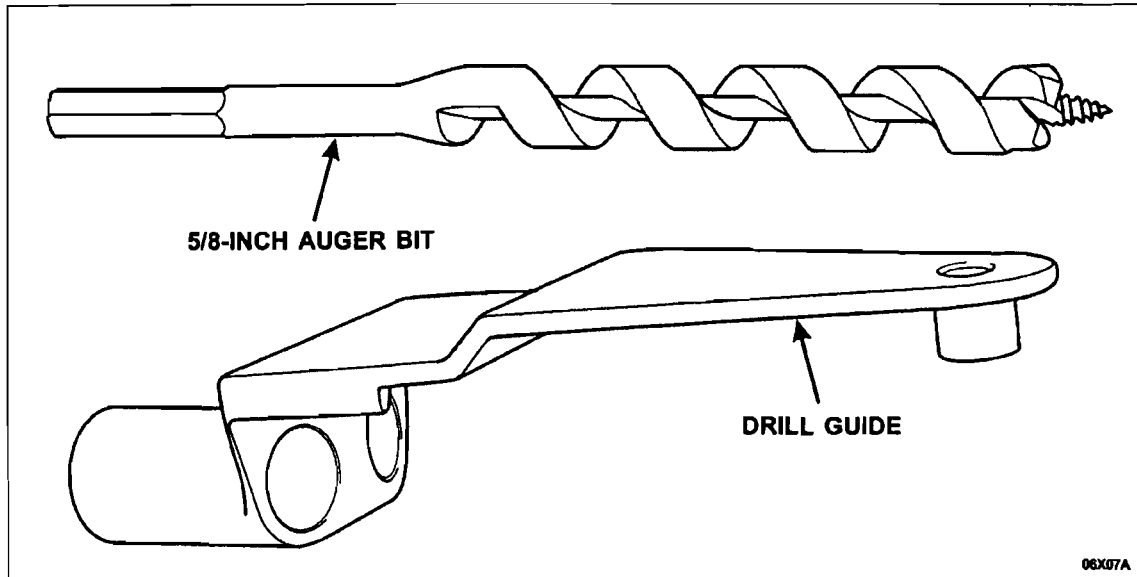
FIGURE 1

This program involves lowering the headliner enough to inspect the structural foam blocks which are mounted above the front corners of the headliner. Depending on the results of the inspection, dealers will either release the vehicle, or modify the structural foam blocks using a special tool and a 5/8 inch auger bit. See Figure 1.

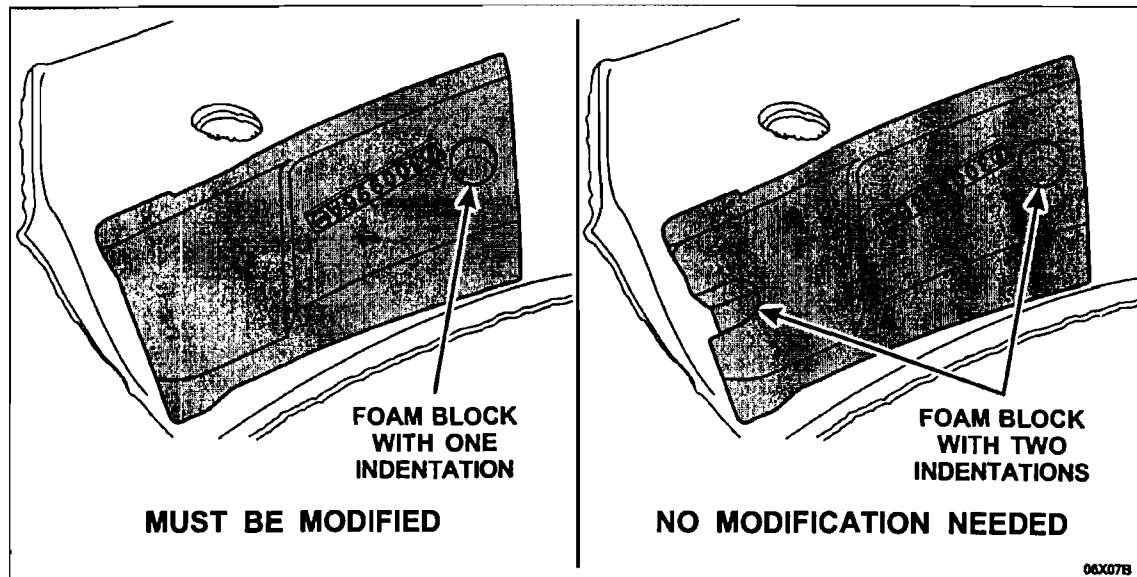
FIGURE 2

1. Without pulling the headliner down beyond its natural hanging rest position, carefully inspect the structural foam blocks mounted at the passenger and drivers side front corners on the top of the headliner to see if they have one (1) or two (2) indentations. See Figure 2.

- If the blocks have only one (1) indentation, proceed to DISASSEMBLY FOR MODIFICATION.
- If the blocks have two (2) indentations, no modification is required. Proceed to ASSEMBLY.
