**SUBJECT:** Safety Recall 03S04 Supplement #1:  
Certain 1998-2002 Model Year Explorer and Mountaineer Vehicles Equipped With  
High Back Seats - Driver Seat Recliner Bolt

**Safety Recall 03S04-S1**  
Certain 1998-2002 Model Year Explorer and Mountaineer Vehicles  
Driver Seat Back Latch Bolt

## CERTAIN 1998-2002 MODEL YEAR EXPLORER AND MOUNTAINEER VEHICLES — DRIVER SEAT RECLINER BOLT

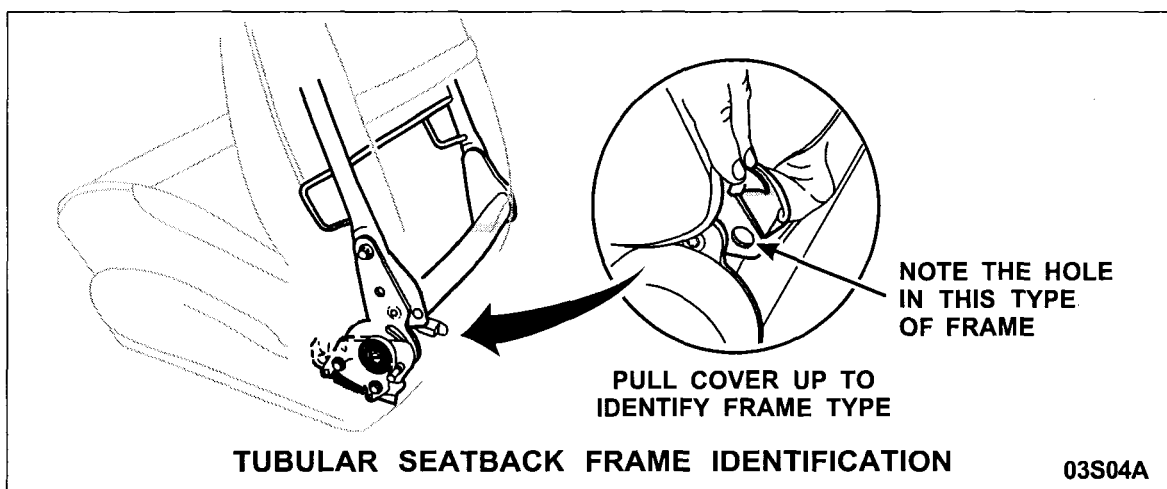
FIGURE 1

- Tubular seatback frames can be identified by a hole in the lower flange where the recliner mechanism attaches to the seatback frame. See Figure 1.
- Stamped seatback frames can be identified by not having the tell-tale hole in the frame that is evident on the tubular seatback frame. See Figure 2.
