Subject: 3rd Notification for 2005 Tribute Headliner Compliance Recall 4006D and 2nd Notification for 2001-2004 Tribute Anti-Lock Brake System Voluntary Safety Recall 4507C.

SUBJECT: 2005 Tribute Headliner Compliance Recall 4006D – **RENOTIFICATION**

2005 Tribute Headliner Compliance Recall 4006D - RENOTIFICATION

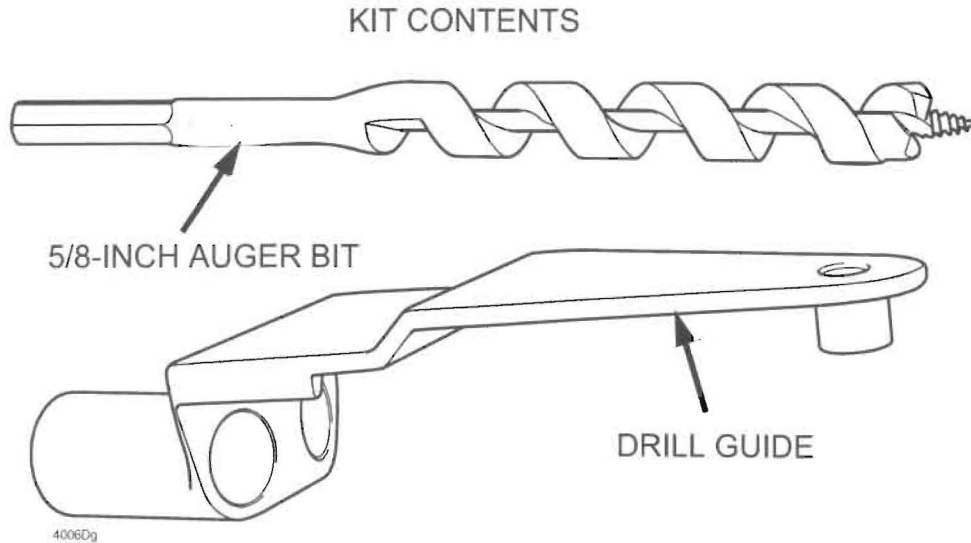
This program involves inspecting the structural foam blocks mounted at the front corners on the top of the headliner. If necessary, the foam blocks will be modified by drilling two (2) holes in each block with a supplied drill guide and auger drill bit.

The purpose of this modification is to bring the foam blocks into compliance with FMVSS 201, Occupant Protection in Interior Impact. Vehicles equipped with a moonroof or side air curtains are not involved.

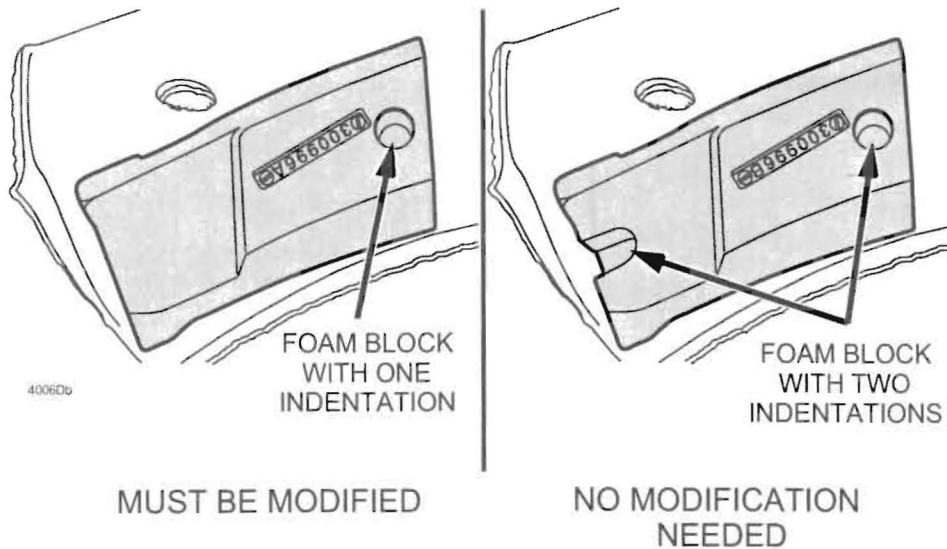
1. Without pulling the headliner down beyond its natural hanging rest position, carefully inspect the structural foam blocks mounted at the passenger and drivers side front corners on the top of the headliner to see if they have one (1) or two (2) indentations.

- If the blocks have two (2) indentations, no modification is required. Proceed to ASSEMBLY.
- If the blocks have only one (1) indentation, proceed to DISASSEMBLY FOR MODIFICATION.
