## BMW Motorrad Service Information Bulletin

### **\*\*Recall Campaign 06V-134 - Sensor Cable Routing\*\***

**Subject:** Recall 06V-134 - Change to the routing of the front ABS sensor cable

**Model:** R 1200 GS (K25), R 1200 RT (K26), R 1200 ST (K28) with Integral ABS

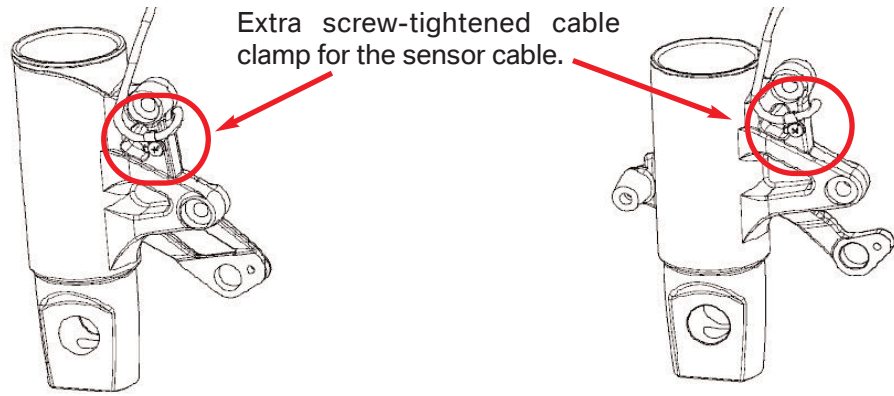
**Production Solution:** The routing of the sensor cable has been changed in series production for all three types of motorcycle (see Figs. 1-3).

Fig. 1: New routing, R 1200 GS sensor cable

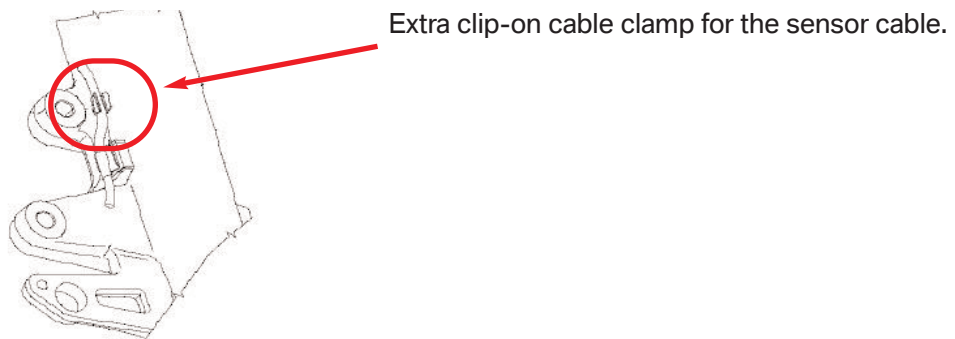
Fig. 2: New routing, R 1200 ST sensor cable

Fig. 3: New routing, R 1200 RT sensor cable

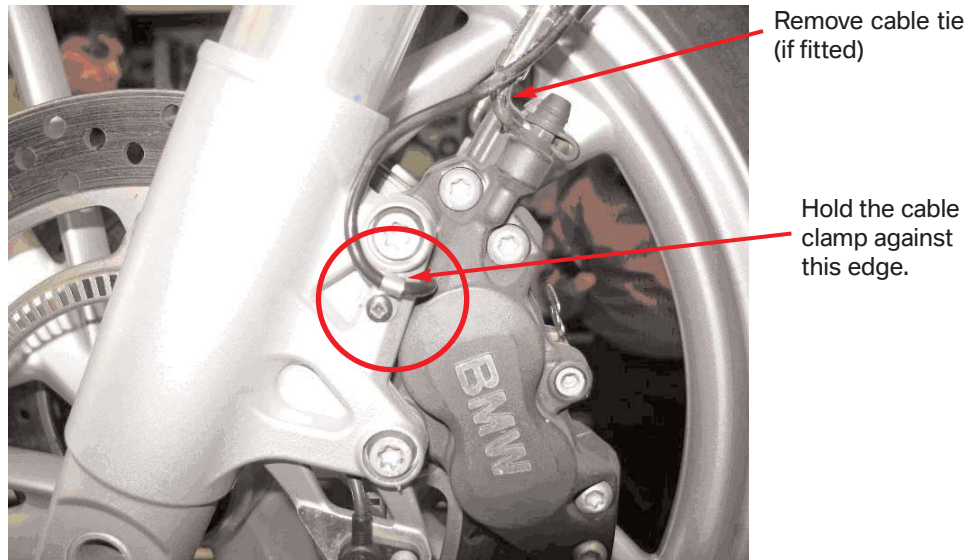
Fig. 4: location of the new sensor cable routing of the R 1200 GS.

1. Remove the left brake caliper
2. Hold the cable clamp as shown in Fig. 4 at the bottom edge for the mount of the brake-caliper screw and use a centre-punch to mark the position for drilling the hole in the middle of the dome.
3. Drill a hole 3.7 mm in diameter through the brake-caliper mount.
4. It might be necessary to open a cable tie underneath the fuel tank to obtain enough slack on the sensor cable.
5. Use the new cable clamp to secure the sensor cable as shown in Fig. 4.
6. Position the double clips on the brake line as shown in Fig. 5.

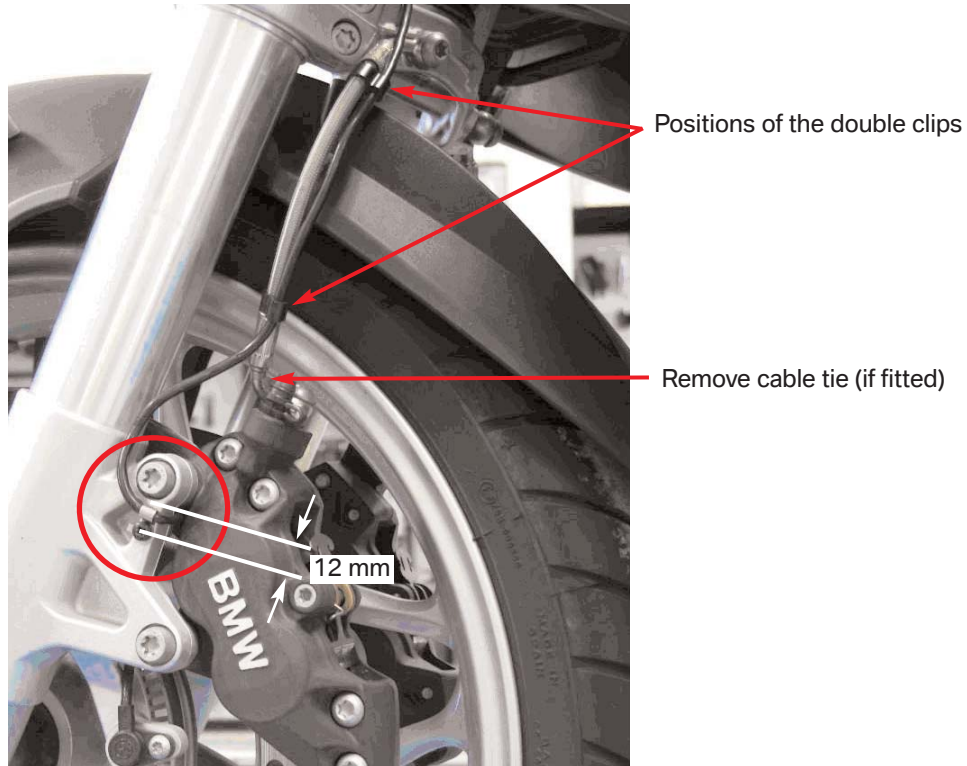
Fig. 5: location of the new sensor cable routing of the R 1200 ST.

1. Remove the left brake caliper
2. Centre-punch to mark the position for drilling the hole. See Fig. 5 for details of the position for the hole.
3. Drill a hole 3.7 mm in diameter through the brake-caliper mount.
4. It might be necessary to open a cable tie underneath the fuel tank to obtain enough slack on the sensor cable.
5. Use the new cable clamp to secure the sensor cable as shown in Fig. 5.
6. Position the double clips on the brake line as shown in Fig. 5.

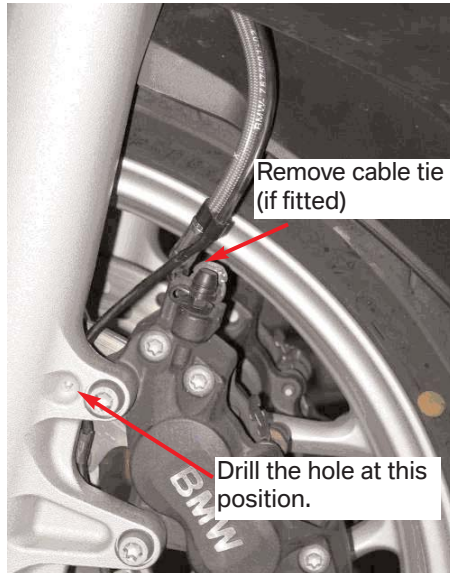
Fig. 6: Location of the new sensor cable routing of the R 1200 RT.

1. Remove the left brake caliper.
2. Remove and unclip the ABS sensor from its holder.
3. Working from the outboard side, drill a hole 4 mm in diameter through the brake-caliper mount, as shown in Fig. 6.
4. Working from the inboard side, seat the clip in the hole you just drilled and secure the sensor cable as shown in Fig. 7.
5. Position the double clips on the brake line in the same way as for the R 1200 GS and R 1200 ST (see Fig. 5).

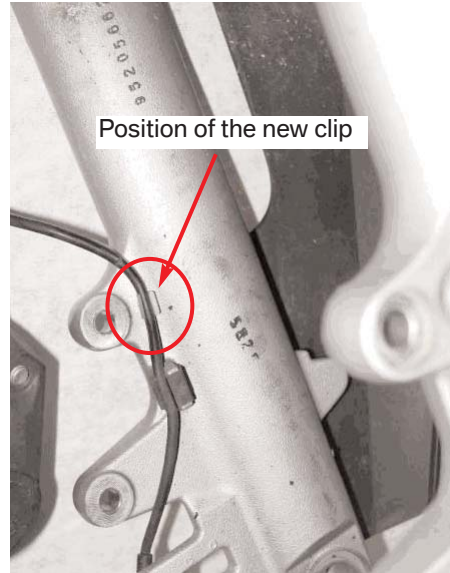
Fig. 7: Inboard side of the R 1200 RT front fork showing the location of the new clip
