December 7, 2006
Bulletin SB06-09-S002

2006 ISUZU *i*-280 AND *i*-350 SAFETY RECALL CAMPAIGN
BRAKE LAMPS INOPERATIVE OR CONTINUOUS ILLUMINATION

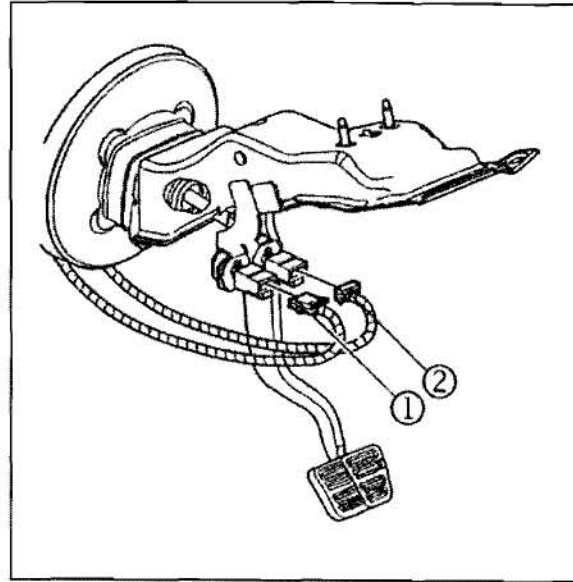
IMPORTANT: *There are two switches above the brake pedal - the cruise control switch (1) and the stop lamp switch (2). The cruise control switch is in the outboard position and the stop lamp switch is in the inboard position.*

1. Disconnect the cruise control switch connector (1) and stop lamp switch electrical connector (2).
2. Rotate the stop lamp switch (2) counter clockwise.
3. Remove the stop lamp switch (2) from the bracket.
4. Remove the stop lamp switch (2) from the vehicle. Discard the stop lamp switch (2).
5. Inspect the stop lamp switch retainer.
 - If the stop lamp switch retainer is not broken, proceed to Step 6.
 - If the stop lamp switch retainer is broken, replace the retainer and then proceed to Step 6.
6. Position the new stop lamp switch near the bracket.
