## WORKHORSE CUSTOM CHASSIS SERVICE BULLETIN

**BULLETIN NO:** 20601-C **May, 2006**

**SUBJECT:** Steering Intermediate Shaft

**MODELS:** Certain 2005 and 2006 W20/22/24 Series Motorhome Chassis

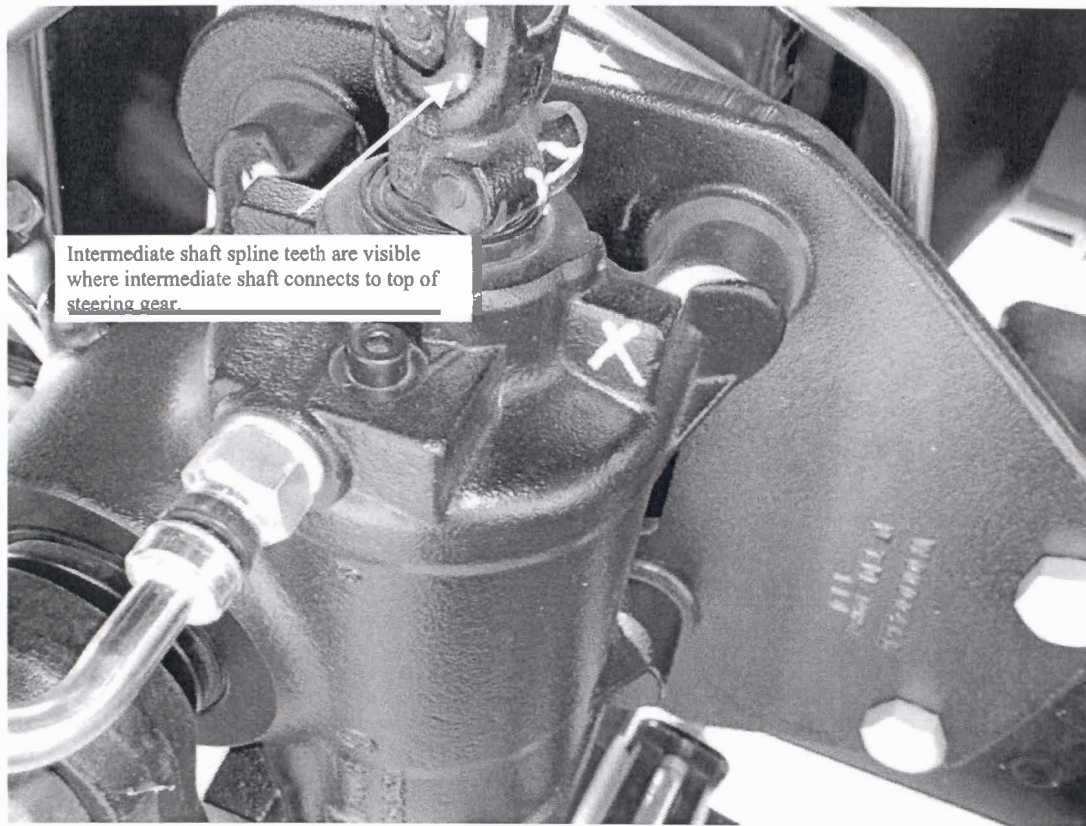
Inspect the intermediate shaft where it is connected to the input shaft at the top of the steering gear. The spline on the intermediate shaft is visible above the tip of the steering gear input shaft, as indicated in the photograph below:

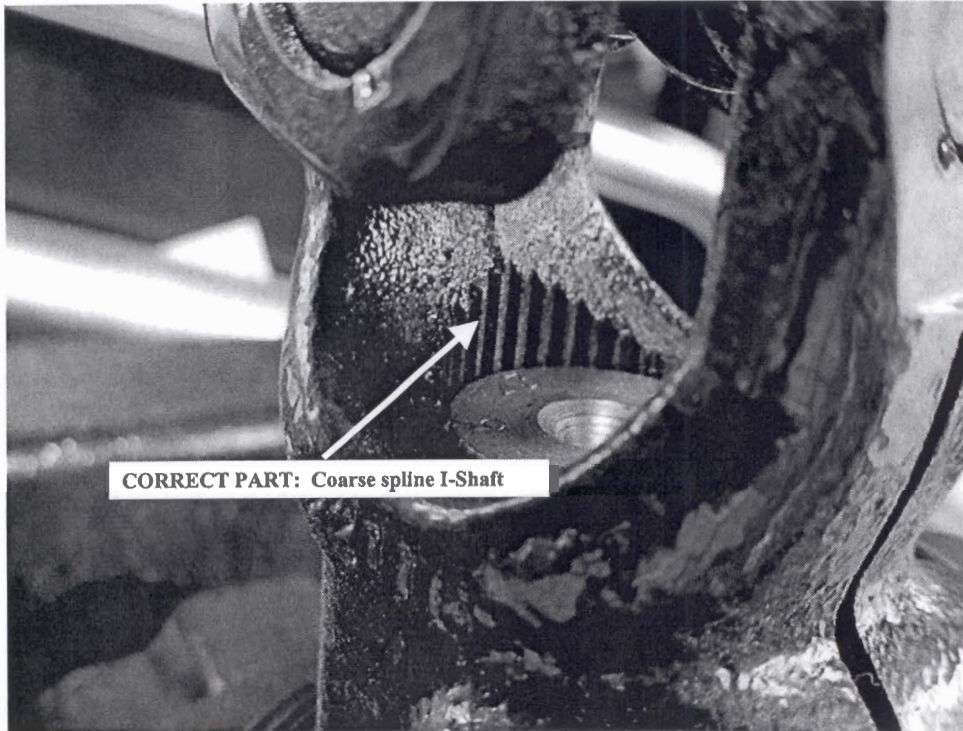
The coarse spline I-shaft is shown above. This is correct for W20/22/24 models.

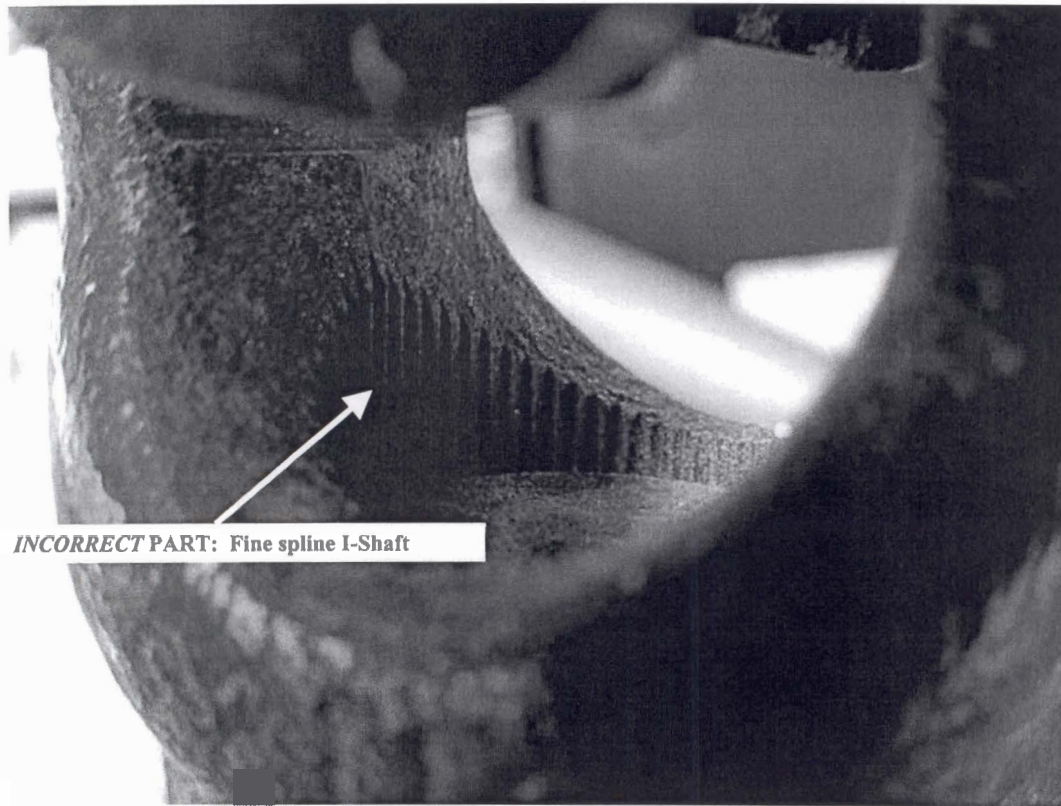
An incorrect steering intermediate shaft may have been installed on some of the subject chassis during the relevant production period. The incorrect part (W0007621) has a finer pitch spline than the correct part (W0000450). Use of the incorrect part may cause the spline not to match correctly with the corresponding steering gear input shaft. On vehicles equipped with the incorrect part, the spline can strip if the steering wheel is turned with a significant amount of force. The force required to strip the spline (i.e., steering wheel input of 10 to 90 ft-lbs of torque) is more than ordinary users will experience. This failure is likely only to occur when the vehicle is stopped or during tight turning maneuvers at very low speeds. This condition may result in a loss of steering control.

The fine spline I-shaft is shown above. This is *incorrect* for W20/22/24 models.

The service procedure for this recall requires inspection of the steering intermediate shaft to determine if the correct part was installed (as shown in the attached Inspection Procedure). If an incorrect shaft is identified, it should be replaced with the correct part (Part Number W0000450). Torque pinch bolt to 36-40 ft-lbs.
