Reference: NHTSA Identification Number 06V-149

Dealer Service Instructions for:

**Safety Recall F18 - Rear Brake Tubes****Models****2006 (LX) Chrysler 300, Dodge Charger and Magnum**

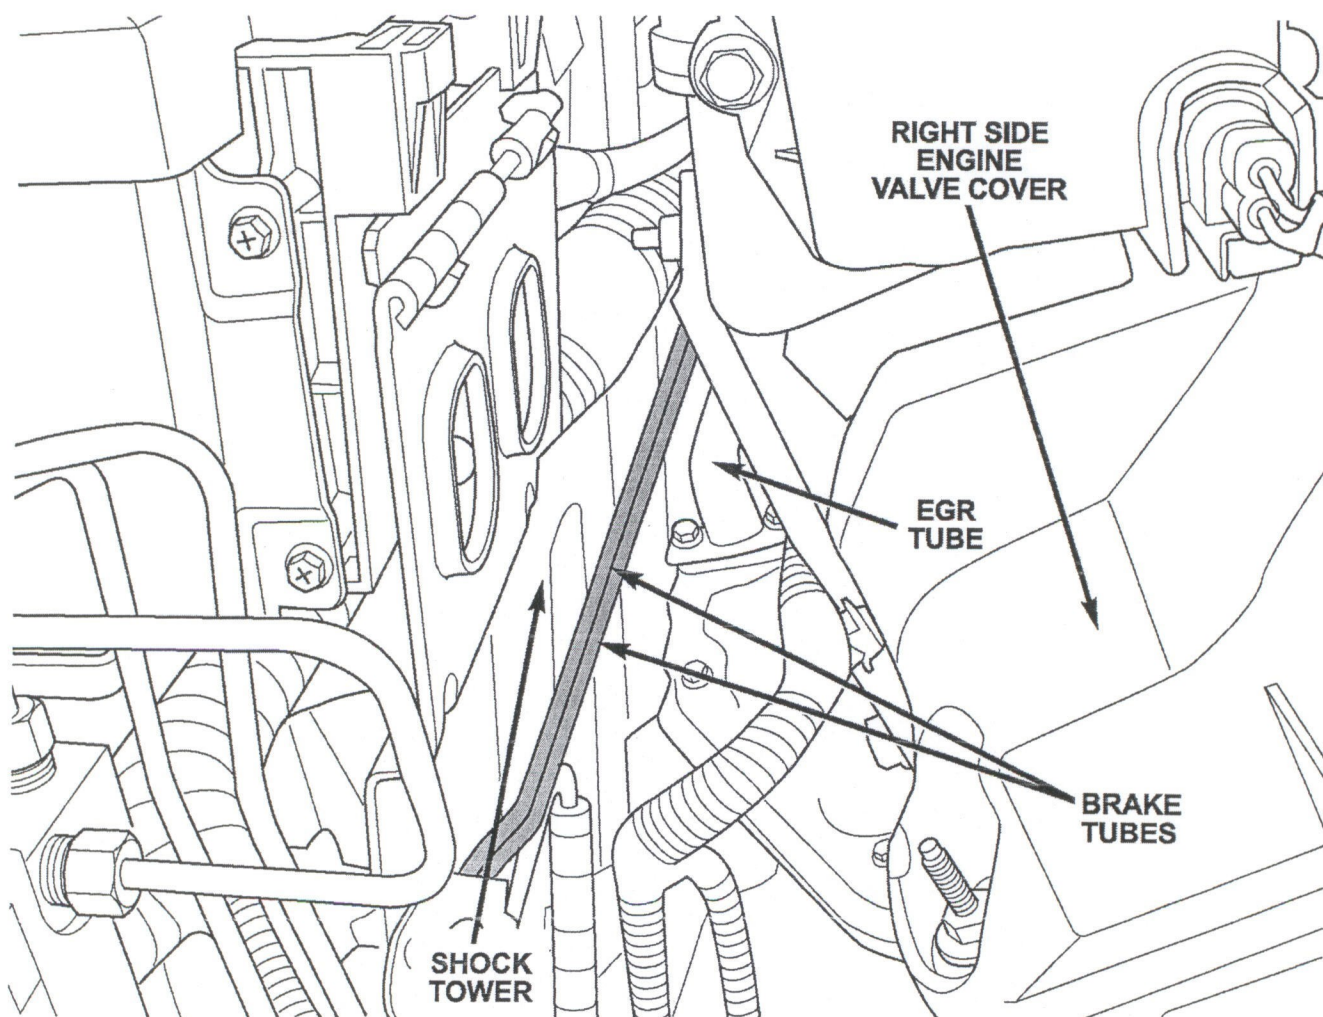
Figure 1

1. Open the hood.
2. Inspect the rear brake tubes that route along the right shock tower for contact with the engine EGR tube (Figure 1).
  - If neither brake tube has contacted the EGR tube or has lightly contacted the EGR tube without rubbing through the black protective coating on the tube, continue with **Section C – Install Rear Brake Tube Retaining Clip**.
  - If either brake tube has contacted the EGR tube and is leaking brake fluid or has rubbed through the black protective coating, continue with **Section B – Replace Rear Brake Tube(s)**.
